The invisible conveyor belt destroyers

Conveyor systems are major components of the average bulk material stockyard, and it is important that they are safeguarded against damage. This article addresses how ozone and ultra violet is dramatically shortening the working life of conveyor belts

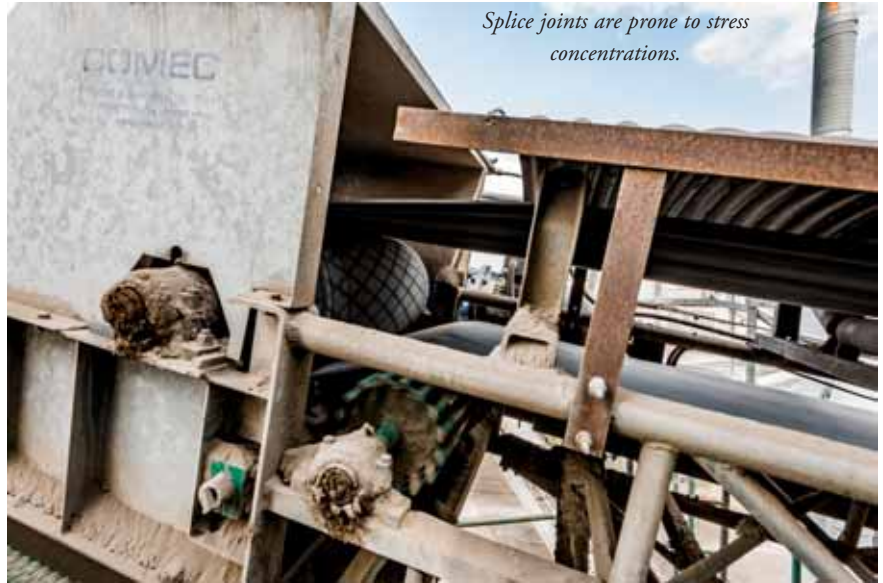
ISO 1431. Lateral cracking. The effects of ozone on rubber.

Ozone cracks form in rubber that is under tension. However, the critical strain needed is only very small. Even a belt that is not fitted on a conveyor has a certain amount of intrinsic tension. The cracks are always oriented at right angles to the strain axis. Ozone attack will occur at the points where the strain is greatest and the rubber is flexing in use. Splice joints are particularly prone to stress concentrations.

At first glance, fine cracks in the surface rubber may not seem to be a major problem but over a period of time the rubber becomes increasingly brittle. Transversal cracks deepen under the

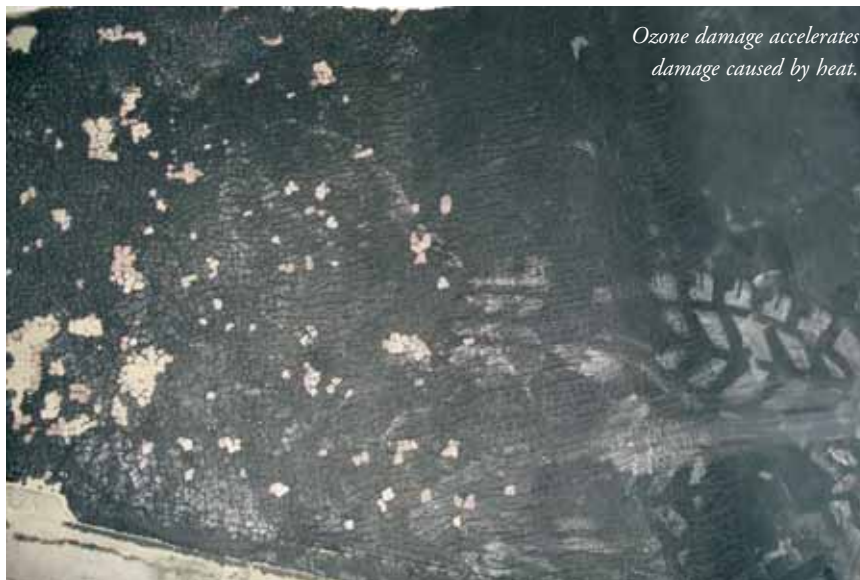
Ozone damage accelerates damage caused by heat.

Apart from the damage caused in their own right, the cracking of the rubber covers by ozone and UV exposure also play a major role in magnifying other causes of damage. As the rubber covers become more brittle and lose strength they also lose the ability to resist abrasive wear. Oil-resistant belts also suffer because the cracked surface

allows the oil to penetrate much more quickly and deeply leading to increased swelling and belt distortion. In heat-resistant belts, the cracks allow heat to penetrate the carcass more easily. An increase of only 10°C in the core temperature of the belt carcass can reduce the life of the belt by as much as 50%.

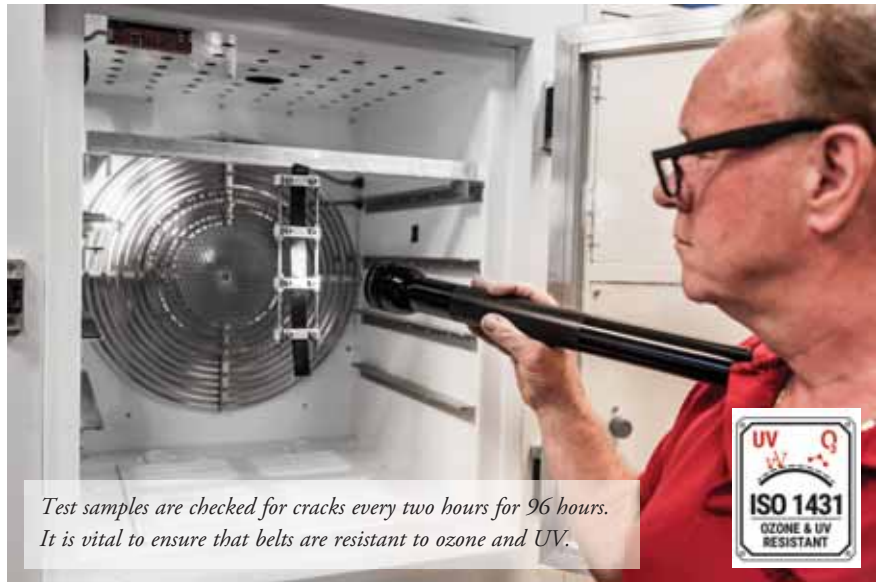
Test samples are checked for cracks every two hours for 96 hours. It is vital to ensure that belts are resistant to ozone and UV.

To scientifically measure resistance to ozone in accordance with the EN/ISO 1431 test method, samples are placed under tension (20% elongation) inside the ozone testing cabinet and exposed to highly concentrated levels of ozone for a period up to 96 hours. Every sample is closely examined for evidence of cracking at two-hourly intervals and the results carefully measured and recorded.

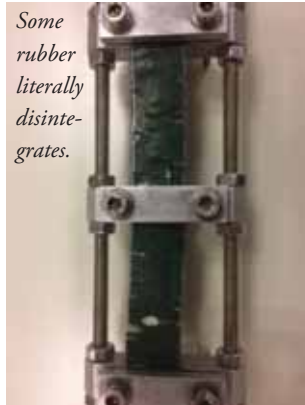
Some rubber literally disintegrates.

It may sound cynical but the reality is that it is not really in the best interests of belt manufacturers (or traders and service companies for that matter) for conveyor belts to run and run and run, particularly if they are trying to compete on price, which is pretty much the usual approach. This is especially so when you consider that a huge proportion of belting is directly or indirectly imported from Asia. We have hardly ever tested a competitor's belt (and never an Asian import belt as far as I know) that has survived the EN/ISO 1431 test specific conditions without cracking. In many cases the rubber literally disintegrates.
