No more dirty tricks and false economies

In the second of a two-part series, Dunlop Conveyor Belting's **Les Williams** reveals why profiled conveyor belts can be so notoriously unreliable and prone to damage, the truth about fire-resistance, and the dirty tricks used by unscrupulous suppliers

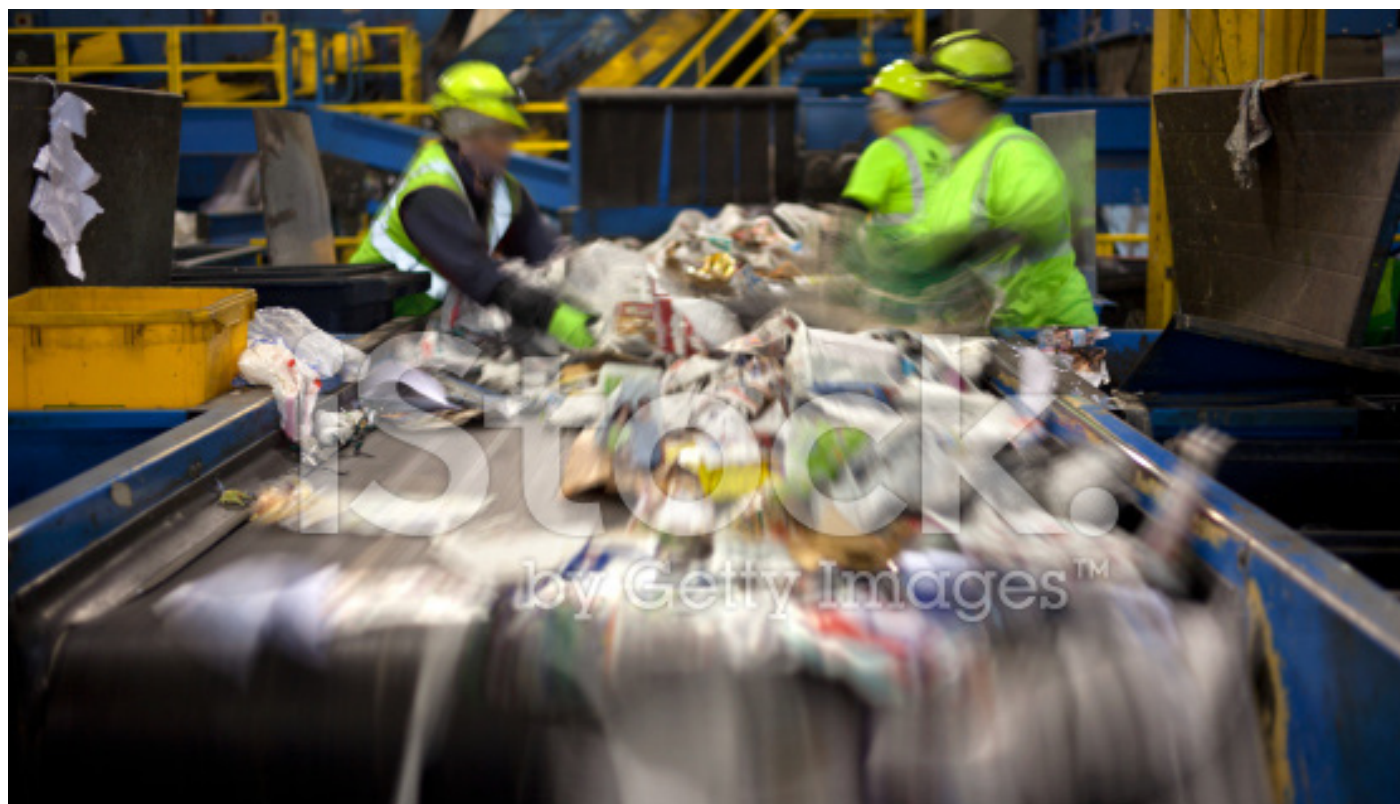
The Holy Grail for materials recovery facilities are conveyors that keep materials flowing and prevent items from getting jammed

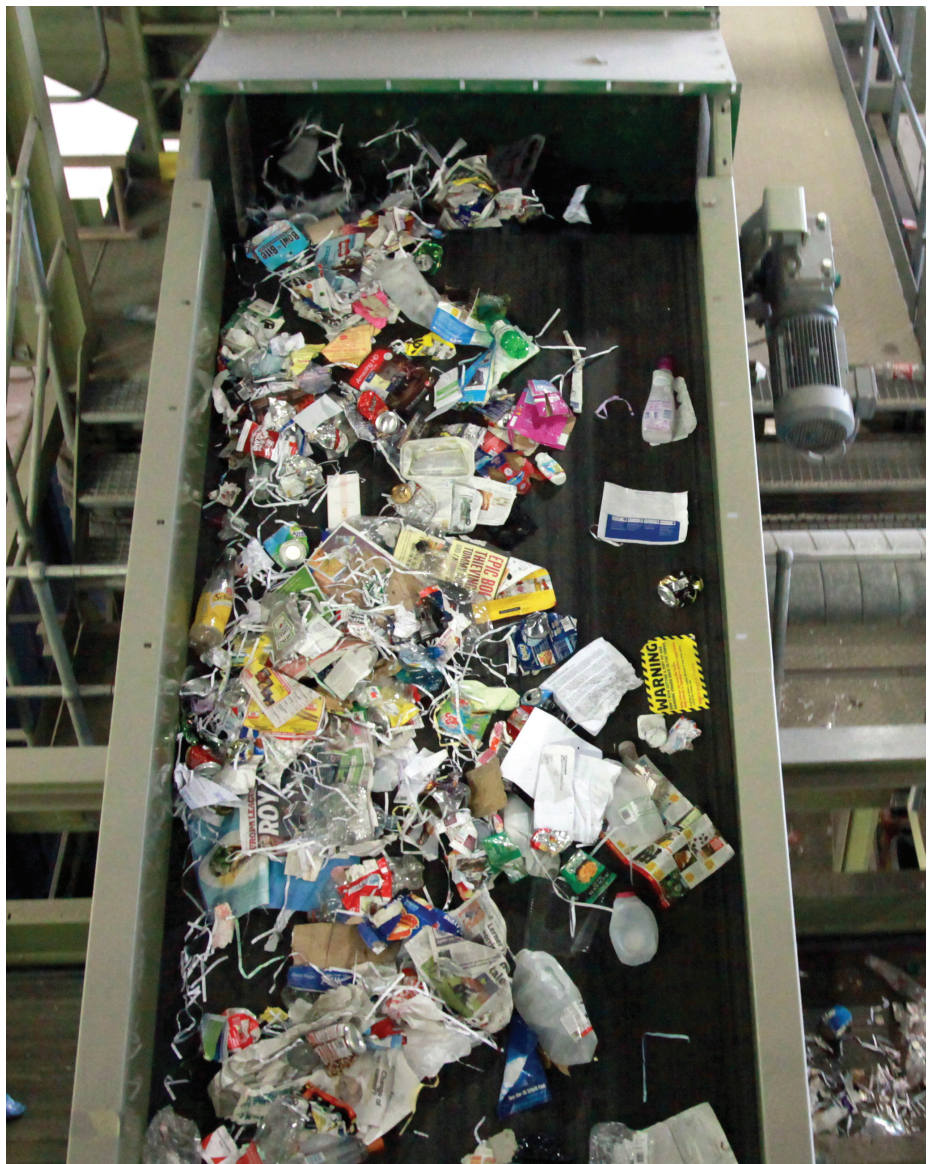
A conveyor belt should have an average abrasion resistance level of no more than 150mm³

To get the longest possible belt life (and thereby best value for money) buyers should always demand that the belt has an average abrasion resistance level of no more than 150mm³.

Remember that, with abrasion resistance measurement, lower figures represent better wear resistance.

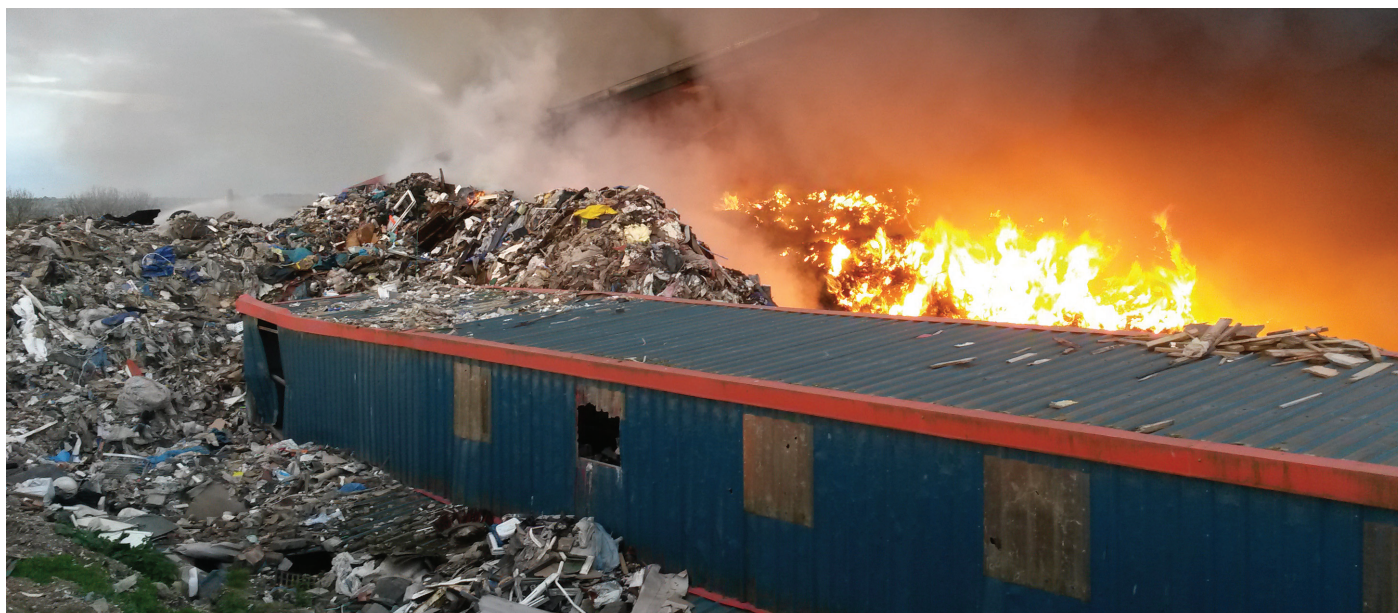
If a conveyor belt that is supplied as being fire-retardant catches fire, the consequences can be catastrophic

And if a conveyor belt that is supplied as being fire-retardant catches fire but does not resist fire the way it should, the consequences can be catastrophic.
