Leslie David, Conveying Expert

Tightening the belt

Factors to look out for to reduce conveyor belt expenditure...

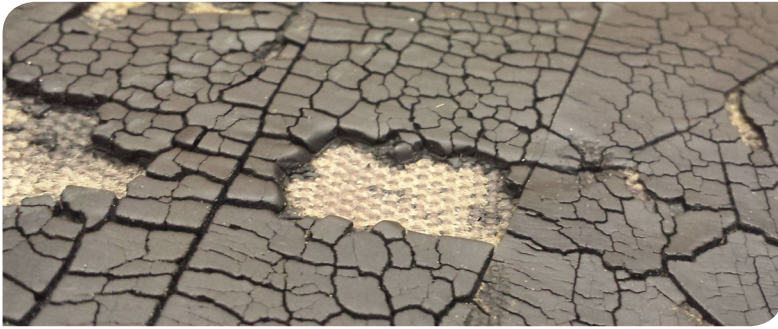
Above: Severe wear caused by heat damage that has been accelerated by UV exposure.

Belts that can resist high temperatures are widely used in the cement industry. Of all the demands placed on industrial conveyor belts, heat is widely regarded as the most unforgiving and damaging. High temperature materials and working environments cause an acceleration of the ageing process of the rubber that causes it to harden and crack.
