Leslie David, Dunlop, UK, explains how both ozone and ultraviolet light can dramatically shorten the working life of conveyor belts, and considers how fertilizer manufacturers can protect against these effects.

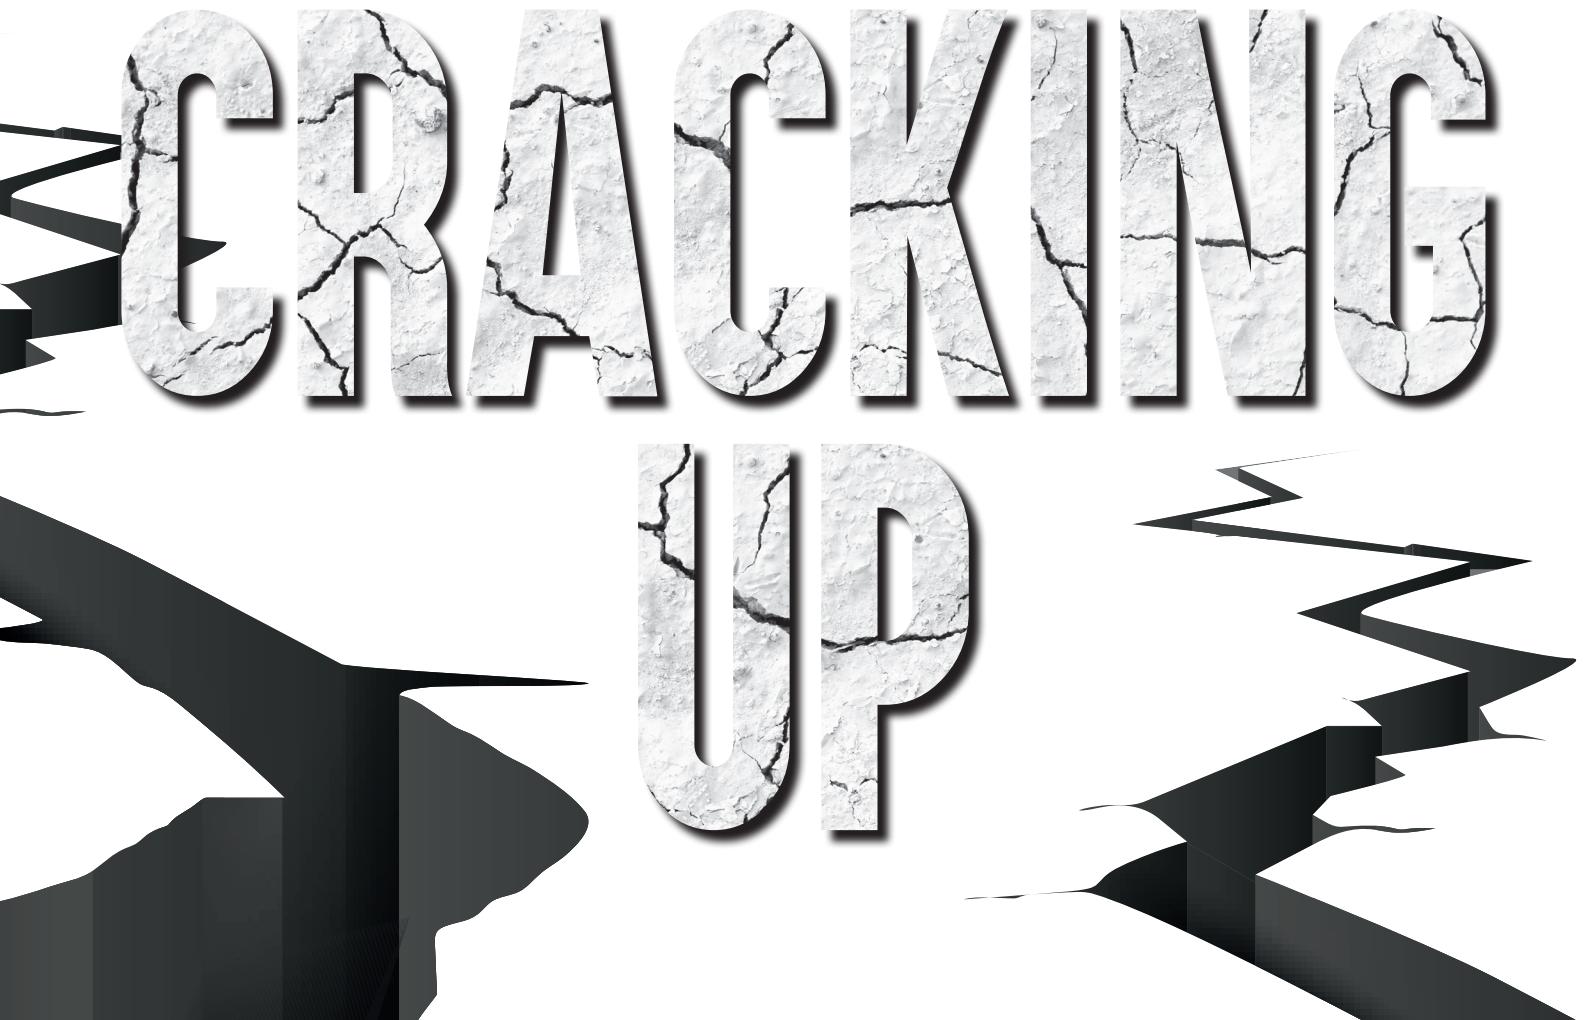
Figure 1. Ozone cracks in the surface of the rubber.

O_3 cracks form in rubber that is under tension. This is sometimes referred to as 'dry rotting'. It is important to bear in mind that the amount of tension (critical strain) needed is only very small. Even a belt that has not yet been fitted on a conveyor has a certain amount of intrinsic tension. The cracks are always oriented at right angles to the strain axis.

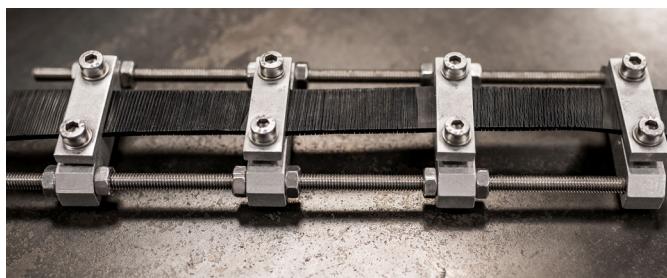
Figure 3. The cracks are always orientated at right angles to the strain axis.

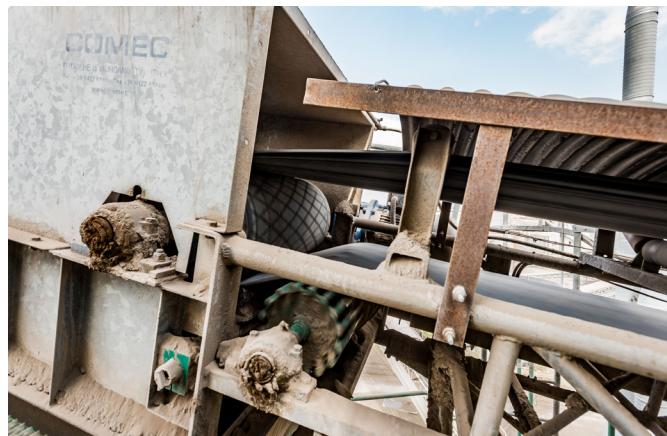
Figure 4. Transversal cracks deepen under the repeated stress of passing over the pulleys and drums.

At first glance, having small cracks in the surface rubber may not seem to be a big problem, but over a surprisingly short amount of time, the rubber becomes increasingly brittle. Transversal cracks deepen under the repeated stress of passing over the pulleys and drums. The O_3 continues to attack so the cracks will steadily grow until catastrophic failure occurs. Cracks often present other potential risks such as scrapers catching on them and tearing off parts of the cover. Re-splicing can also become increasingly difficult over time as the adhesion properties of the rubber diminish.

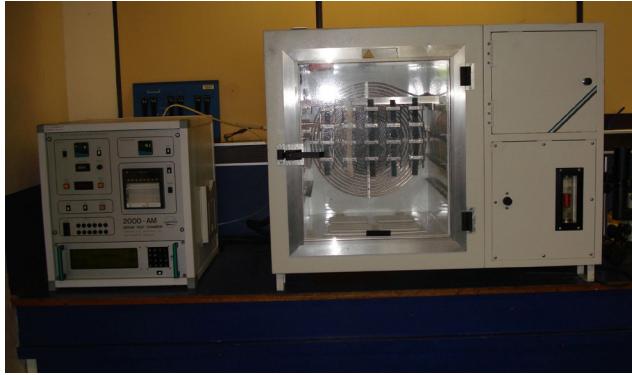
Figure 5. Dunlop's ozone testing cabinet.

To scientifically measure resistance to O₃ in accordance with the EN/ISO 1431 test method, samples are placed under tension (e.g. 20% elongation) inside an O₃ testing cabinet and exposed to highly concentrated levels of O₃ for a period of up to 96 hours (at 40°C, 50 ppm and 20% strain).

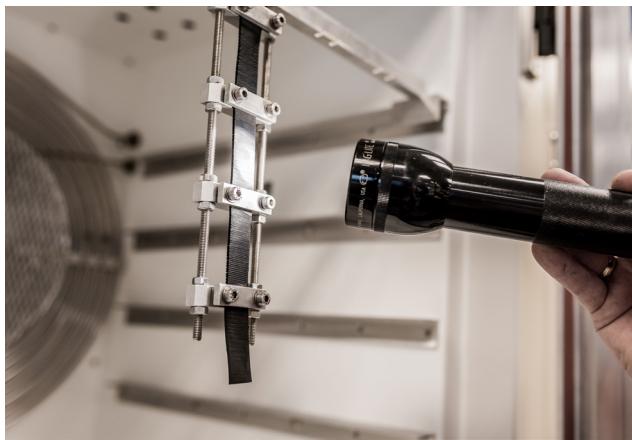
Figure 6. Samples are checked for cracking at two-hourly intervals.

Samples are closely examined for evidence of cracking at two-hourly intervals and the results are carefully measured and recorded. Experience has determined that in order for the rubber to be regarded as adequately resistant, the pass criteria needs to be that the rubber sample does not show any signs of cracking within the 96-hour period.

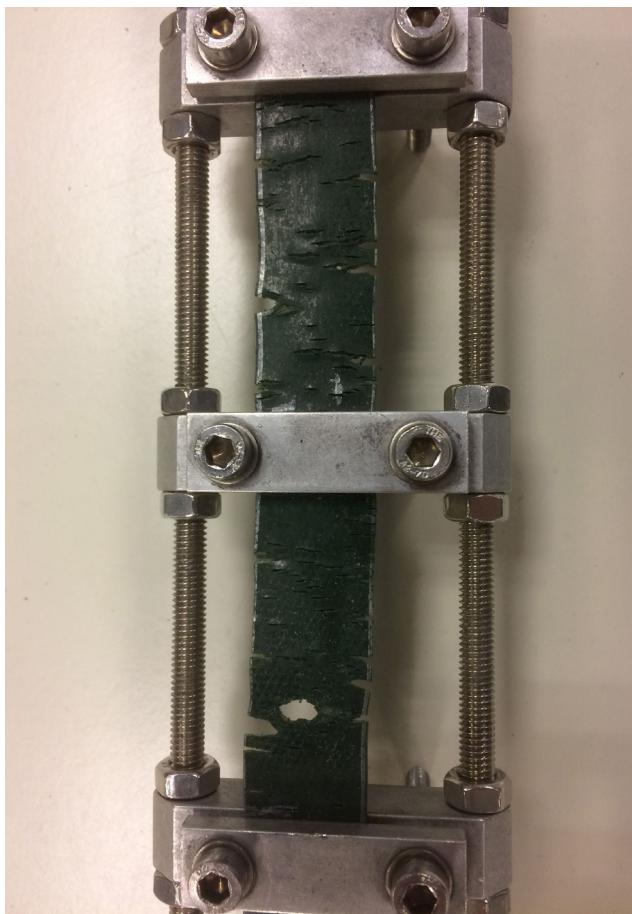
Figure 7. Some rubber disintegrates within hours.

As mentioned previously, more than 90% of belts tested in Europe fail the EN/ISO 1431 test. Worse still, in the majority of cases, the cracks start to appear as early as six to eight hours within the target time of 96 hours. In fact, it is not uncommon to see rubber samples completely disintegrate within a few hours.
