# Moving into high gear

## with bulk conveyor systems

### Chevron conveyor belts – the good, the bad and the ugly

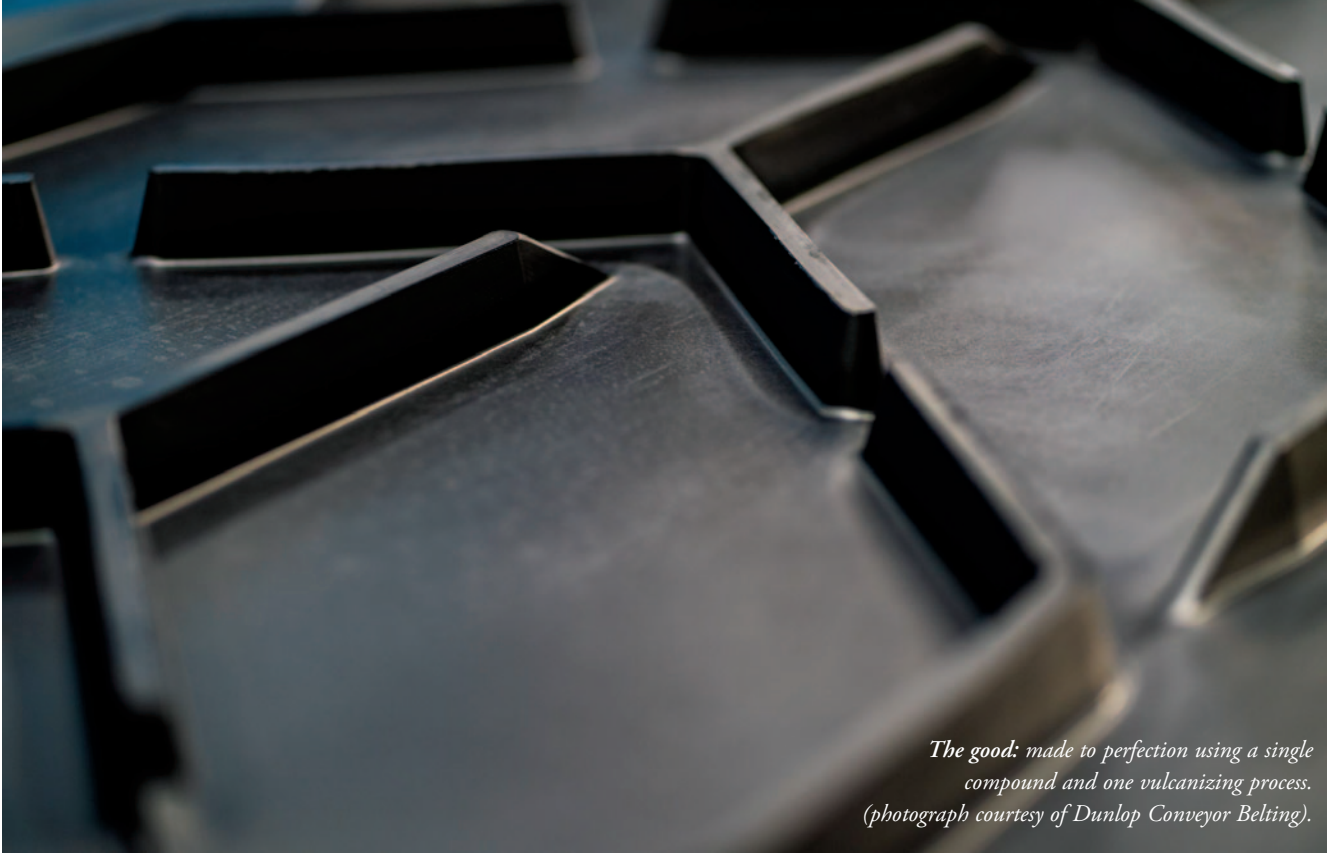
*The good: made to perfection using a single compound and one vulcanizing process.  
(photograph courtesy of Dunlop Conveyor Belting).*

The essential requirements needed to manufacture a durable, low-operating cost chevron belt are two-fold. First is the use of a single rubber compound formula for both the base belt structure and the chevrons. This then allows the creation of a single, homogenous structure using a one-step vulcanization production process rather than the more common two-step process.

A completely homogenous structure can handle the dynamic stress forces created by the continual flexing around pulleys and drums much more easily. In fact, the whole structure is significantly stronger and more resilient against spreading damage or having profiles that split or shear off.

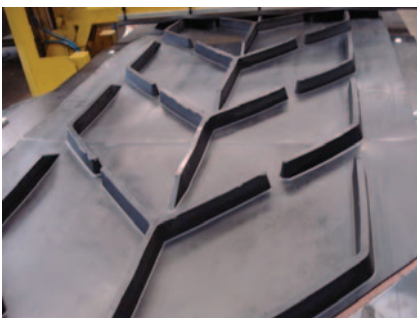
*The rubber is the single biggest opportunity for cost-cutting by manufacturers who want to compete for orders based on price.*

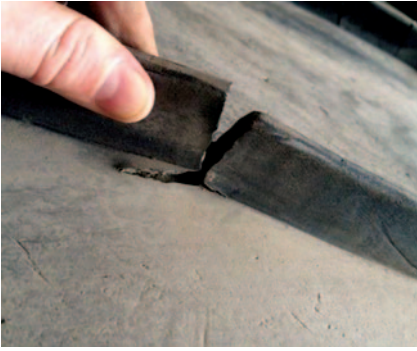
*The bad: constant flexing can cause dynamic stress fractures in conventionally produced chevron belts.*

contact point where the two different rubber compounds join instantly becomes a point of weakness because, as explained earlier, the chevron profiles constantly stretch and flex under significant tension each time they run around a pulley or drum. This means that unless the bond between the base belt carcass and the chevron profile is absolutely flawless then sooner or later dynamic stress fractures in the profile will begin to occur, eventually causing the profile to split and all too often completely part company with the rest of the belt.

This problem is significantly magnified on mobile conveyor equipment with relatively small pulley diameters. The smaller the pulley then the higher the dynamic stress. Failure will happen even sooner if, as I touched on earlier, one (or both) of the rubber compounds are not fully resistant (as per ISO 1431 testing) to the effects of degradation (surface cracking) created by chemical reactions in the rubber caused by ground level ozone and ultraviolet light. Sad to say, as a consequence of the relentless pursuit of low prices, the vast majority of

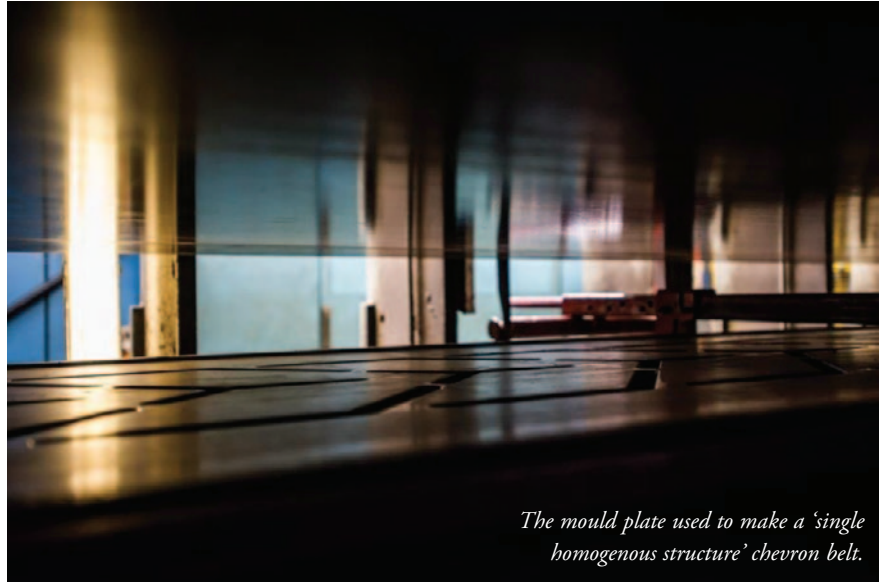
*The mould plate used to make a 'single homogenous structure' chevron belt.*

To create a single homogenous structure the base belt (at this stage comprising of only uncured rubber) is placed in the vulcanizing press between the base plate of the press and a chevron mould plate positioned immediately below it. The base belt will already have a specific quantity of uncured rubber on the top cover surface in addition to the volume of rubber needed to achieve the minimum thickness of the top cover of the base belt and create the chevron profiles following vulcanization. The actual amount of 'extra' rubber needed depends on the design and depth of the chevron pattern. The compression of the upper and lower plates then forces the additional rubber to flow into and fill the mould cavities. Vulcanization of both the

base belt structure and the rubber-filled moulds then takes place simultaneously to form a single homogenous unit.

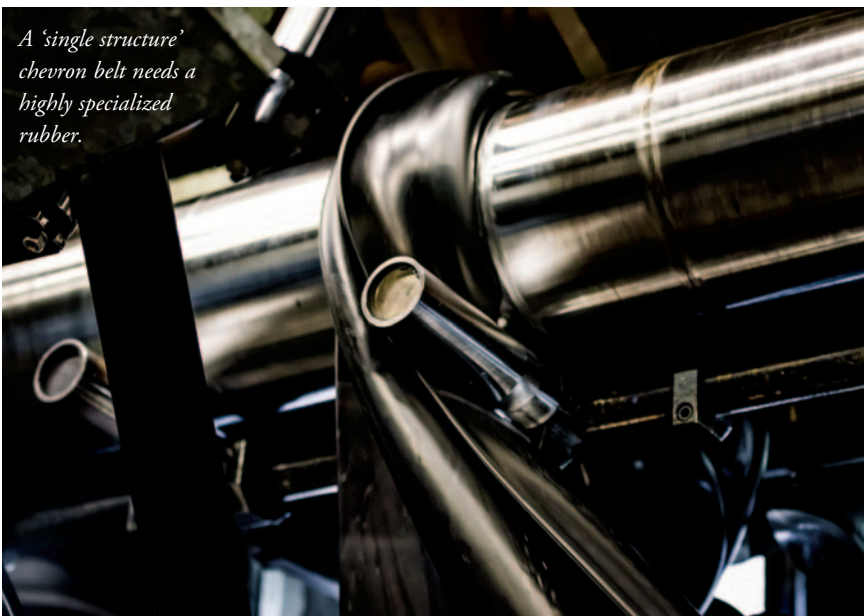
*A 'single structure' chevron belt needs a highly specialized rubber.*

An essential requirement of the one-step production process is having a single rubber compound that has been specially engineered for both the base belt structure and the chevrons and which can be vulcanized virtually simultaneously within the mould and the base belt structure. In addition to being sufficiently malleable to allow it to flow smoothly and evenly into the moulds, the rubber also needs to have all the physical properties mentioned earlier including being fully resistant to the effects of ozone and ultraviolet light. It also needs to conform to European REACH regulations so that the end-product is also safe for conveyor operators to handle.

This may sound relatively straightforward but it is actually extremely difficult (and more costly) to produce such a versatile, multi-faceted rubber compound. This is due to the huge number of chemicals, polymers and additives that need to be used, which have to be very precisely balanced and mixed so that the final compound 'cocktail' possesses all of the necessary physical properties. Fortunately, the difficulties are hugely outweighed by the considerable advantages.

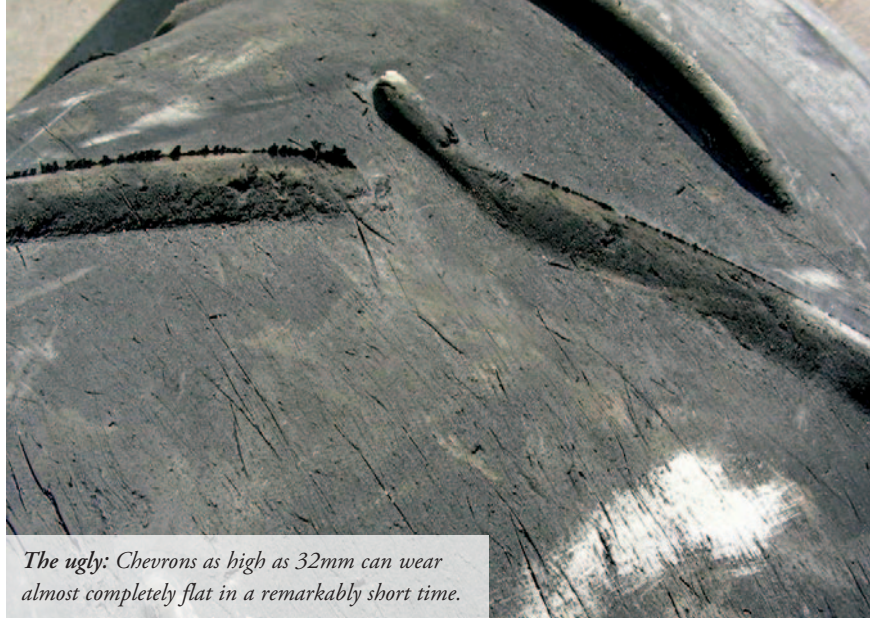
*The ugly: Chevrons as high as 32mm can wear almost completely flat in a remarkably short time.*

Research and experience has shown that the rubber used to make the chevrons in the two-step production process will almost certainly have a much lower resistance to abrasive wear than would normally be acceptable. It is not unusual, especially among so-called 'economy' belts imported from Asia, that even chevrons as high as 32mm can wear almost completely flat within a matter of a few months and in some cases, weeks. And while this is happening the efficiency of the belt steadily diminishes.
