# Motor Maximisation

Conveyor belt specialist Leslie David examines the key causes of conveyor drive motor inefficiency and outlines practical strategies to maximise performance and reliability.

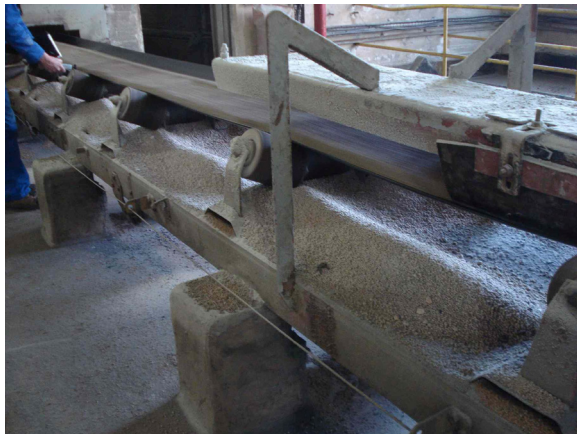
**An unclean working environment is often the cause of accelerated wear and damage.**

An unclean working environment is often the cause of accelerated wear and damage to conveyor components including, of course, the drive motor, so areas where product spillage occurs need to be actioned for more regular cleaning. Also watch out for worn drum linings

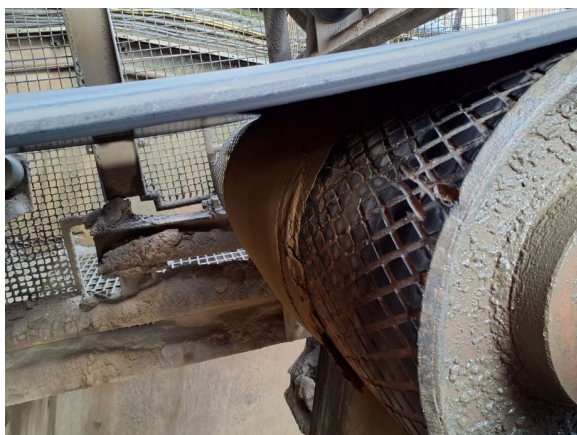
**Belt slippage caused by waste matter on the drum increases strain on the motor.**

When a belt loses traction on the pulley it slips, often producing a high-pitched screeching sound. This creates extreme friction that heats up the pulley and strains the motor as it tries to move the load. The most common causes are inadequate belt tension, worn drum linings, waste matter between belt, and belt surfaces where the rubber has aged and become brittle.

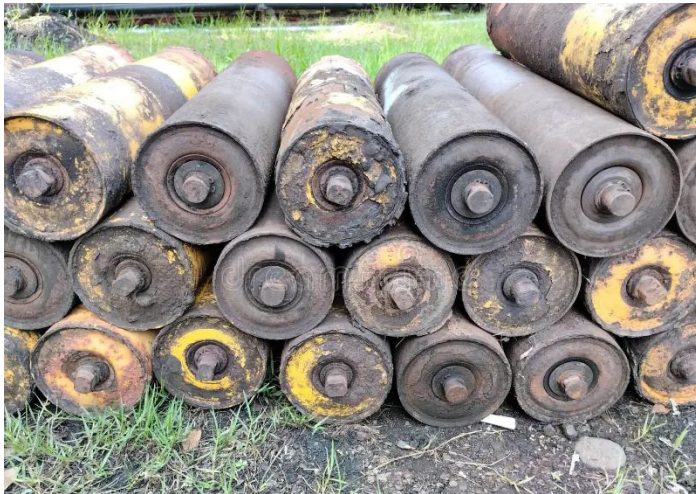
**Easy come, easy go – low-priced components are low priced for a reason.**

Many operators choose low grade components to reduce outlay, but experience shows time and time again that a purchasing criteria based on the low buying price of a component rather than its whole life cost is invariably a false economy. Low-grade bearings and rollers are susceptible to premature wear and can seize up or disintegrate very easily, causing significant friction that can lead to motor burnout or extremely expensive belt damage so only use premium quality rollers.

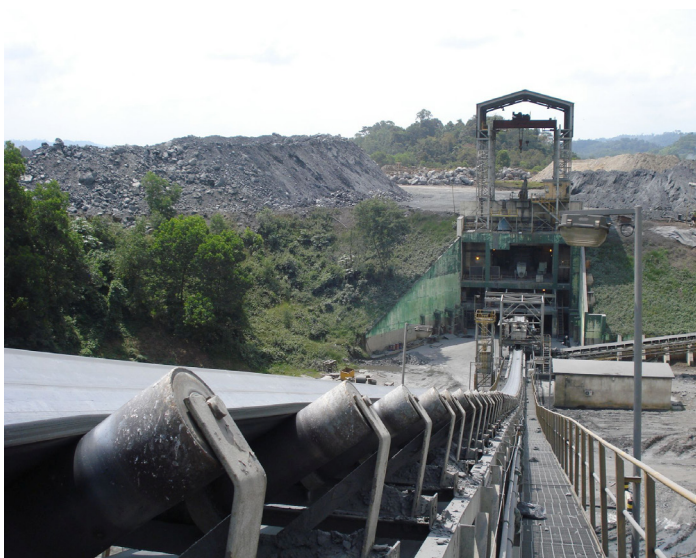
**Bigger is not always better – installing a heavier belt can increase absorbed motor power.**

Belts that are too thick or have a tensile strength that is too high can cause troughing and handling problems. Even more significantly, when it comes to drive motors, the added weight can also increase the absorbed motor power of the system.

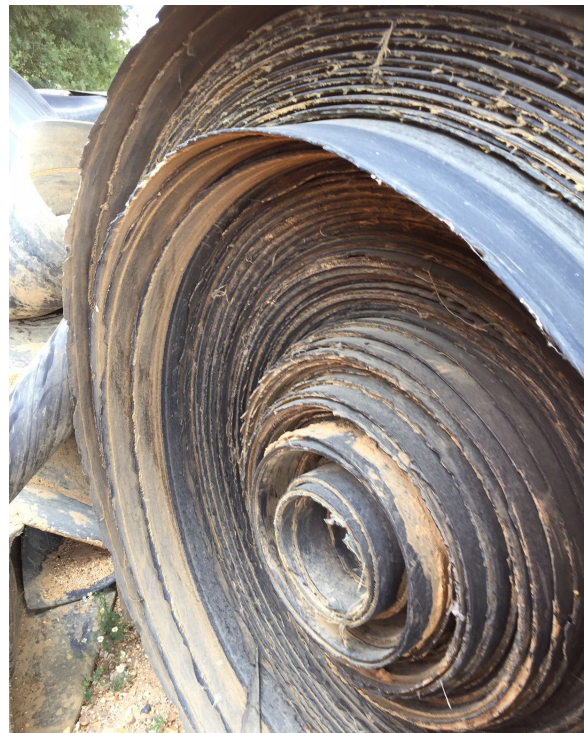
**Rubbing against the conveyor structure strains the motor and damages the belt.**

A misaligned belt that rubs against the conveyor structure creates excessive friction, which again puts unnecessary extra load on the motor and irreparably damages the belt at the same time.
