Moving into high gear

with bulk conveyor systems

Chevron conveyor belts – the good, the bad and the ugly

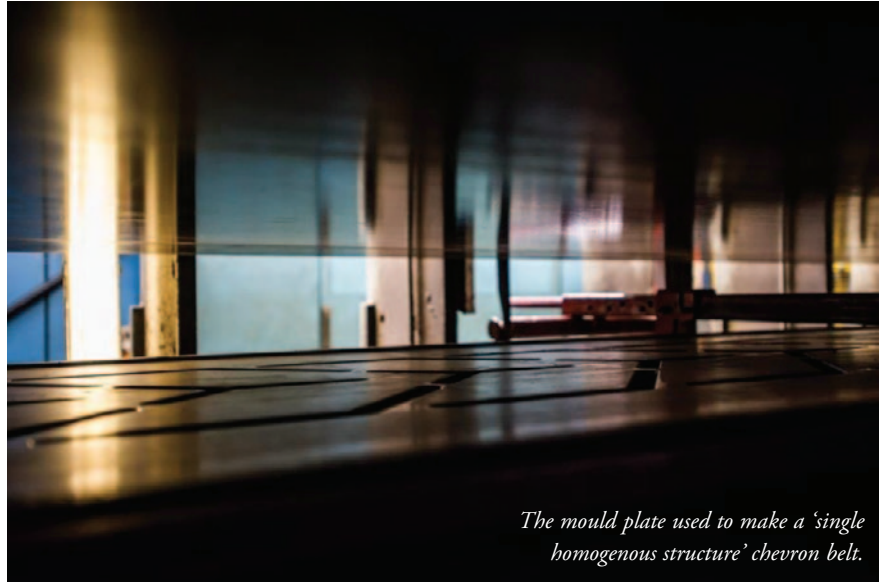
The mould plate used to make a 'single homogenous structure' chevron belt.

To create a single homogenous structure the base belt (at this stage comprising of only uncured rubber) is placed in the vulcanizing press between the base plate of the press and a chevron mould plate positioned immediately below it. The base belt will already have a specific quantity of uncured rubber on the top cover surface in addition to the volume of rubber needed to achieve the minimum thickness of the top cover of the base belt and create the chevron profiles following vulcanization. The actual amount of 'extra' rubber needed depends on the design and depth of the chevron pattern. The compression of the upper and lower plates then forces the additional rubber to flow into and fill the mould cavities. Vulcanization of both the

base belt structure and the rubber-filled moulds then takes place simultaneously to form a single homogenous unit.

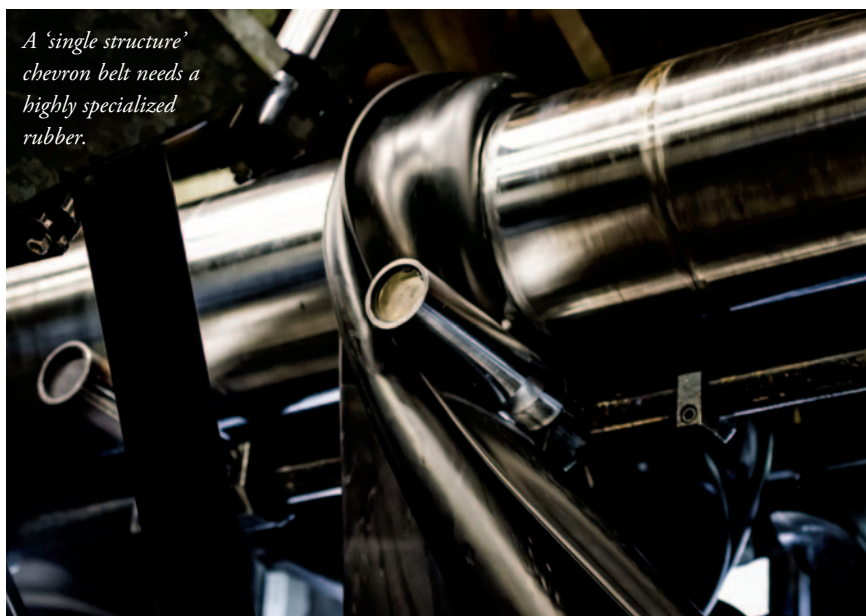
A 'single structure' chevron belt needs a highly specialized rubber.

An essential requirement of the one-step production process is having a single rubber compound that has been specially engineered for both the base belt structure and the chevrons and which can be vulcanized virtually simultaneously within the mould and the base belt structure. In addition to being sufficiently malleable to allow it to flow smoothly and evenly into the moulds, the rubber also needs to have all the physical properties mentioned earlier including being fully resistant to the effects of ozone and ultraviolet light. It also needs to conform to European REACH regulations so that the end-product is also safe for conveyor operators to handle.

This may sound relatively straightforward but it is actually extremely difficult (and more costly) to produce such a versatile, multi-faceted rubber compound. This is due to the huge number of chemicals, polymers and additives that need to be used, which have to be very precisely balanced and mixed so that the final compound 'cocktail' possesses all of the necessary physical properties. Fortunately, the difficulties are hugely outweighed by the considerable advantages.

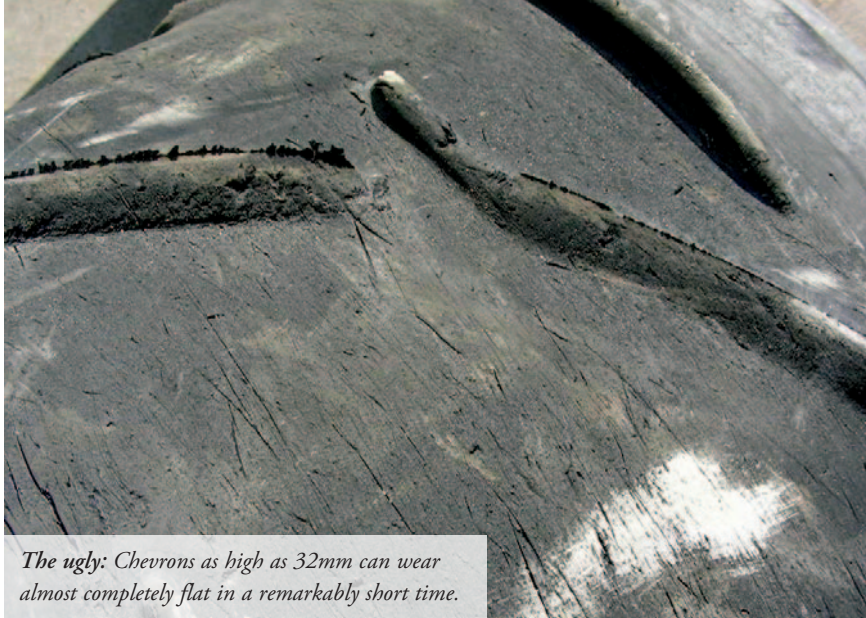
The ugly: Chevrons as high as 32mm can wear almost completely flat in a remarkably short time.

identical rubber compounds are vulcanized (bonded) together. One compound formula is used to create the base belt and a different, more malleable compound is used in the mould plates. The first big disadvantage is that the bond between the different compounds is naturally weaker and more prone to the effects of dynamic stress. The second big disadvantage is that the more pliable compound used for the mould plates invariably has a much lower resistance to cutting and abrasion.

Research and experience has shown that the rubber used to make the chevrons in the two-step production process will almost certainly have a much lower resistance to abrasive wear than would normally be acceptable. It is not unusual, especially among so-called 'economy' belts imported from Asia, that even chevrons as high as 32mm can wear almost completely flat within a matter of a few months and in some cases, weeks. And while this is happening the efficiency of the belt steadily diminishes.
