## Six keys ... ... to conveyor belt longevity

Jeremy Clark

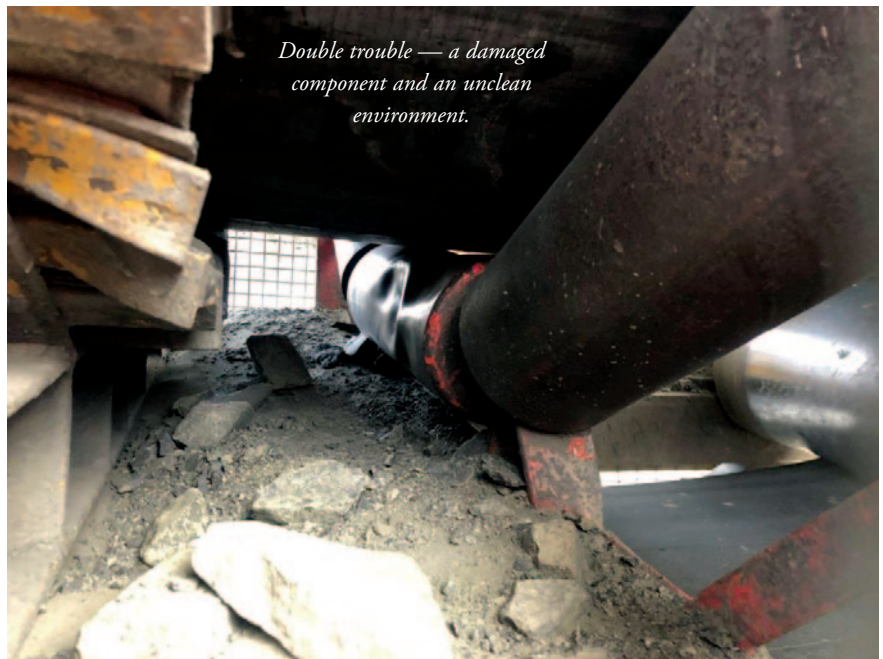
*Double trouble — a damaged component and an unclean environment.*

Apart from increasing the chances of an object becoming trapped, waste build-up is a common cause of damage to idlers and drums, which can cause a lot of collateral belt damage. A significant proportion of damage is caused by incorrect installation of auxiliary equipment, damaged, protruding steelwork and components vibrating loose and ultimately becoming detached, all of which can be identified and dealt with through regular inspection.

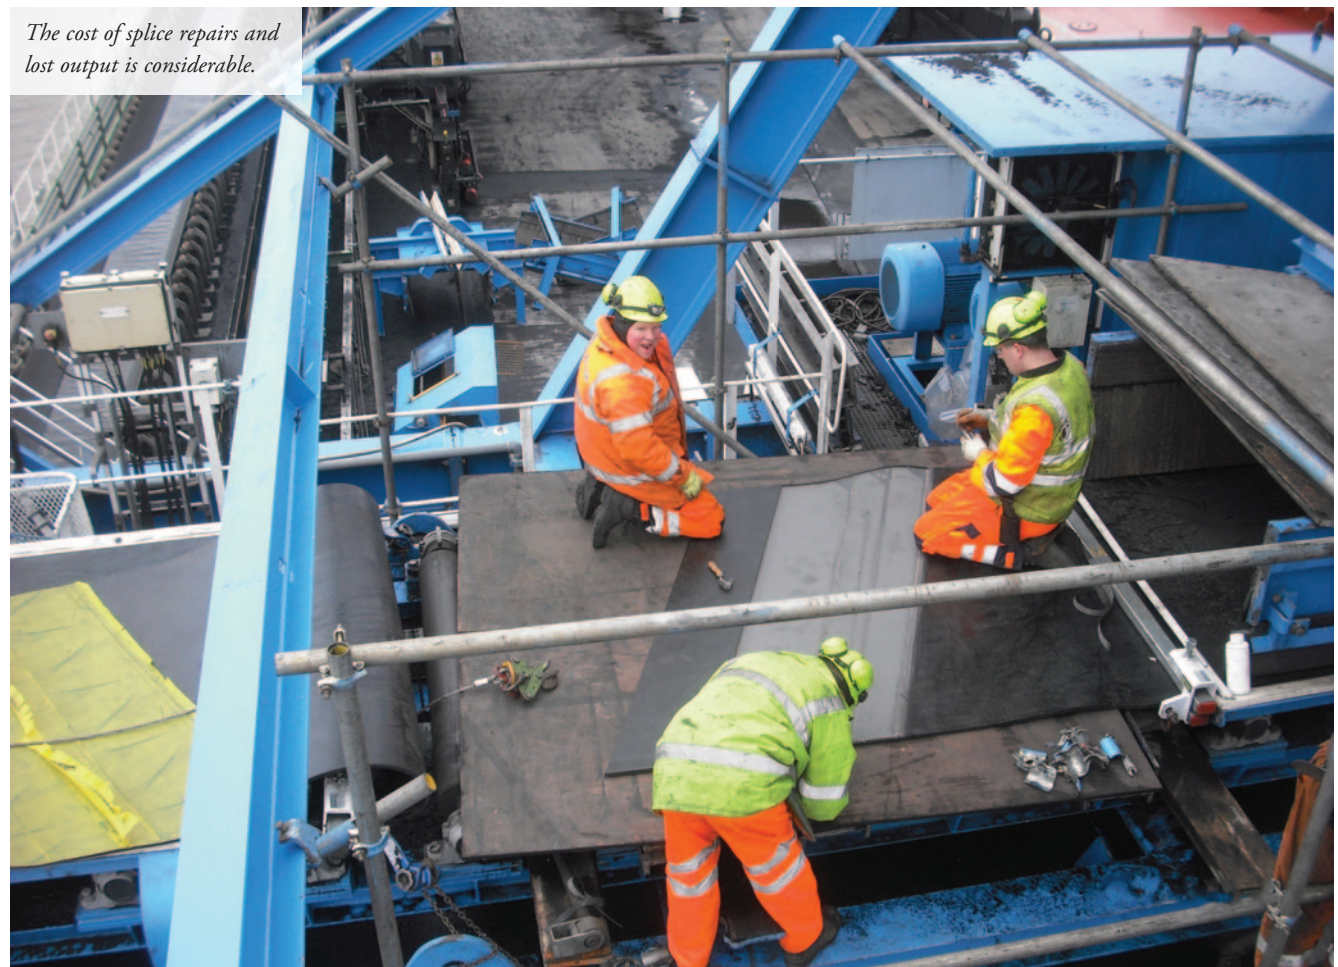
*The cost of splice repairs and lost output is considerable.*

The joints used to create a continuous loop are the weakest point of any conveyor belt. It is estimated that splice joint problems account for some 80% of unplanned repair stoppages. The cost of repairing splice joints including the cost of lost output is considerable but should not be necessary at all. The biggest causes of splice problems are shortcomings in the quality of the conveyor belt itself, the materials used to join the belt and the quality of the workmanship.

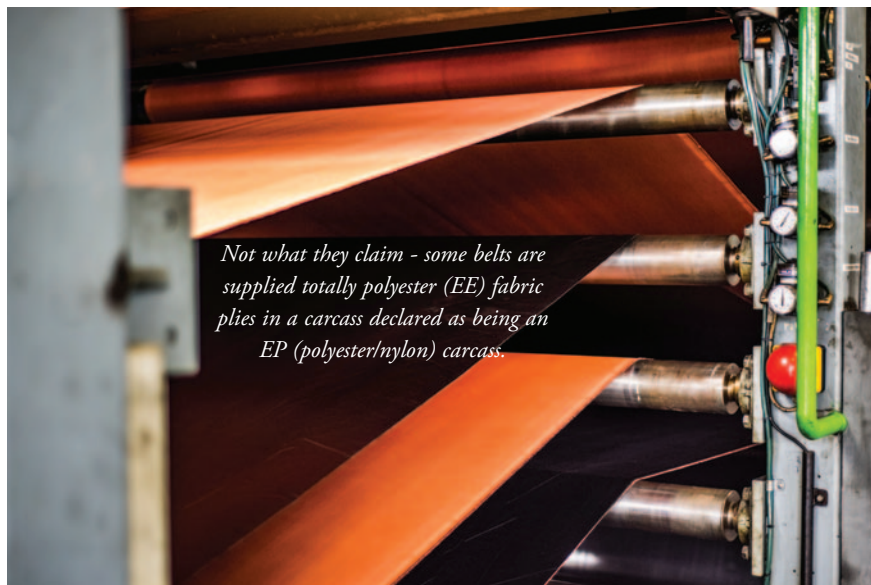
*Belts that are not fully resistant to ozone and UV have a much shorter lifespan.*

The first visible sign is cracks in the surface of the rubber. These steadily grow until they complete a 'circuit' and the product separates or fails. Its 'partner in crime' is ultraviolet light from sunlight and fluorescent lighting, which accelerates rubber degradation by producing photochemical reactions that promote the oxidation of the rubber surface resulting in a loss in mechanical strength. These processes begin as soon as rubber is vulcanized.
