## Rubber conveyor belts: are you being sold belts with a limited life expectancy?

### CONVEYING ADVICE

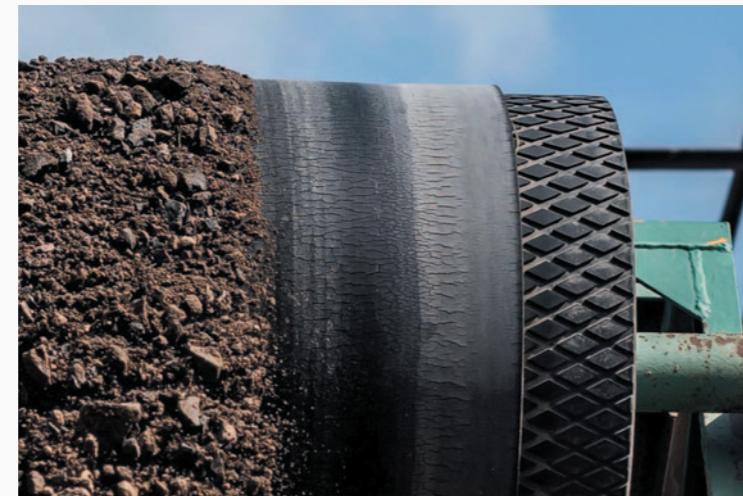
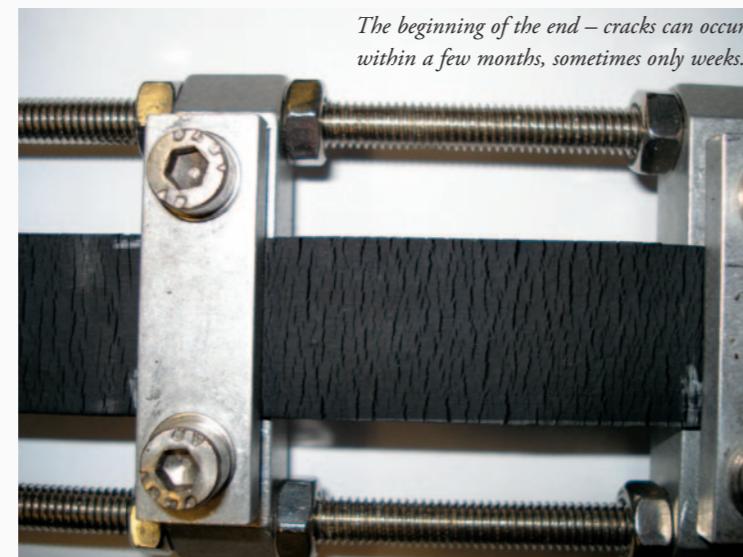
Resistance to ozone is measured in accordance with the EN/ISO 1431 test method in which samples of rubber are placed under tension (20% strain) inside an ozone testing cabinet and exposed to highly concentrated levels of ozone for a period of up to 96 hours (@ 40°C, 50pphm). The pass criteria needs to be that the rubber sample does not show any signs of cracking within the 96-hour period.

Worryingly, the vast majority of samples tested typically fail within only six to eight hours, which experience equates as a real time equivalent of within six working months. Despite its crucial importance, ozone and UV resistance is very rarely, if ever, mentioned by conveyor belt manufacturers and suppliers. This is because the ingredients needed to protect the rubber and prolong its working life cost money, thereby reducing the price competitive advantage. A more sinister but nonetheless valid aspect of the non-use of protective agents is that anything that prolongs the working life of belts is not good for business so, together, they explain the widespread absence of protection.

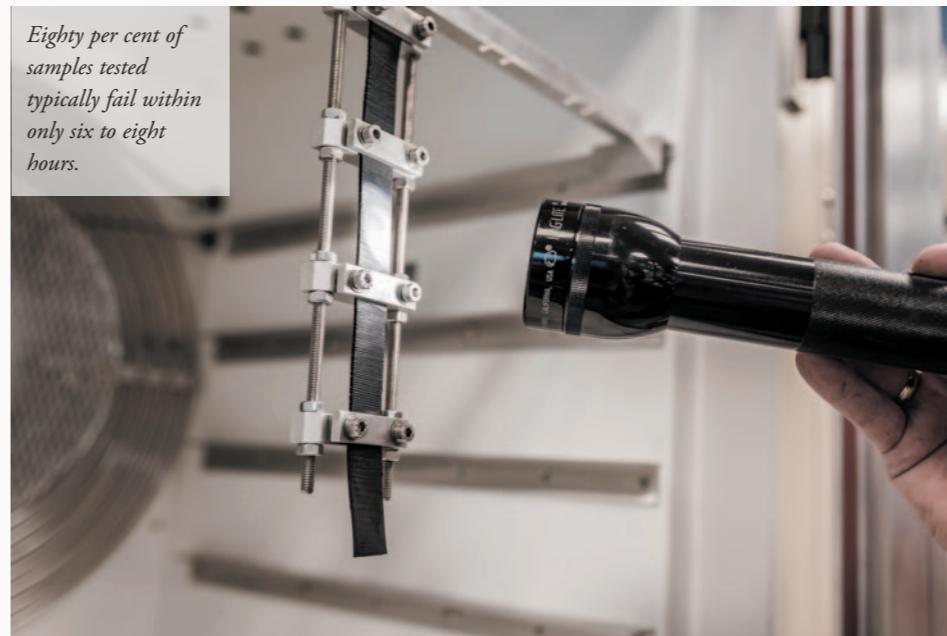
*Eighty per cent of samples tested typically fail within only six to eight hours.*
