# MINING & QUARRY WORLD

# Conveyor Belts – The Invisible Destroyer

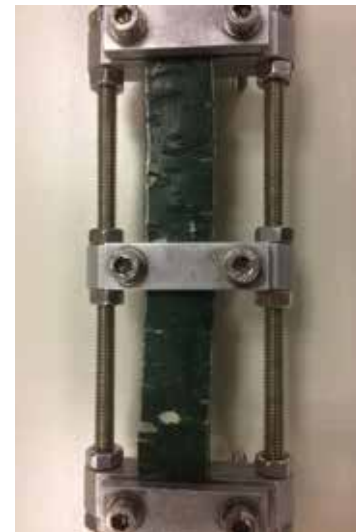
Disintegrated – the effects of ozone and ultraviolet exposure

The weakness I refer to is the almost non-existent resistance to ground level ozone (O<sub>3</sub>) ultraviolet light (UV). Exposure to light and air begins from the moment the rubber is vulcanised during the production process and not, as some wrongly believe, occurs slowly over the years. The damage it causes is considerable. The early signs are small cracks appearing in the rubber surface, in some cases within weeks of first being fitted with much worse to come as the rubber becomes increasingly brittle and inflexible. This is sometimes referred to as 'dry rotting'. Further attacks occur inside the newly exposed cracks, which grow steadily until they complete a 'circuit' and the rubber fails.

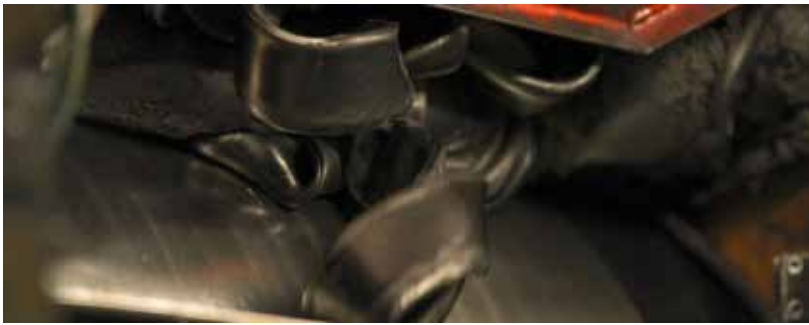
Prevention is achieved by including antioxidants and anti-degradants when making the rubber compound

The most annoying and frustrating part is that the damage is entirely preventable thanks to the use of a range of special antioxidants such as 2,2,4-Trimethyl-1,2-dihydroquinoline polymer (MQ), anti-degradants, antifatigue agents and antiozonants, which when included in sufficient quantities during the creation of the rubber compound. Despite this, surveys of the results of EN/ISO 1431 international testing standards continue to show that more than 80%

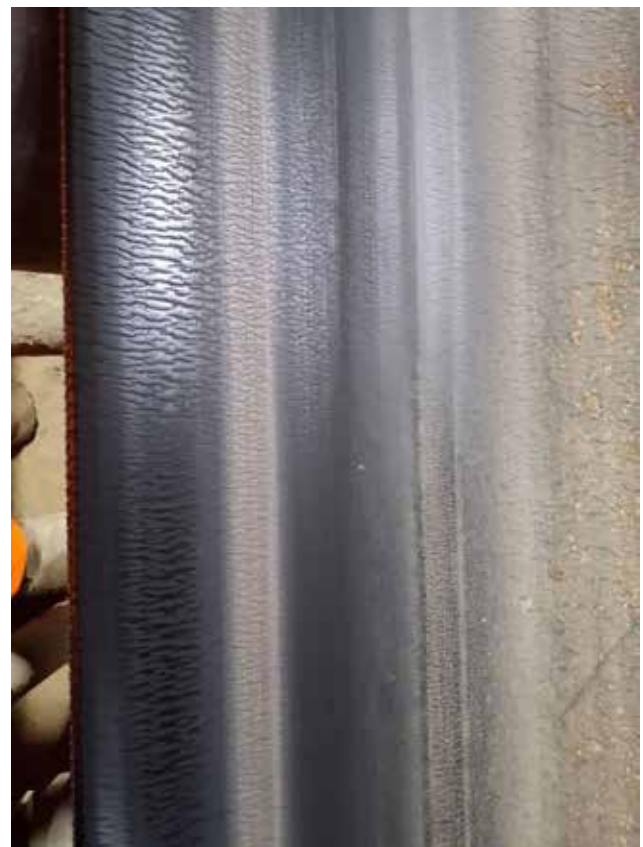
Ozone cracks are always oriented at right angles to the strain axis.

Ozone cracks form in rubber that is under tension. It is important to bear in mind that the amount of tension (critical strain) needed is extremely small. Even a belt in storage has a certain amount of intrinsic tension. The cracks are always oriented at right angles to the strain axis. The dynamic stress that a conveyor belt undergoes while in operation is considerable. Ozone attack occurs at the points where the strain is greatest.

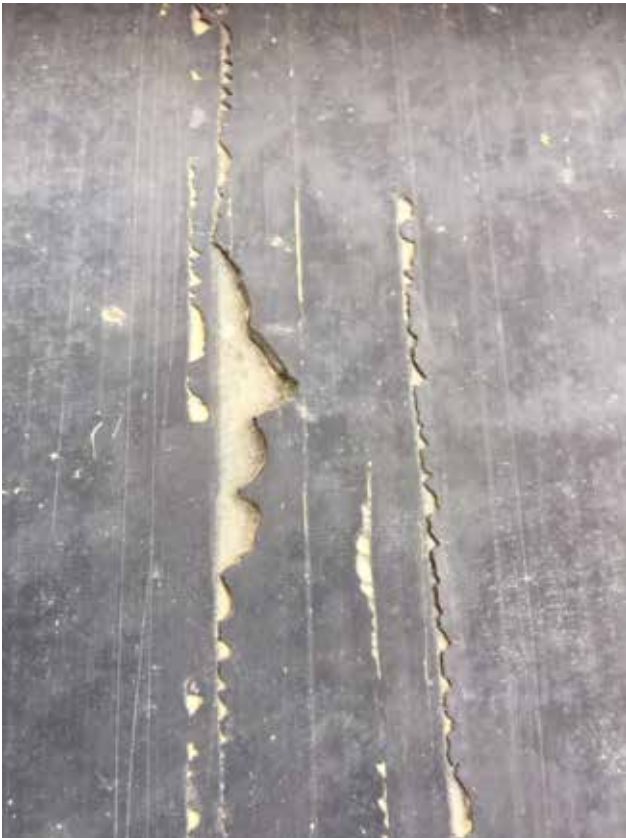
The 'longer term' effects of ozone & UV can occur within a few months

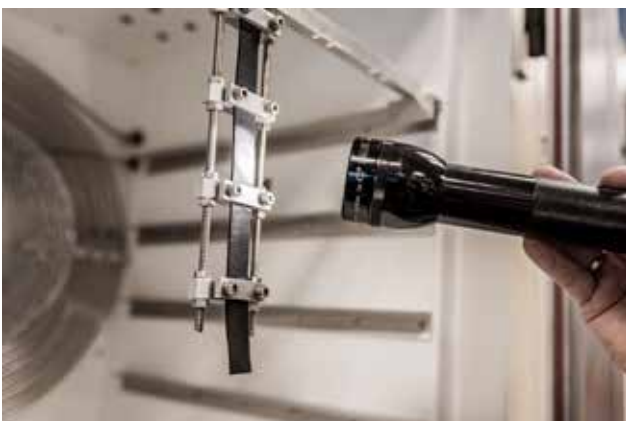
80% of samples tested typically fail within 8 hours

Ozone resistance is measured in accordance with the EN/ISO 1431 test method in which samples of rubber are placed under tension (20% strain) inside an ozone testing cabinet and exposed to highly concentrated levels of ozone for a period of up to 96 hours (@ 40°C, 50 ppm).

Samples are examined for evidence of cracking at two-hourly intervals and the results carefully measured and recorded. Experience has determined that in order for the rubber to be regarded as adequately resistant, the pass criteria needs to be that the rubber sample does not show any signs of cracking within the 96-hour period. The vast majority of samples tested, however, crack within less than 8 hours, which experience shows can equate to be as short as three working months in real time.

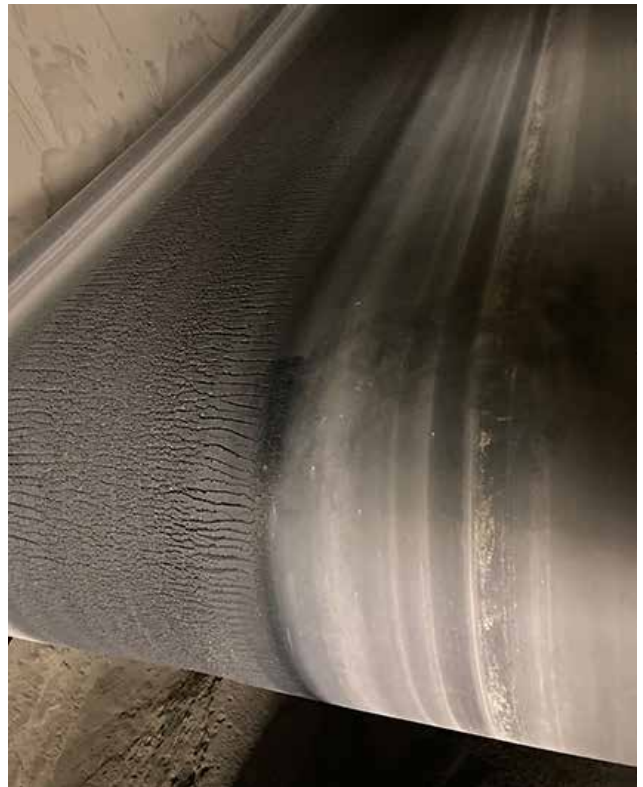
Cracks deepen under the repeated stress of passing over the pulleys and drums.

The repeated action of the mechanical stress of the conveyor belt and the frictional process from the idlers trigger an oxidative chain reaction that forms a chemical process that breaks the molecular chain and activates the oxidation process. This in turn magnifies a whole range of problems. Over a surprisingly short time, (literally months or even weeks without built in protection), the rubber becomes increasingly brittle and less able to stretch and contort as it should; wear resistance diminishes while transversal cracks steadily deepen and grow under the stress of passing over the pulleys and drums until catastrophic failure occurs.
