NO TIME FOR DOWNTIME

Unplanned conveyor stoppages – causes, effects and solutions

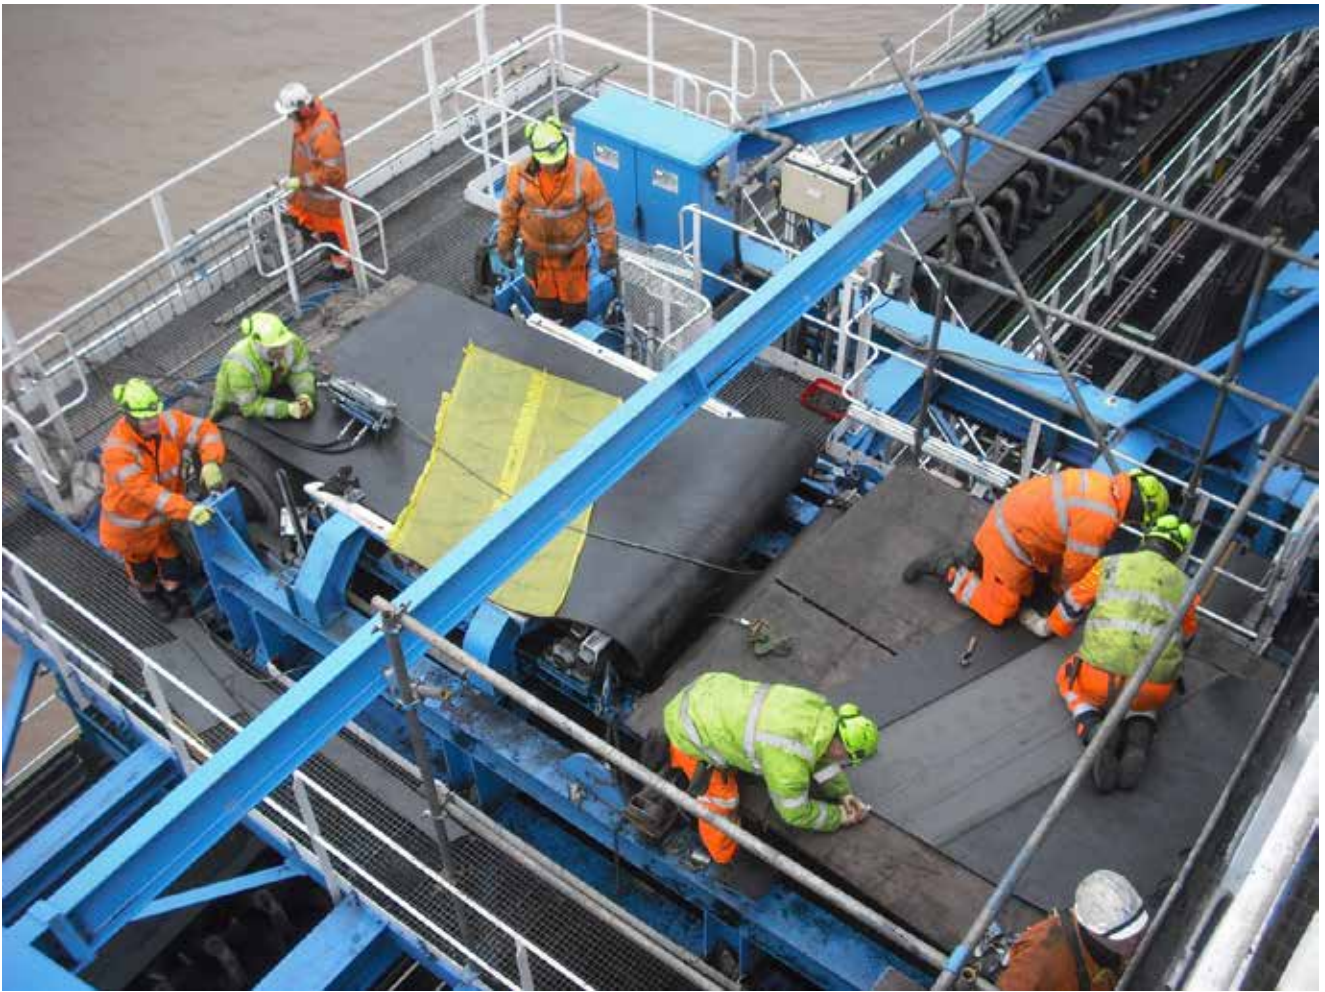
Splice joint problems are a major cause of stoppages for repair or replacement.

The weakest point of any conveyor belt is the splice joint. Consequently, splice joint problems are widely regarded as the most common cause of conveyor stoppages. Because of the serious loss of output, as well as the safety implications caused by sudden splice joint failure, it is critically important to maximise the strength and long-term durability of the joint.

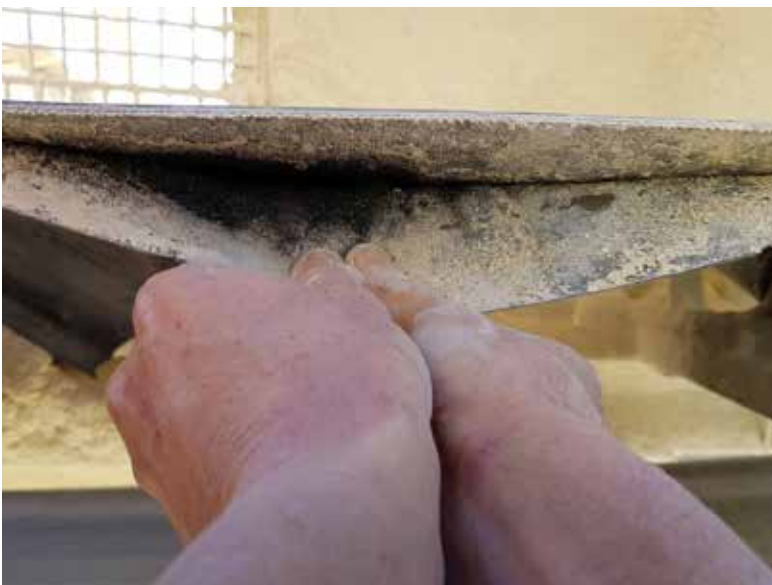
Insufficient elongation can cause delamination.

In addition, low elongation can lead to shear stresses that may in turn cause delamination (ply separation) issues. On the flip side, too much elongation can result in insufficient tension, which can lead to premature wear and tear.

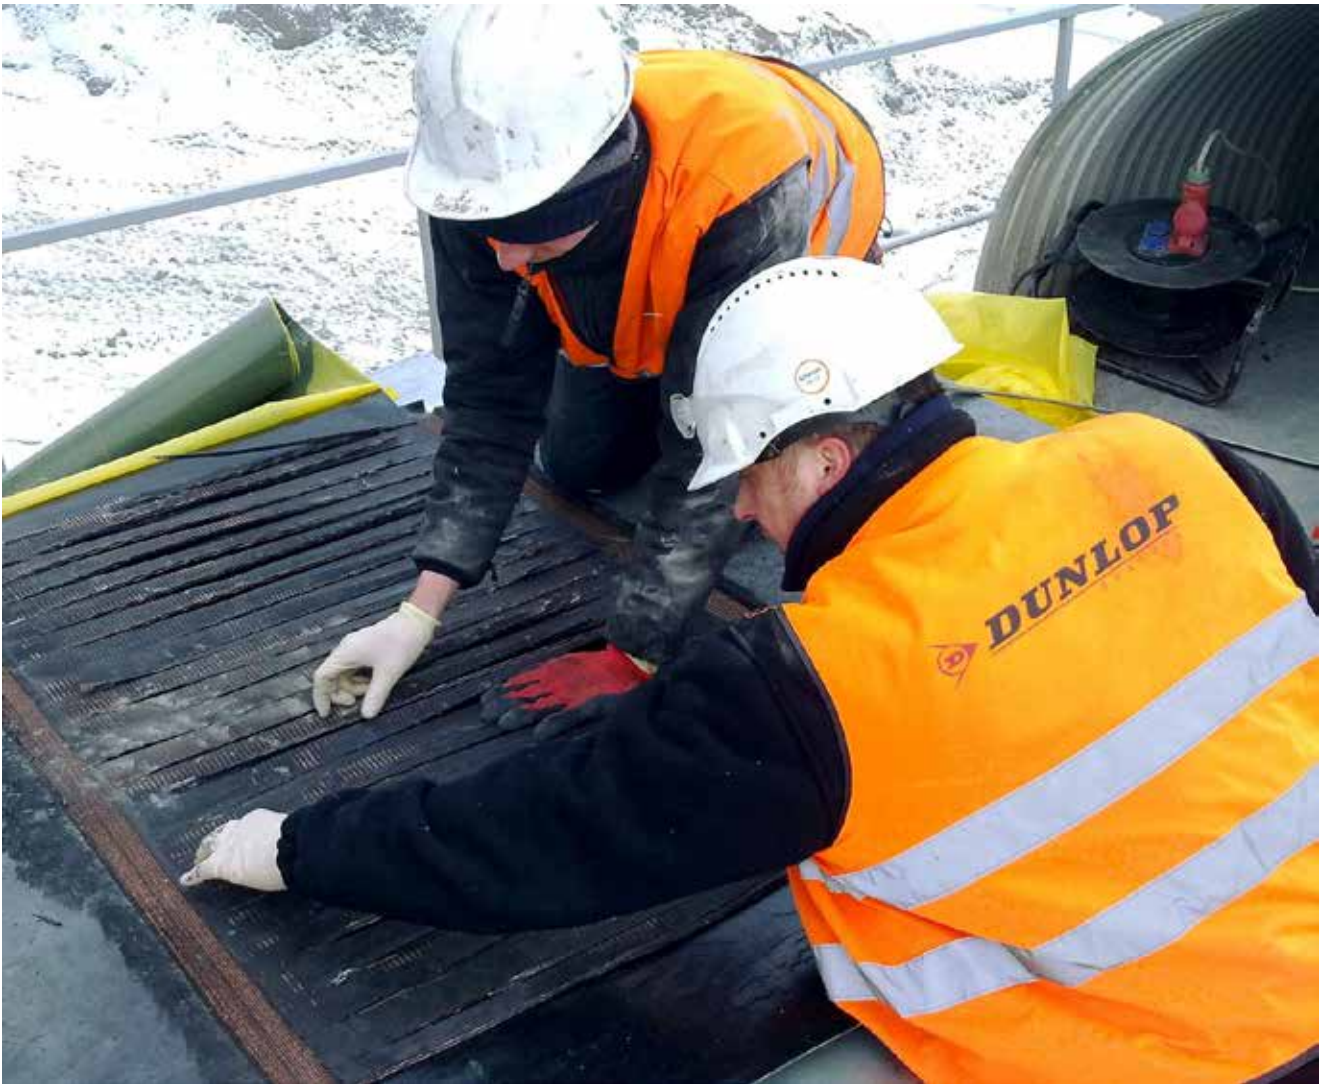
Finger splices are far stronger and more reliable and retain a much higher tensile strength. (Image courtesy of Fenner Dunlop Conveyor Belting).

Crucially, when the belt is working under load, the finger splice is vastly superior to a stepped splice in terms of resistance to dynamic failure. The superior strength and durability of finger splices therefore reduces the frequency to repair and re-splice.

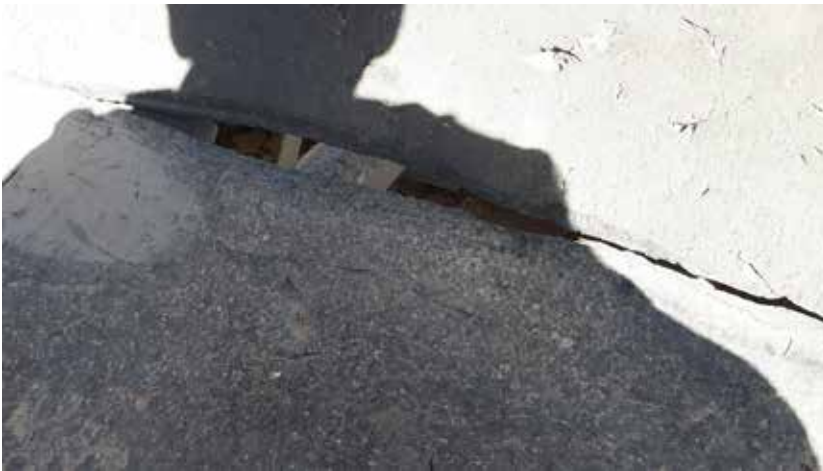
'Cheap' imported belts are much more prone to ripping.

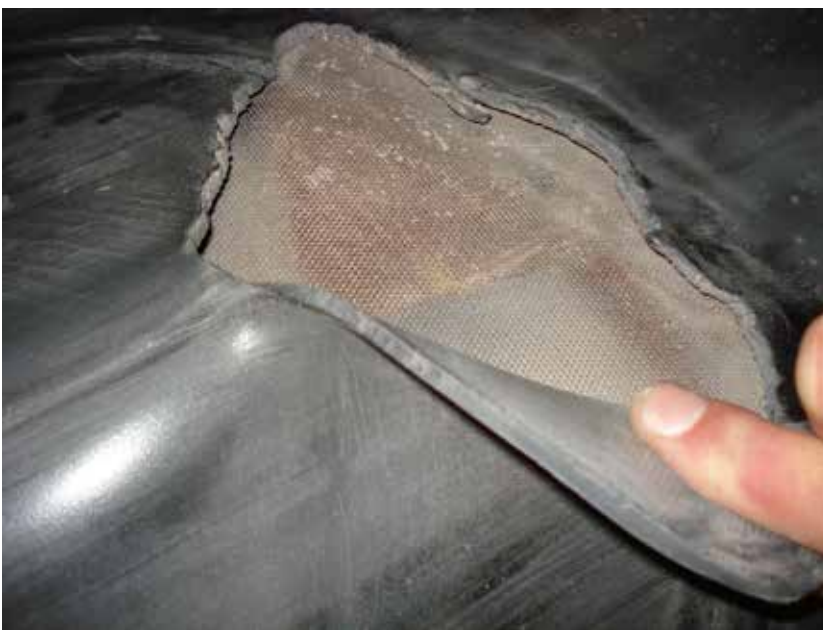
Surface cuts in low grade rubber propagate more quickly and link up with other areas of damage, causing pieces of rubber to detach completely.

Much also depends on the overall strength of the rubber and its resistance to cut and tear propagation. If the latter is insufficient, then even a seemingly insignificant area of damage can easily increase in size due to the continuous material loading and the flexing around the drums and pulleys. In time, this spreads and links up with another area of damage causing pieces of rubber to be cut out

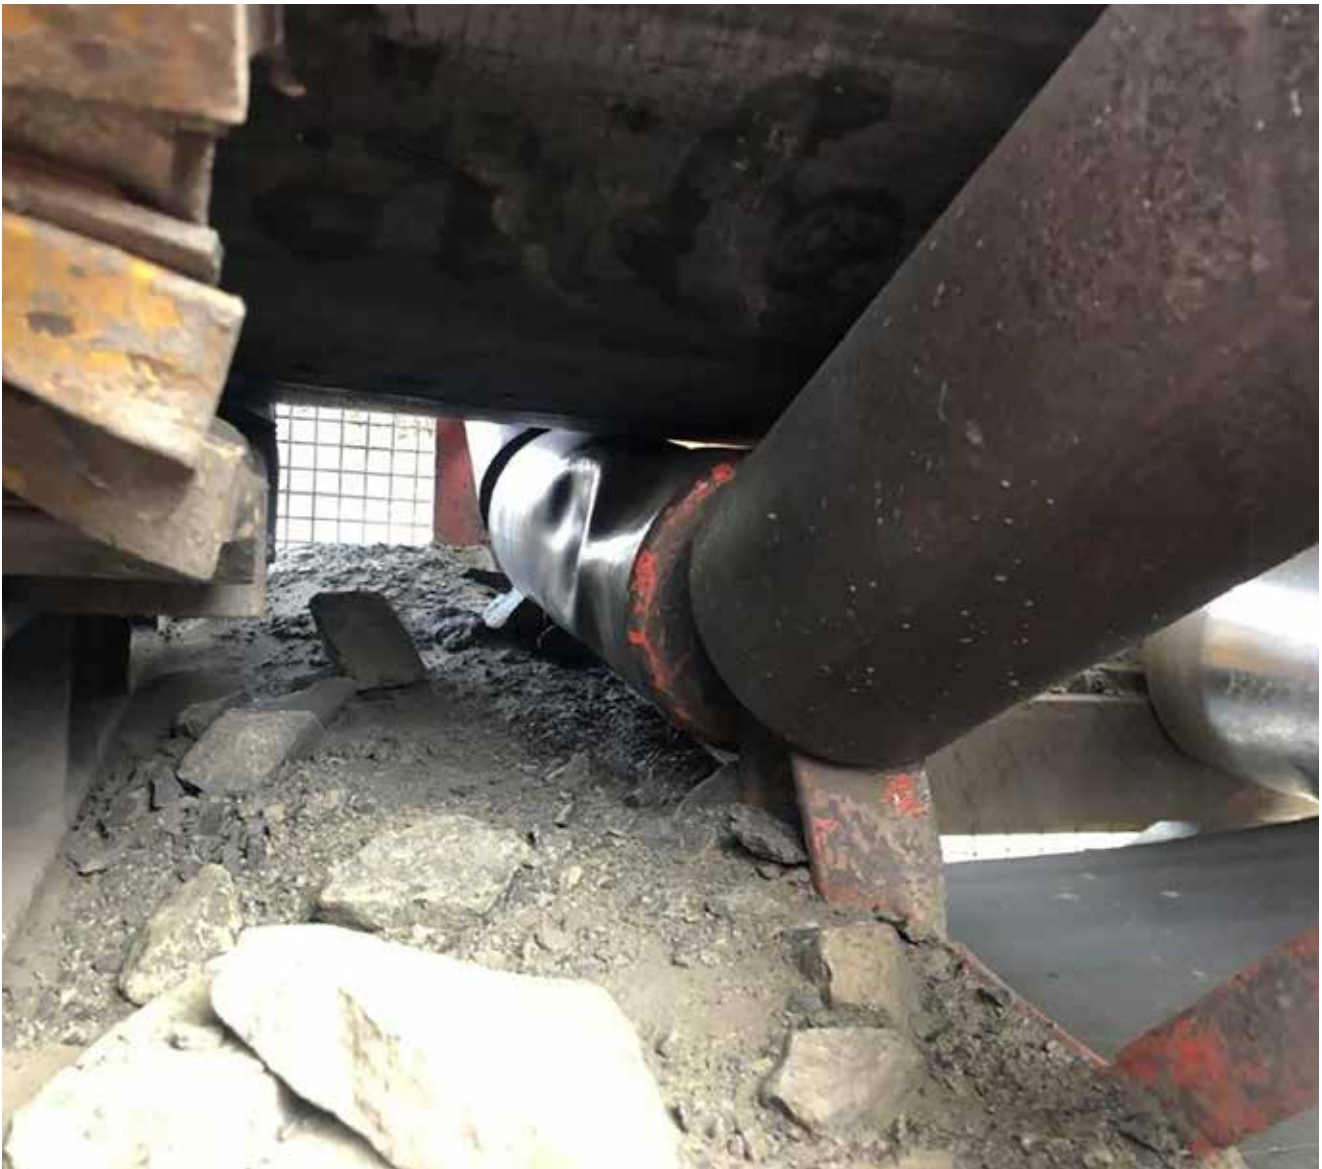
Double trouble – a damaged component and an unclean environment.

Apart from increasing the chances of an object becoming trapped, waste build-up is a common cause of damage to idlers and drums, which can cause a lot of collateral
