# On the right track

## No time to lose: conveyor stoppages – the causes, the cost & the solutions

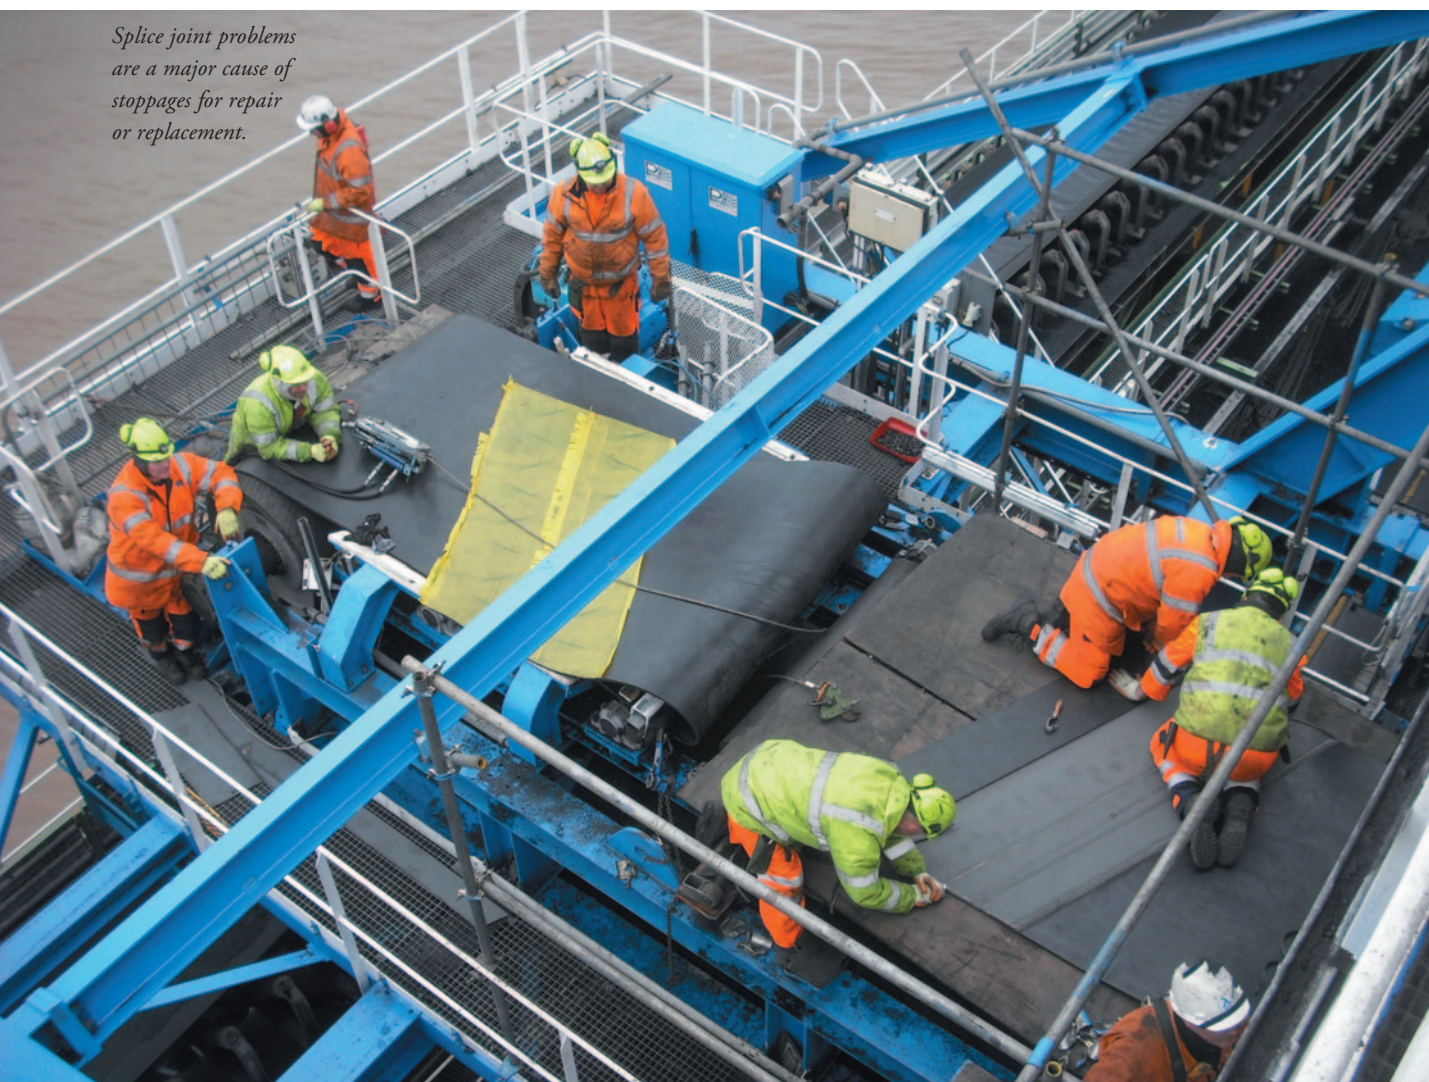
*Splice joint problems are a major cause of stoppages for repair or replacement.*

**Unreliable splice joints:** the weakest point of any conveyor belt is the splice joint. Consequently, splice joint problems are a very common cause of stoppages. Because of the serious loss of output, as well as the safety implications caused by sudden splice joint failure, it is critically important to maximize the strength of the splice and consequently its reliability and durability.

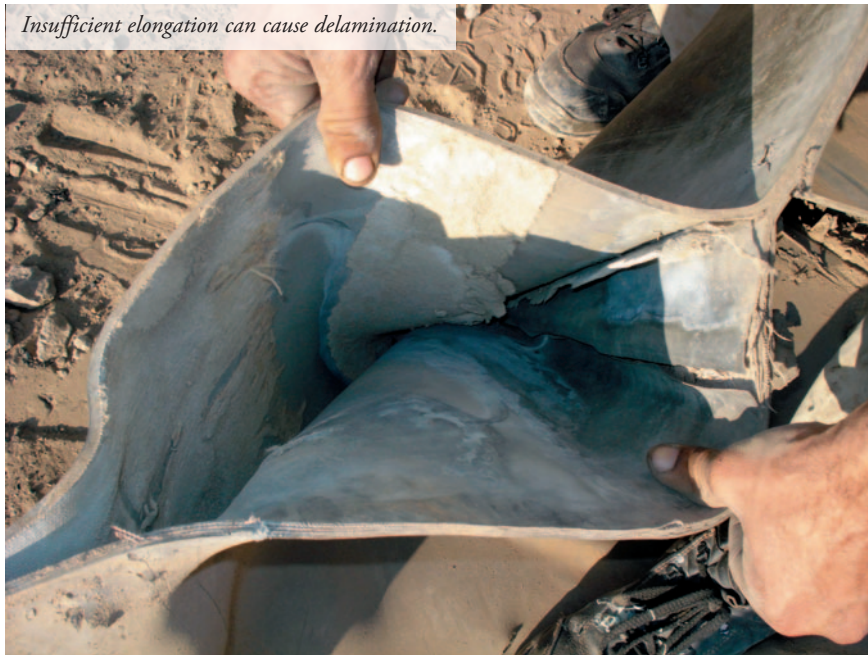
*Insufficient elongation can cause delamination.*

As with poor adhesion, insufficient elongation is symptomatic of low-grade belting, again due to poor quality rubber and fabric ply material. This is mostly an issue in areas where the belt needs to stretch, such as troughing and bending round pulleys and can cause localized tension build-up, which can have an especially negative effect on the integrity of the splice joint.

In addition, low elongation can lead to shear stresses that may in turn cause delamination (ply separation) issues whereas too much elongation can result in insufficient tension, which can lead to premature wear and tear.

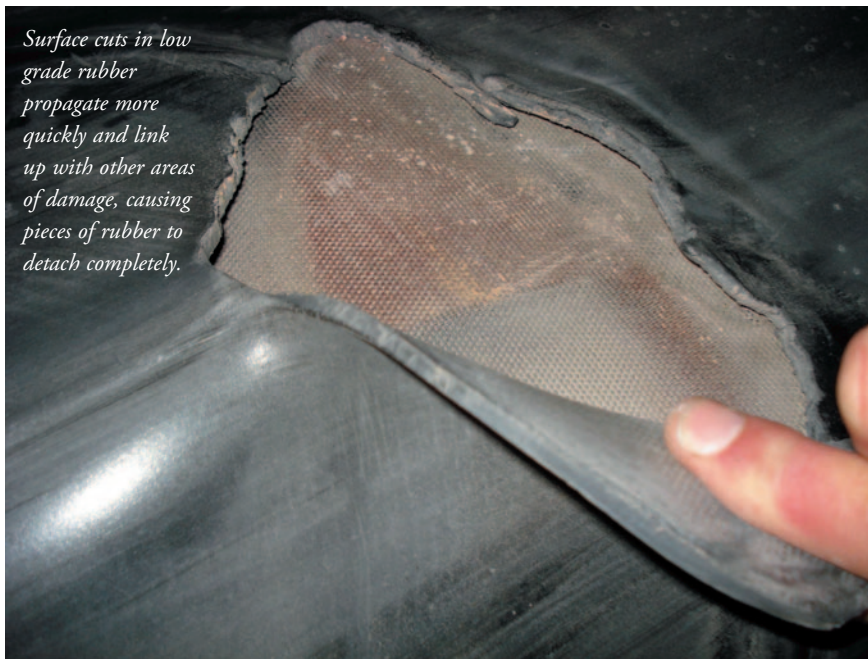
*Surface cuts in low grade rubber propagate more quickly and link up with other areas of damage, causing pieces of rubber to detach completely.*

physical properties of the rubber are the single biggest influence on the length of a belt's operational lifetime. The primary cause of cover damage is the use of rubber with an inadequate resistance to wear & tear, ripping, cutting and gouging rather than rubber that is deliberately engineered to withstand such demands. Much depends on the resistance to cut and tear propagation. If it is insufficient then even a seemingly insignificant area of damage can

easily spread due to the continuous material loading and the flexing around the drums and pulleys. In time, this links up with another area of damage causing pieces of rubber to be cut out from the surface and becoming yet another reason to stop and carry out running repairs.

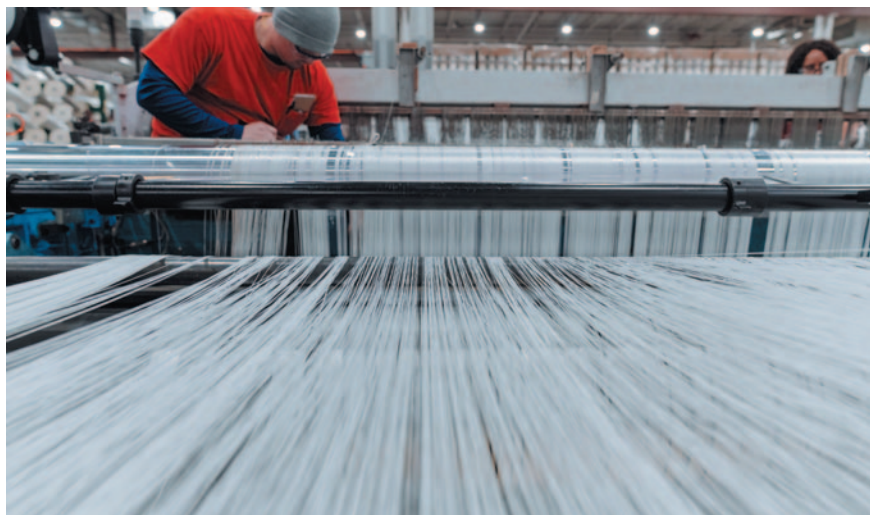
*Special weave patterns using super-strong synthetic strands like Fenner Dunlop's X Series range are the best way to combat rip, tear and impact problems.*

**Thicker is not the answer:** when faced with recurring stoppages caused by belt damage, fitting a thicker, heavier belt is almost invariably not the solution. First and foremost, it is the quality, strength and design of the rubber and the inner plies that have the biggest influence rather than the thickness of the covers and the number of plies. There are also a number of downsides including increased dynamic stress within a carcass that is too thick for the size of pulleys and drums and reduced flexibility in both length and width leading to troughing and handling problems. Thicker covers will also not prevent surface damage and its propagation, and neither will they prevent rip and tear. For rip, tear and impact damage problems, the only true solution is to fit belts that have been specifically engineered to handle such demands.
