# Testing the value

The Fenner Dunlop laboratory, situated in its Drachten plant in the Netherlands, lies at the very heart of everything that the company does, writes Leslie David. Having established a reputation for quality and innovation over the past 100 years, the laboratory plays a pivotal role in the quality control process and research & development. For example, every single batch of rubber compound has to be thoroughly tested and approved by the lab technicians before it is allowed to be used to produce conveyor belts. This is key to achieving consistency of quality and performance.

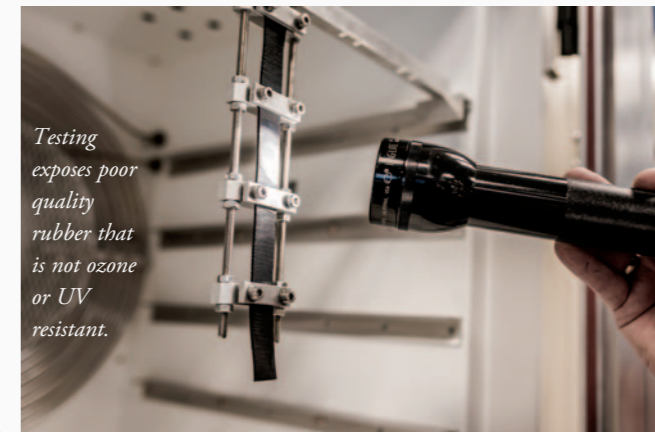
*Testing exposes poor quality rubber that is not ozone or UV resistant.*

- ❖ **Ozone resistance:** the cover started to crack within only eight hours exposure of the total test time of 96 hours exposure static ozone resistance testing (EN ISO 1431/1 procedure B). This is a very poor performance and will result in premature cracking of the covers and loss of physical properties when the belt is in use.
