THE BEST OF BOTH WORLDS

Rob van Oijen, Fenner Dunlop, the Netherlands, explains how fertilizer producers can increase the working lifetime of conveyor belts, whilst decreasing their cost.

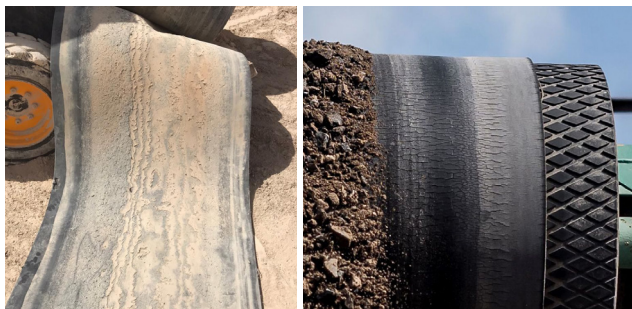
Figures 1 & 2. Insufficient resistance to abrasion is a prime cause of premature belt replacement (left) and the seriously damaging effects of ozone and ultraviolet light (right).

To provide cost-effective longevity, the rubber covers that protect the inner carcass of the belt must have a good standard of at least two basic properties – abrasion (wear) resistance and ozone and ultraviolet resistance. Insufficient resistance to abrasion is one of the biggest reasons why belts need to be replaced much sooner than should be necessary.

produces photochemical reactions that promote the oxidation of the rubber surface, resulting in a loss in mechanical strength. One of the many unwanted side effects of rubber degradation caused by ozone and ultraviolet radiation is that the ability of the rubber to resist wear and surface cutting is steadily reduced, thereby significantly reducing the operational lifetime of the belt. A good standard of abrasion resistance, and ozone and UV resistance, should therefore be absolute prerequisites when buying any type of rubber conveyor belt.

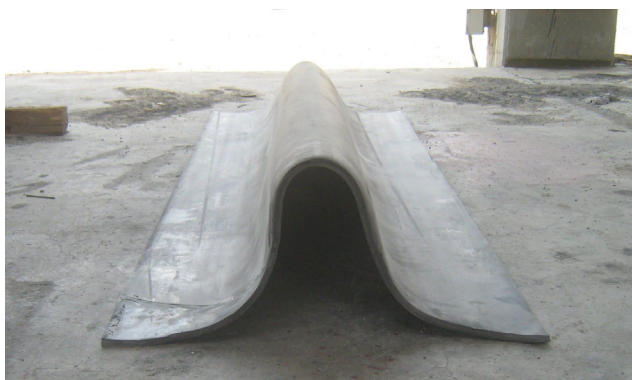
Figure 3. Serious distortion – the effect of oil on a flat rubber belt.

contained within them or which are used as part of the production process. Many have a seriously damaging effect on the outer covers of conveyor belts and consequently on both their day-to-day performance and life expectancy. When oil penetrates rubber it causes it to soften, swell and distort. The process is relatively gradual but it leads to all kinds of problems.

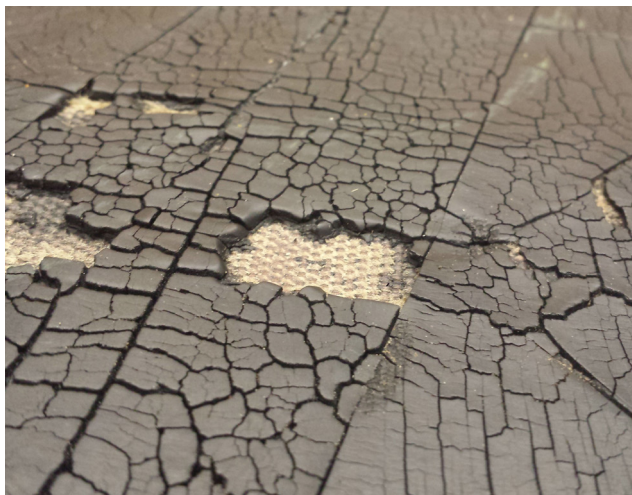
Figure 4. Heat is the ultimate belt killer.

The high temperature materials and working environments found in the fertilizer industry create arguably the most destructive forces of all. Heat causes a rapid acceleration in the ageing process of the rubber, causing it to harden and crack. Tensile strength and elongation can be reduced by as much as 80%, effectively destroying the operational strength and flexibility of the belt and seriously weakening splice joints.

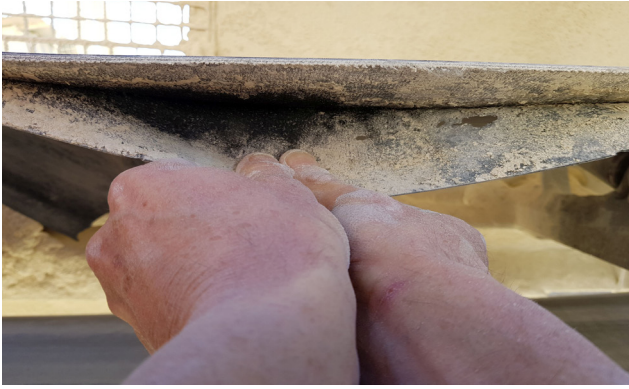
Figure 5. Delamination – if the inner carcass becomes too hot, the belt will literally fall apart.

The covers of the belt wear much faster because the resistance to abrasive wear diminishes considerably. Worse still, if the core of the carcass becomes too hot, then the bond between the covers and fabric layers can separate (delaminate) and the belt will quite literally fall apart. However, as with inadequate resistance to the other life-shortening factors previously described (abrasion, ozone, ultraviolet, oils and chemicals), the quality of resistance to high temperatures is often sacrificed in the pursuit of 'economy'.
