The Invisible Belt Destroyers

How ozone and ultraviolet light dramatically shorten the working life of conveyor belts

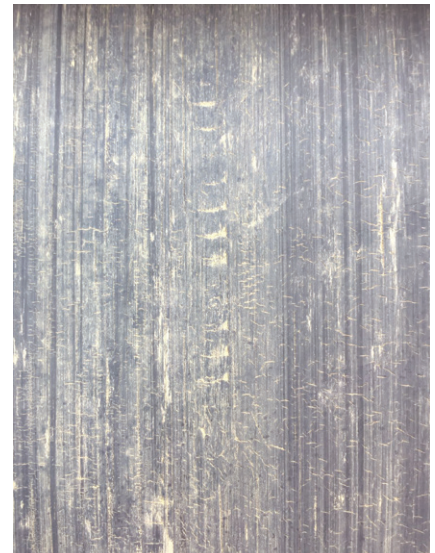
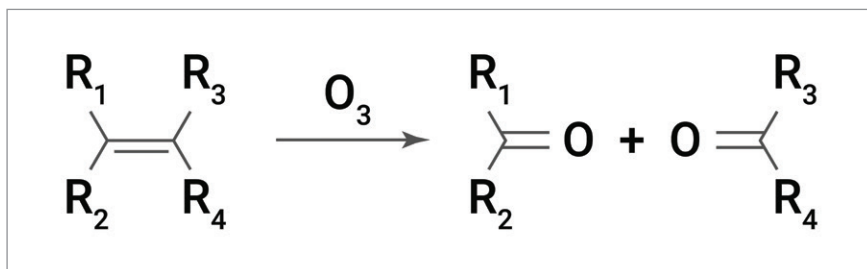
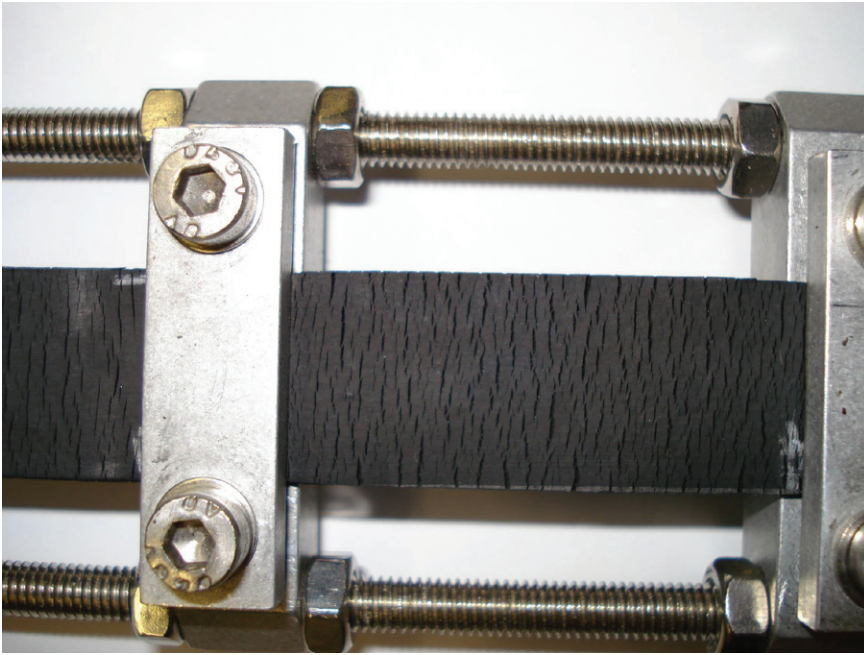
The beginning of the end – innocent-looking cracks in the surface of the rubber

The cracks are always oriented at right angles to the strain axis

Ozone cracks form in rubber that is under tension. This is sometimes referred to as 'dry rotting'. It is important to bear in mind that the amount of tension (critical strain) needed is extremely small. Even a belt that has not yet been fitted has a certain amount of intrinsic tension. The cracks are always oriented at right angles to the strain axis. The dynamic stress that a conveyor belt undergoes while in operation is considerable. Ozone attack occurs at the points where the strain is greatest.

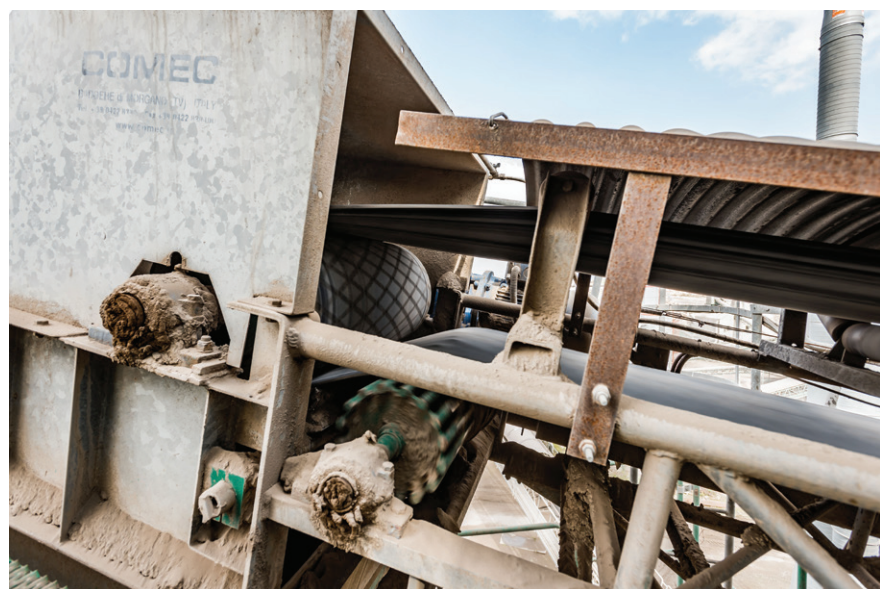
Transversal cracks deepen under the repeated stress of passing over the pulleys and drums

At first glance, having small cracks in the surface rubber may not seem to be significant, but over a surprisingly short time, the rubber becomes increasingly brittle. As just mentioned, transversal cracks deepen under the repeated stress of passing over the pulleys and drums. The ozone continues to attack so the cracks will steadily grow until catastrophic failure occurs. Cracks often present other potential risks such as scrapers catching on

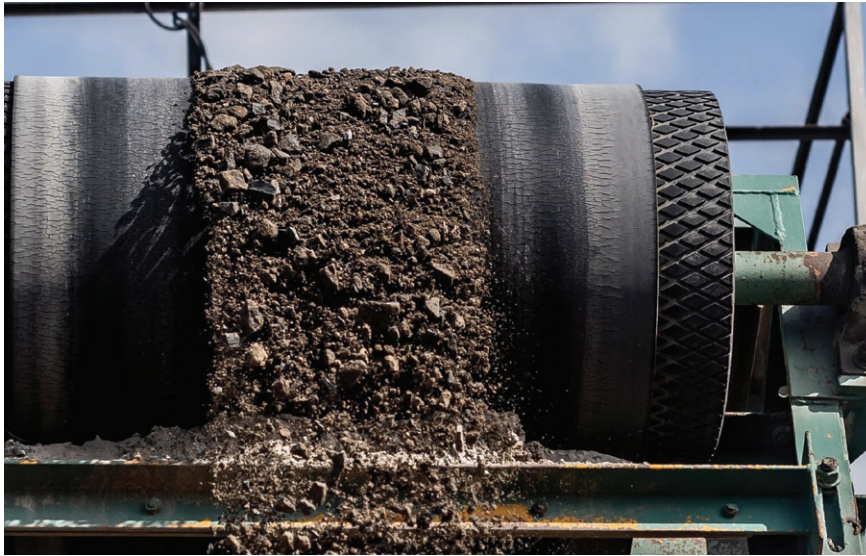
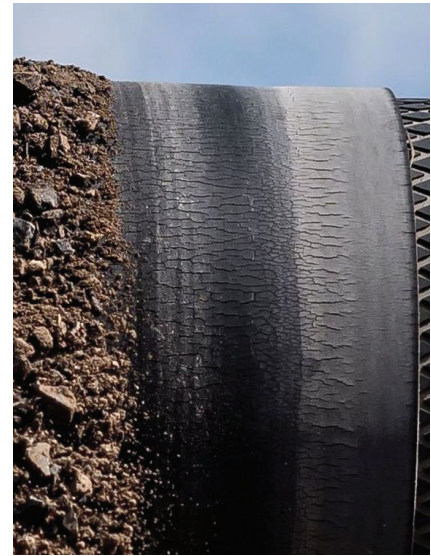
Left: Pollution problems – fine particles of dust penetrate cracks and are then discharged (shaken out) on the return (underside) run of the belt. Right: Close up of the cracks

Yet another 'hidden' problem is that moisture seeps into the cracks. This penetrates down to the actual carcass of the belt. In multi-ply belts, the synthetic fibres of the weft strands of the plies expand as they absorb moisture, which, in turn, causes sections of the carcass to contract (shorten) as the weft strands pull on the warp strands of the ply. This can lead to tracking problems that can be very difficult to pinpoint, and which no amount of steering idler adjustment can compensate for. There can also be significant environmental and health and safety consequences because fine particles of dust penetrate the cracks and are then discharged (shaken out) on the return (underside) run of the belt.

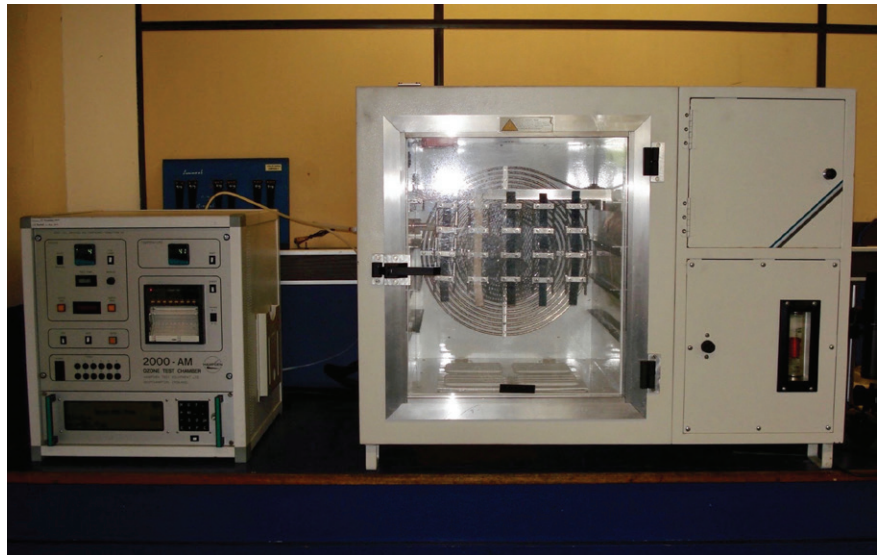
Ozone testing cabinet

The EN ISO 1431 test method is used to scientifically measure resistance to ozone. Samples are placed under tension (eg 20% elongation) inside an ozone testing cabinet and exposed to highly concentrated levels of ozone for a period of up to 96h (@ 40°C, 50pphm and 20% strain).

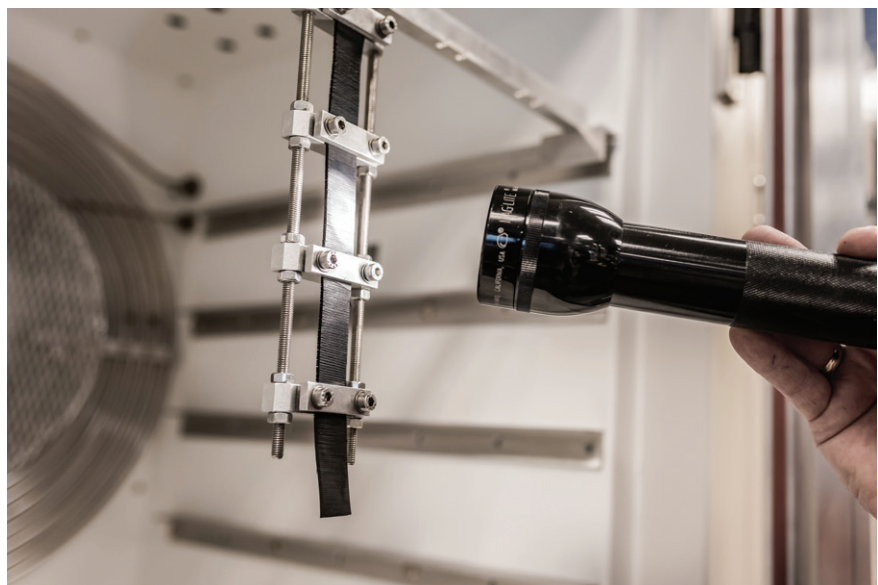
Samples are checked for cracking at two-hourly intervals

Samples are closely examined for evidence of cracking at two-hourly intervals and the results carefully measured and recorded. Experience has determined that in order for the rubber to be regarded as adequately resistant, the pass criteria is that the rubber sample does not show any signs of cracking within the 96h period.

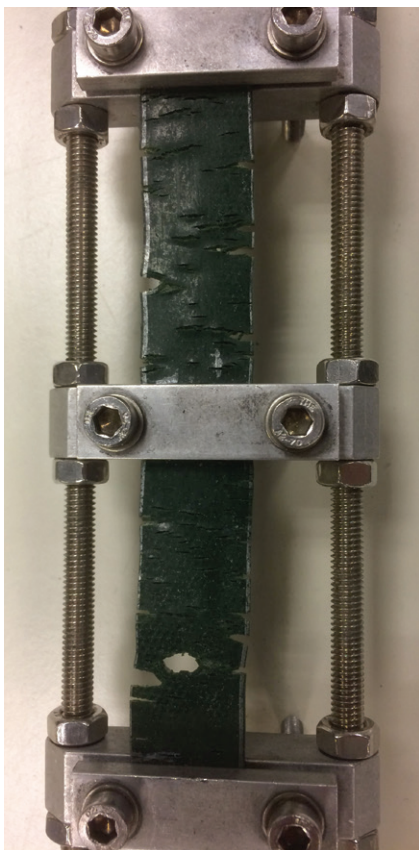
Some rubber literally disintegrates within hours

As mentioned earlier, more than 90% of belts tested in Europe fail the EN ISO 1431 test. Worse still, in the majority of cases, the cracks start to appear as early as 6–8h within the target time of 96h. In fact, it is not uncommon to see rubber samples completely disintegrate within a few hours.
