# TOO SOON ON THE SCRAPHEAP?

**Leslie David, Conveyor Belt Specialist,** describes the causes and effects of conveyor belt wear and tear, as well as the reasons why there are such huge disparities in operational lifetime and durability between one manufacturer and another.

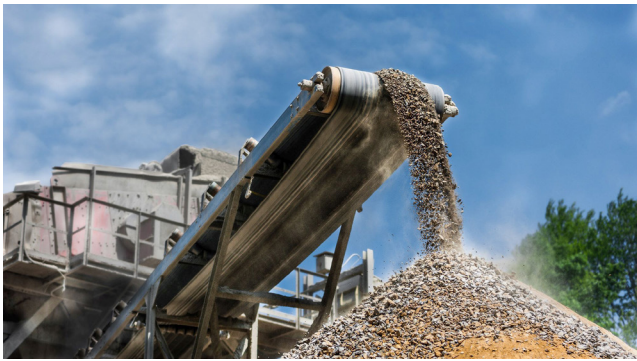
Figure 1. Abrasive material is effectively 'accelerated' across the belt surface.

First and foremost is the abrasive action of the materials being conveyed, especially at the loading point or 'station' and at the discharge point where the material is effectively 'accelerated' across the belt surface. This kind of abrasion is particularly associated with 'fine' materials, such as sand or gravel, which literally act like a piece of coarse sandpaper constantly scouring the rubber cover.

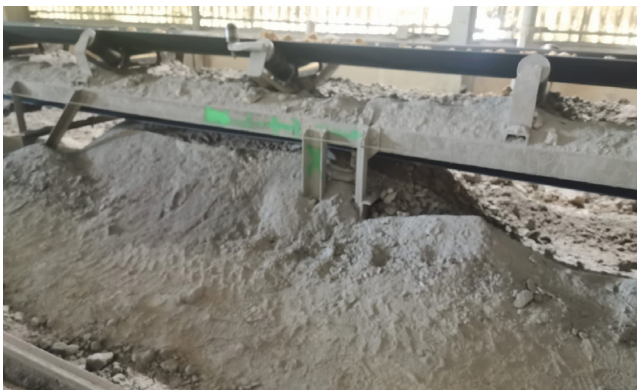
Figure 3. Pollution problems – fine particles of dust penetrate the cracks and are then shaken out on the return run of the belt.

Yet another problem is that moisture seeps into the cracks and penetrates down into the belt carcass. In multi-ply belts, the fibres of the weft strands of the plies expand as they absorb the moisture. This in turn causes sections of the carcass to contract (shorten), as the weft strands pull on the warp strands of the ply, which can result in tracking problems that can be very difficult to pinpoint.

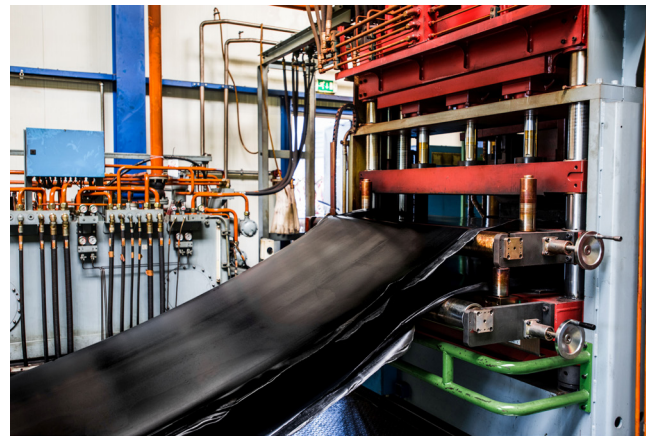
Figure 5. Cost-cutting opportunity – rubber represents 50% of the cost of making a conveyor belt.

The conveyor belt market is hugely competitive. As a result, price is invariably the number one purchasing criteria. Rubber forms some 70% of the volume mass of a conveyor belt and more than 50% of the cost, so it represents the biggest opportunity for manufacturers to achieve price competitiveness. It is therefore not surprising that the primary cause of rapid belt cover wear is low-grade 'economy' rubber that has inadequate resistance to abrasive wear and cutting rather than rubber that has been engineered to provide a high level of resistance. This is also the reason for the huge disparities between one manufacturer and another in terms of price.
