Wearing thin

Conveyors are the most efficient method of handling bulk materials, but their cost-effectiveness depends on the length of working life and lack of need for regular intervention to carry out running repairs.

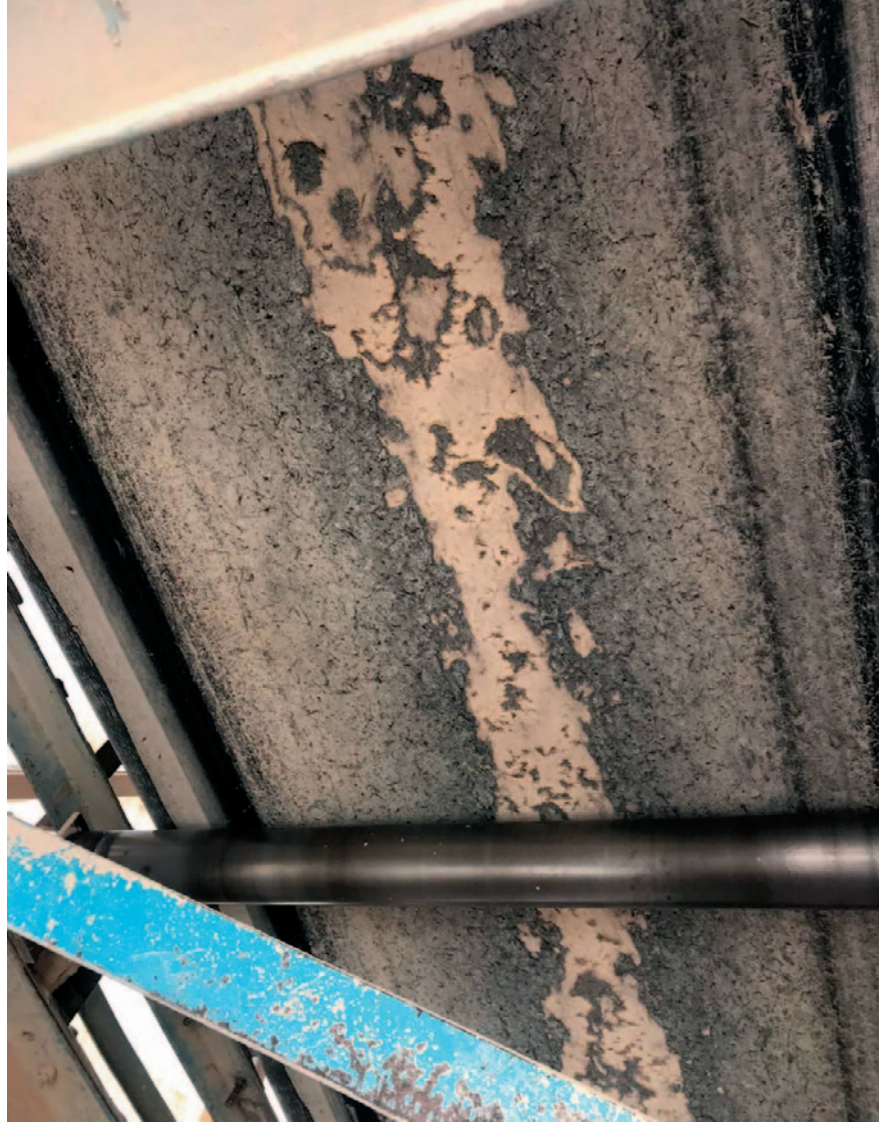
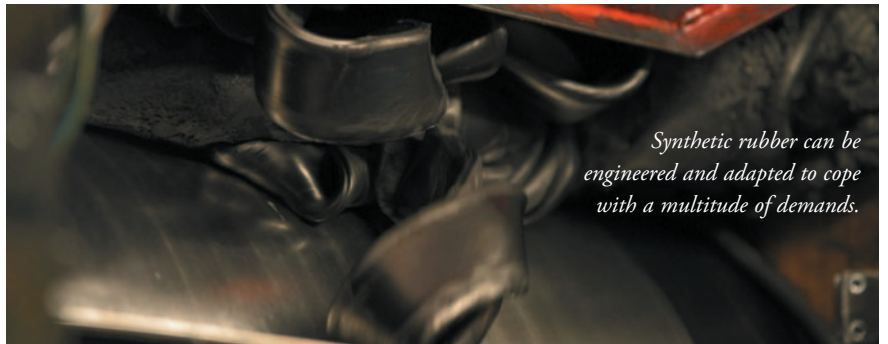
Synthetic rubber can be engineered and adapted to cope with a multitude of demands.

The quality of the rubber is the biggest single influence on the performance and longevity of a conveyor belt. There are many different types of rubber compound used for rubber multi-ply belts because modern-day belts have to deal with a multitude of different (and often combined) demands including abrasion, heat, oil, ozone, fire and more. These compounds are commonly referred to as known as 'cover grades' or 'cover qualities'. They are almost entirely synthetic because of its greater versatility and, by using literally dozens of different chemicals and substances, they can be engineered and adapted to cope with a multitude of demands.

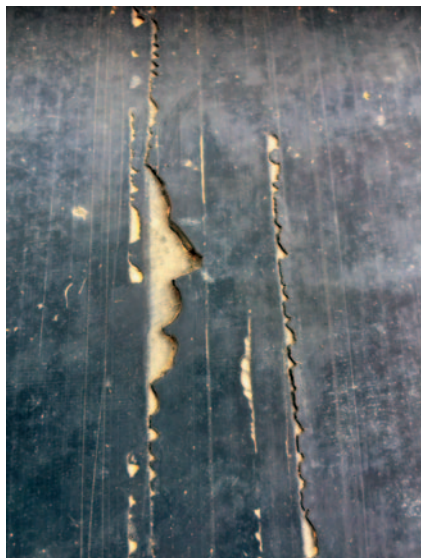
Surface cuts and gouges link up.

effectively 'accelerated' across the belt surface. Many bulk cargoes such as coal are not especially abrasive but materials that are sharp and hard can cut and gouge the surface causing accelerated deterioration. Although the size of the damaged area is often fairly small, they tend to join up with other damaged areas, resulting in pieces of rubber cover being literally cut out of the belt surface.

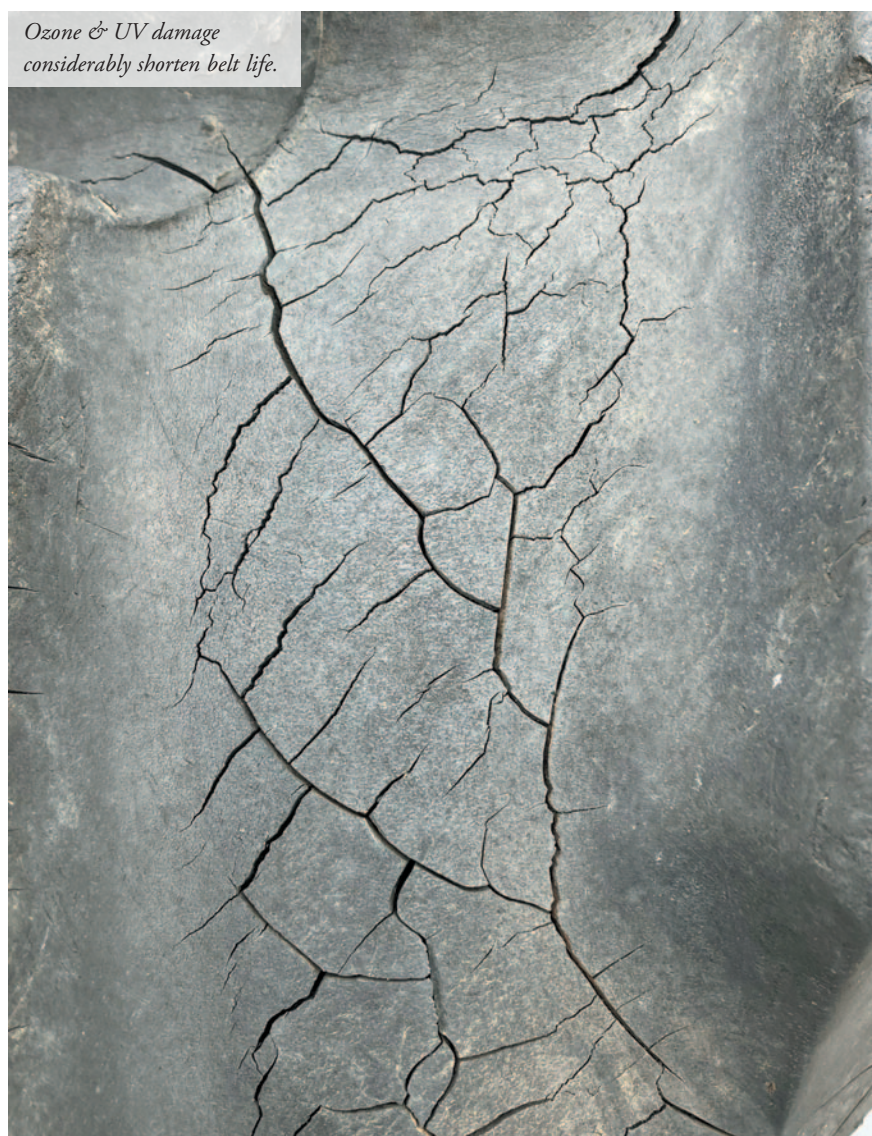
More than 85% of belts sold in Europe fail within six to eight hours of the 96-hour EN ISO 1431 test.

Ozone and ultraviolet damage is entirely preventable simply by the addition of antioxidants to the rubber compound mix. Despite this, tests show that more than 85% of belts sold in Europe fail within only 6 to 8 hours of the 96-hour EN ISO 1431
