WHAT'S THE BIGGEST CRACK?

Independent conveyor belting specialist, Bob Nelson, explains how ozone and ultraviolet light dramatically shorten the working life of conveyor belts.

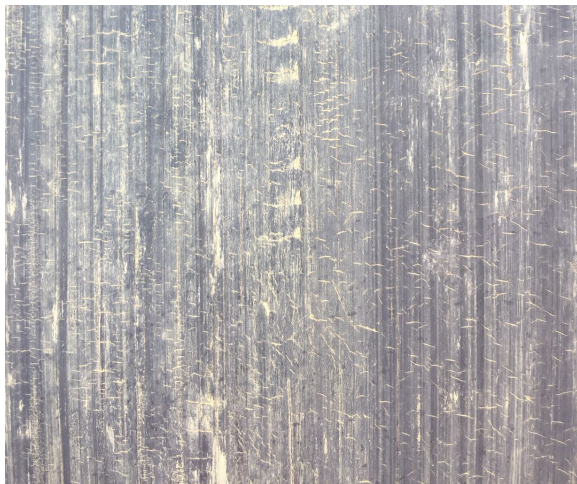
The beginning of the end. 'Innocent' looking ozone cracks in the surface of the rubber.

Ozone cracks form in rubber that is under tension. This is sometimes referred to as 'dry rotting'. It is important to bear in mind that only a very small amount of tension (critical strain) is needed. Even a belt that has not yet been fitted on a conveyor has

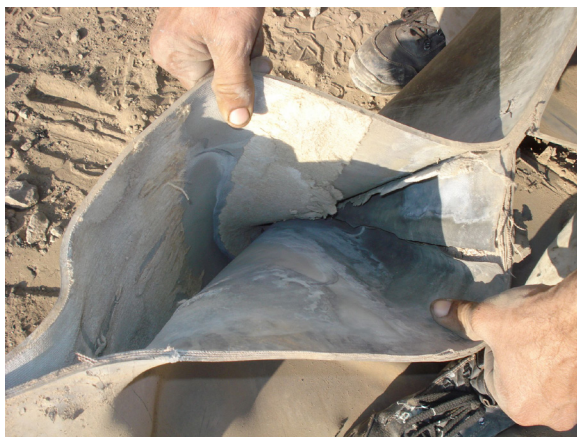
An increase as little as 10°C in core temperature can cause a belt to fall apart.

Last but not least, the ability of the covers to protect the inner carcass from high material temperatures can be seriously compromised because the cracks allow heat to penetrate more easily into the carcass. This is, of course, very serious seeing as even an increase as small as 10°C in core temperature can reduce the life of the belt by as much as 50%. This is because for every 10°C increase in temperature, the rate of rubber oxidation increases by a factor of eight. If the core temperature of the carcass becomes too high, then the bond between the covers and fabric layers

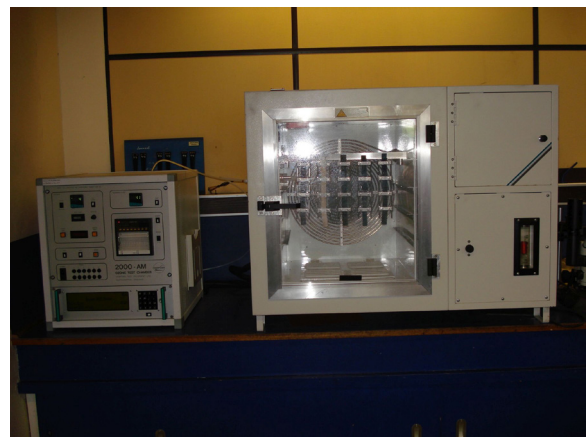
Ozone testing cabinet. Image courtesy of Fenner Dunlop, The Netherlands.

The EN ISO 1431 test method is used to scientifically measure resistance to ozone. Samples are placed under tension inside an ozone testing cabinet and exposed to highly concentrated levels of ozone for a period of up to 96 hours (@ 40°C, 50 pphm and 20% strain). Samples are closely examined for evidence of cracking at two-hour intervals and the results carefully measured and recorded.
