# WHO CARES, WINS

**Leslie David, Conveyor Belt Specialist,** warns of the real cost of poor conveyor maintenance in mining operations.

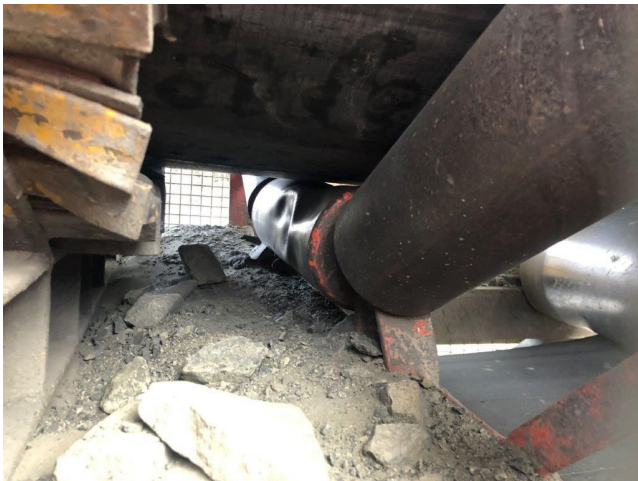
Figure 1. Double trouble – a damaged component and an unclean environment.

A daily inspection is essential. Maintenance teams should 'walk the conveyor' at the start of each shift to spot potential problems before they escalate. At the top of the list should be ensuring that the working environment is clean and safe. Waste build-up is a common cause of damage to idlers and drums as well as a collateral belt damage. Even small accumulations of debris, especially on the bottom side of the conveyor belt or drums and pulleys, can throw off belt alignment sufficiently to cause the belt to catch on the conveyor framework. It also creates uneven component wear, particularly on the conveyor belt. Areas where product spillage occurs regularly need to be actioned for more frequent cleaning. Other factors include making sure that any scrapers are correctly adjusted and that drum linings (where applicable) are in good condition.

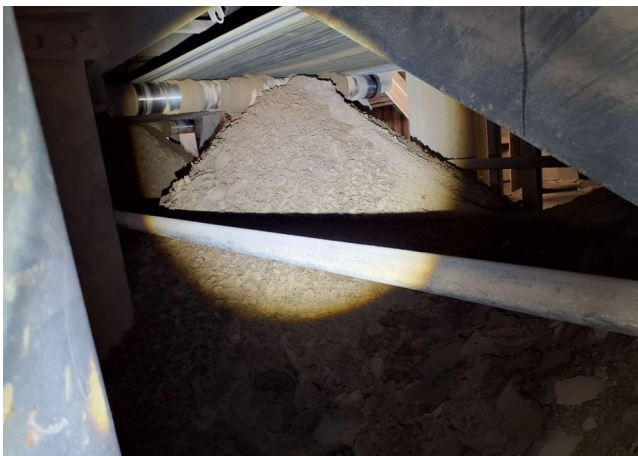
Figure 2. Waste build-up is a common sight and causes a lot of avoidable wear and stoppages.

One of the most common causes of waste build-up is when dust particles penetrate cracks in the surface of rubber belts caused by the effects of ground-level ozone ( $O_3$ ), and ultraviolet light and are then shaken out on the return (underside) run. At low altitude, ozone becomes a pollutant that is created by the photolysis of nitrogen dioxide ( $NO_2$ ). Exposure is unavoidable and even tiny traces of ozone in the air will attack the molecular structure of rubber. Ultraviolet light, including fluorescent light, also accelerates rubber deterioration.

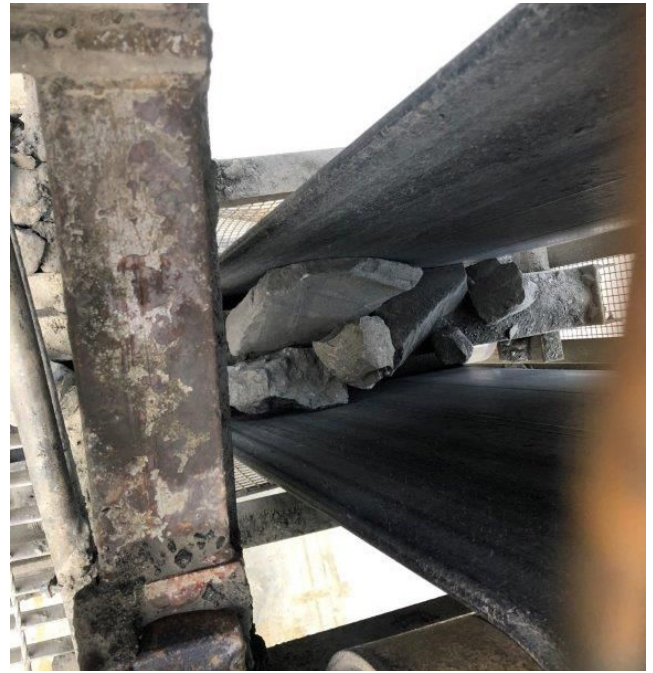
Figure 3. A big cause of stoppages is material becoming trapped.

A big cause of stoppages is conveyor belt damage caused by material becoming trapped. When lodged in part of the conveyor mechanism or simply finding their way between the belt and the drum, even small, sharp stones can puncture the belt cover. Larger objects can penetrate the carcass and, in some cases, cut the belt lengthwise. The first step in reducing the risk is to identify

where foreign objects and rogue material is most likely to become trapped and take preventative measures such as installing skirts or screening.

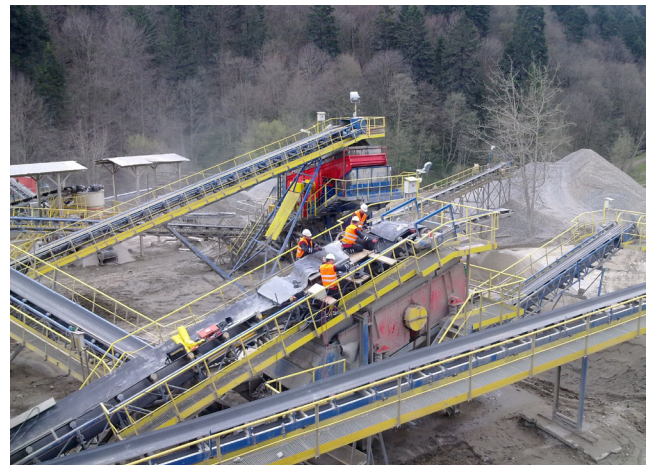
Figure 4. The cost of splice repairs and lost output is considerable

Splice joint repairs are a major cause of stoppages and the biggest single cause of splice problems are shortcomings in the quality of the conveyor belt itself. Poor quality rubber and poor adhesion between the inner plies are both common faults found in the low-grade belts, and as the rubber prematurely ages and degrades because of

ozone and ultraviolet exposure, the problems become increasingly persistent.
