Circumventing Conveyor Costs

Conveyor belting specialist Steven Kidd explains the causes of unplanned conveyor stoppages and how proactive solutions can minimise lost output and costly repairs.

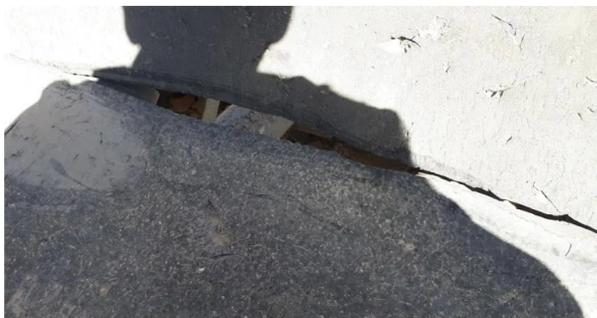
'Cheap' imported belts are much more prone to ripping.

the synthetic fabric used to create the carcass. These are dictated by whether the belt manufacturer is at the 'quality end' of the market or the 'cut-price' end. Despite apparently being the same specification on paper, the strength under load both longitudinally and transversely can be inconsistent. Although the amount of nylon used in the longitudinal strands of the fabric may be sufficient to achieve the required tensile strength, in an effort to reduce cost, the use of the nylon transversal weft material is often kept to a minimum and in many cases, not used at all.

Consequently, rip and tear resistance is reduced, leading to stoppages for patch and clip repairs and, in more serious cases, the replacement of inserts or the entire belt. In addition, low-quality fabric plies with an inconsistent longitudinal and/or transversal spread of tension can cause a conveyor to be stopped to rectify tracking, steering, and handling problems.

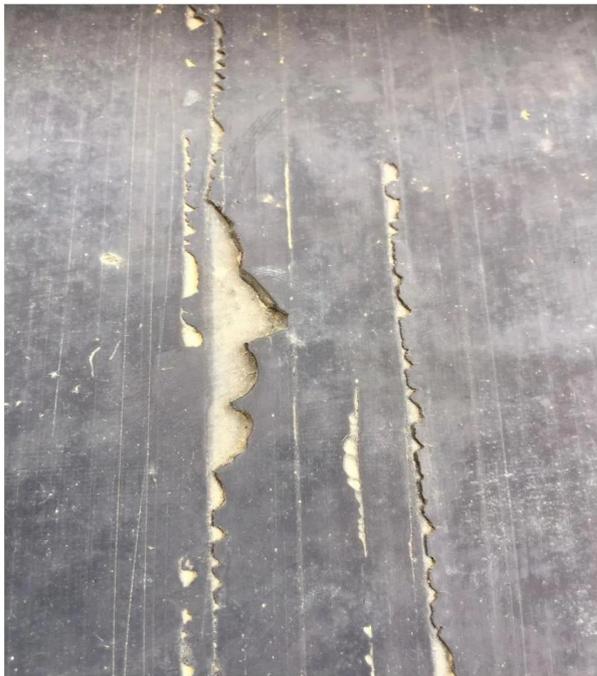
Surface cuts in low grade rubber propagate more quickly and link up with other areas of damage, causing pieces of rubber to detach completely.

Both standards measure abrasion resistance based on the amount of rubber lost during ISO 4649 / DIN 53516 testing, but the test cannot measure resistance to cut and tear propagation. If it is insufficient, a small area of damage can easily grow due to continuous material loading and the flexing around drums and pulleys. This can link with other damaged areas, causing pieces of rubber to be cut from the surface and creating yet another reason for stoppages and running repairs. The overall quality and strength of the rubber is critical in minimising the need to carry out repairs. It is therefore important to understand that rubber represents around 50% of the material cost of producing a conveyor belt. For manufacturers seeking a price-competitive edge, this creates an irresistible temptation to compromise on resilience in exchange for higher sales and faster reordering of replacements. This is why the sharp stone that finds its way between the drum and the belt will cut into low-grade rubber with ease, whereas it will hardly make a mark on good quality rubber that has been deliberately engineered to withstand such demands.

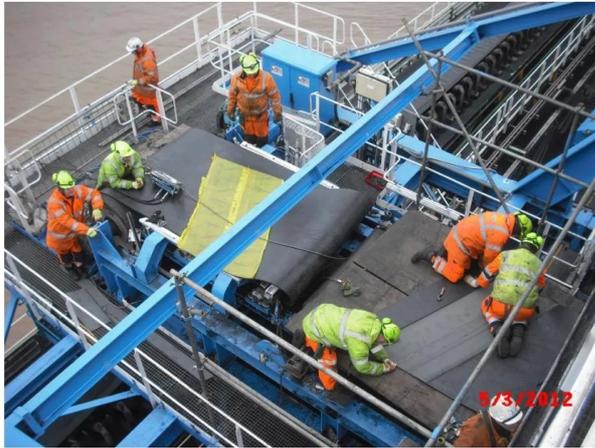
Splice joint problems are a major cause of stoppages for repair or replacement.

The splice joint is the weakest point of any conveyor belt, and splice joint failures are widely regarded as the most common

Joint problems are most prevalent in low-grade imported belting, where poor adhesion between the plies – or between the belt and splicing materials – combined with

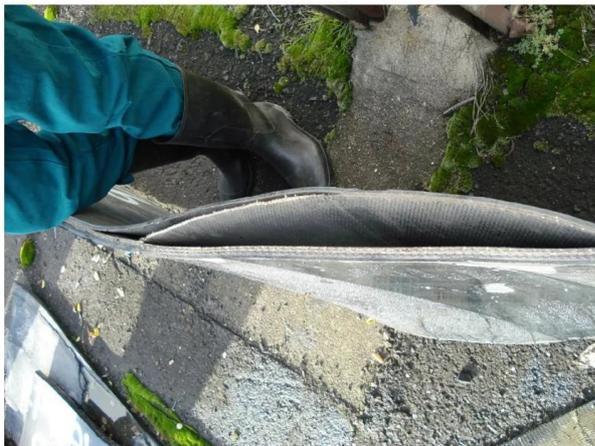
Insufficient elongation is a major cause of delamination.

Low elongation is another symptom of low-price multi-ply belting and is mostly an issue in areas where the belt needs to stretch, such as troughing and bending round pulleys. This can cause localised tension build-up, leading to shear stresses that may, in turn, result in delamination (ply separation) issues.
