# CONVEYING DRIVE RELIABILITY

**Leslie David,  
Conveyor Belt Expert,**  
reviews how conducting  
regular maintenance,  
preventing waste  
buildup, and using high  
quality components can  
enhance the reliability of  
conveyor systems.

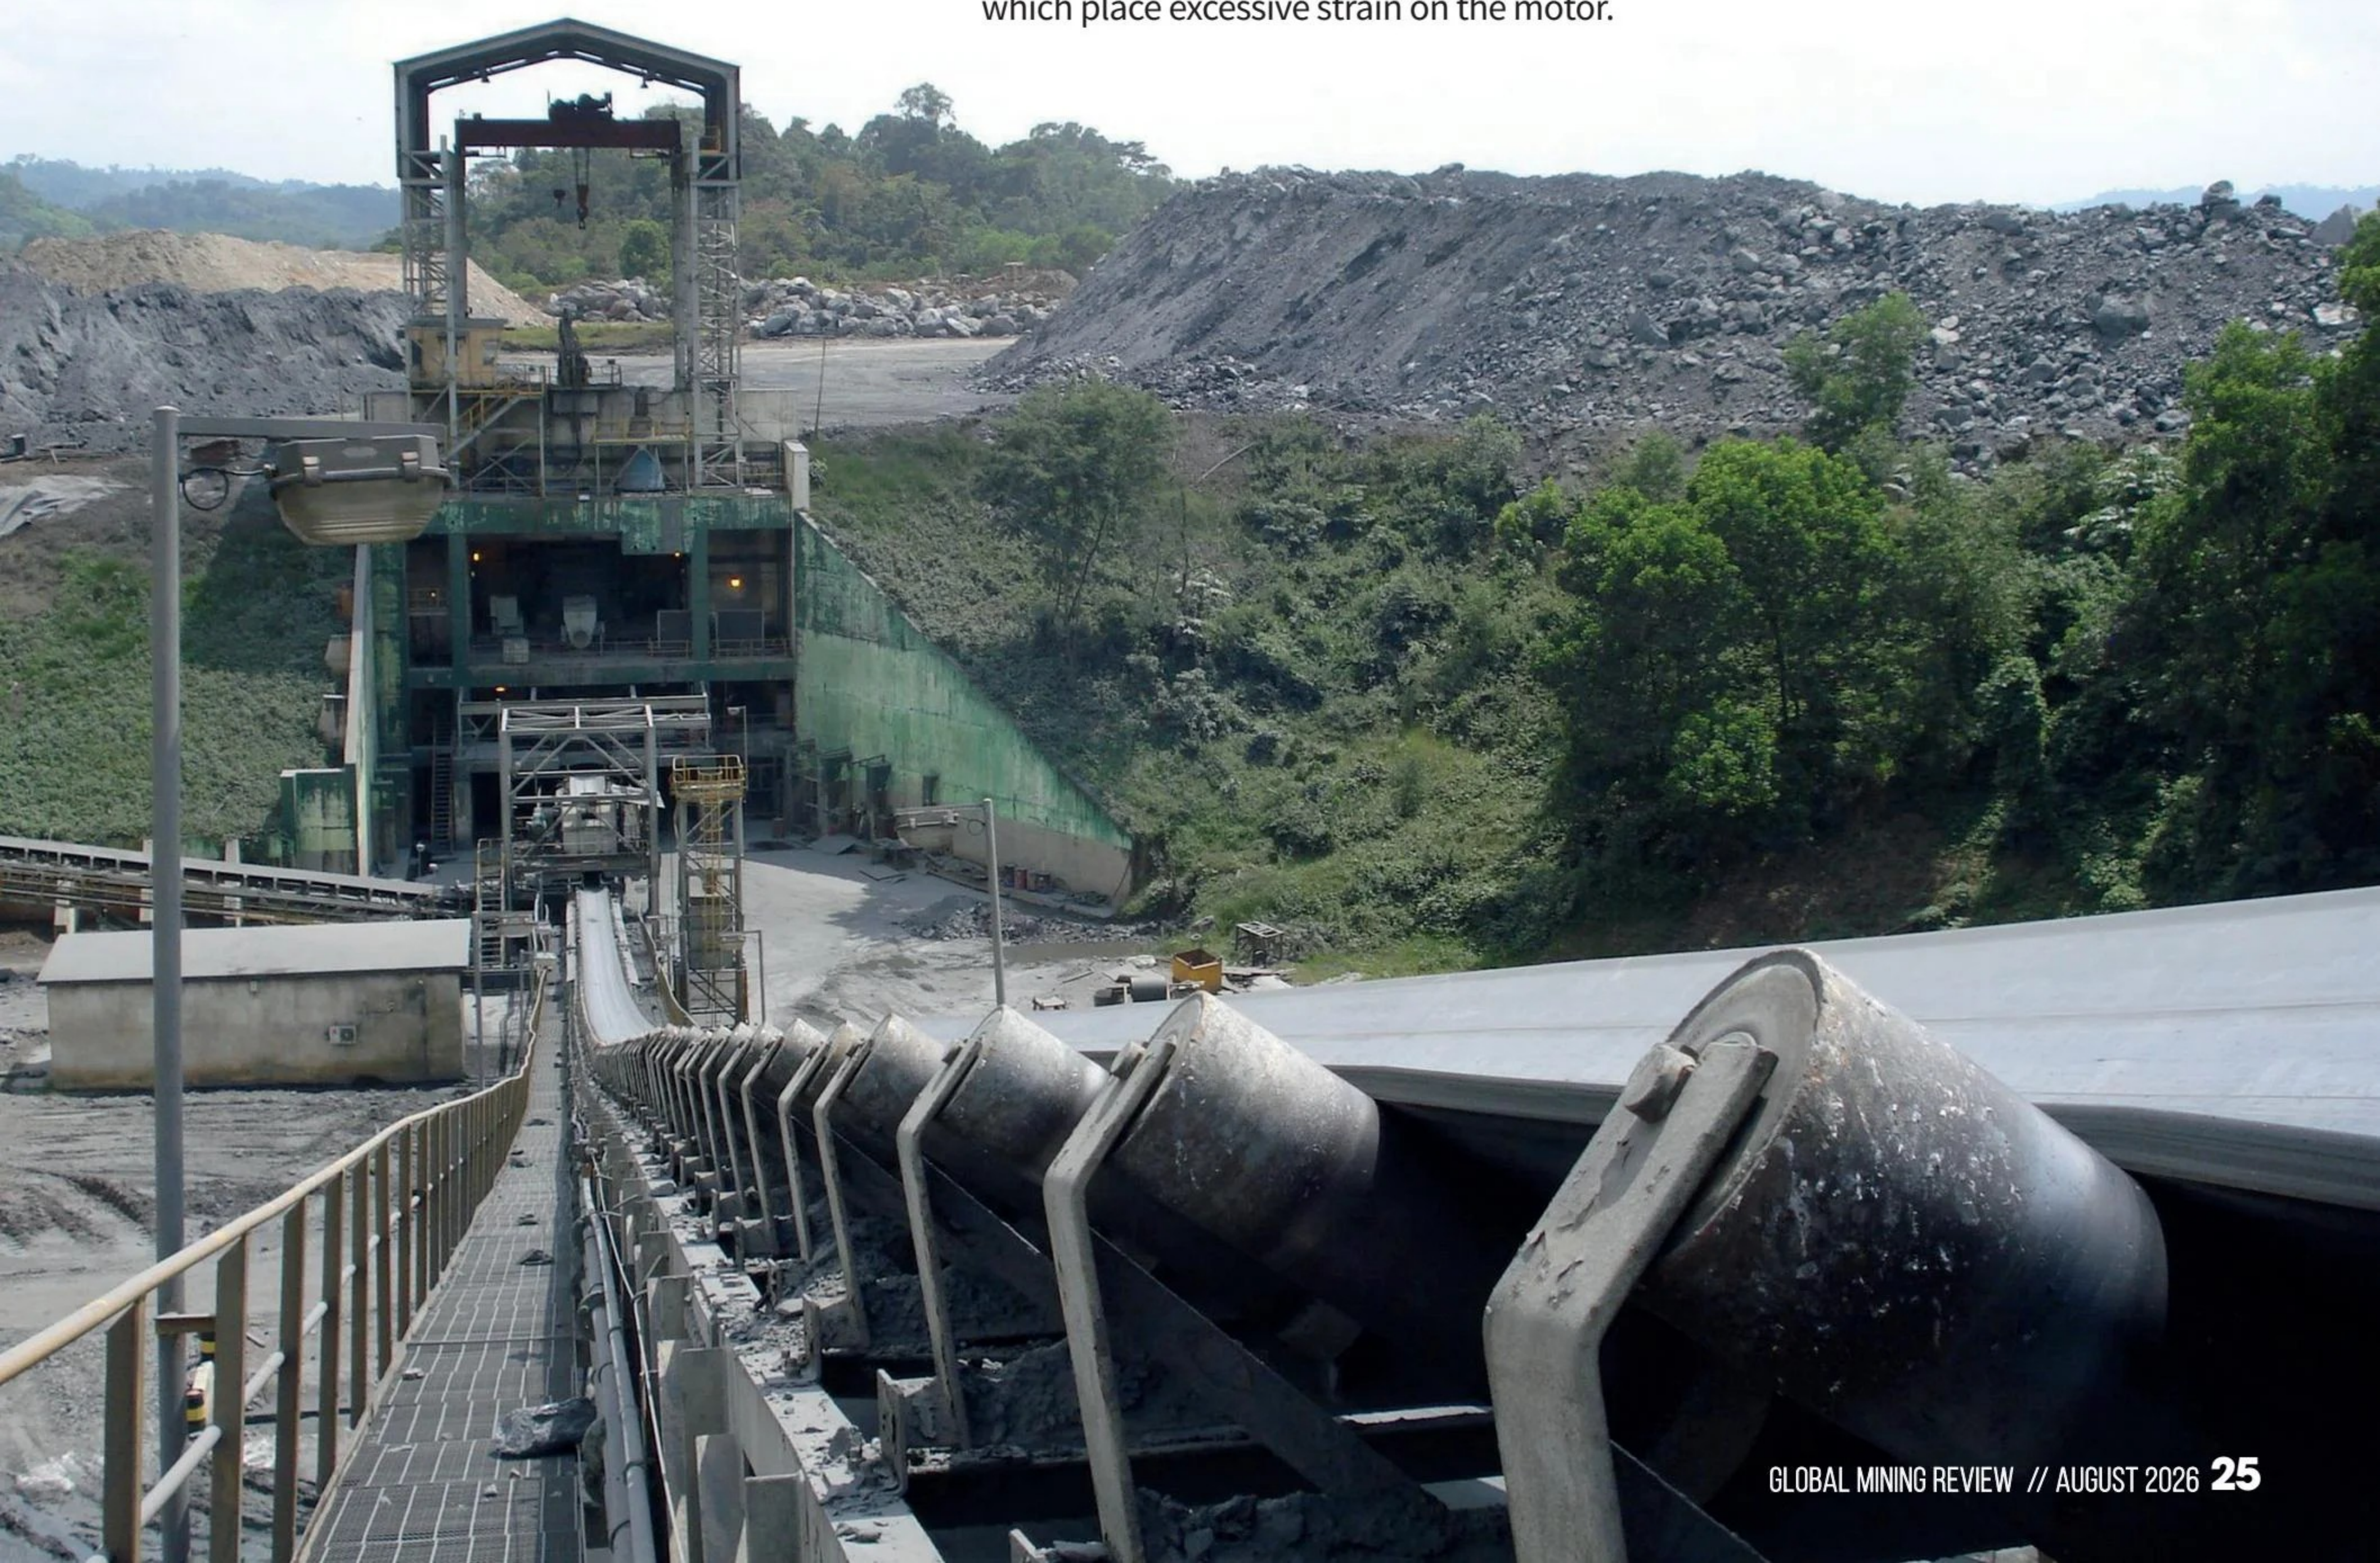
Figure 1. Installing a heavier belt can  
increase absorbed motor power.

## Over-specified belts

When trying to solve rapid cover wear, rip, tear, and impact problems, a common mistake made is to increase the thickness of the covers, the number of plies and/or the tensile strength. Although a seemingly logical action, belts that exceed the belt specification the conveyor was designed for can increase the absorbed motor power as well as causing troughing and handling problems.

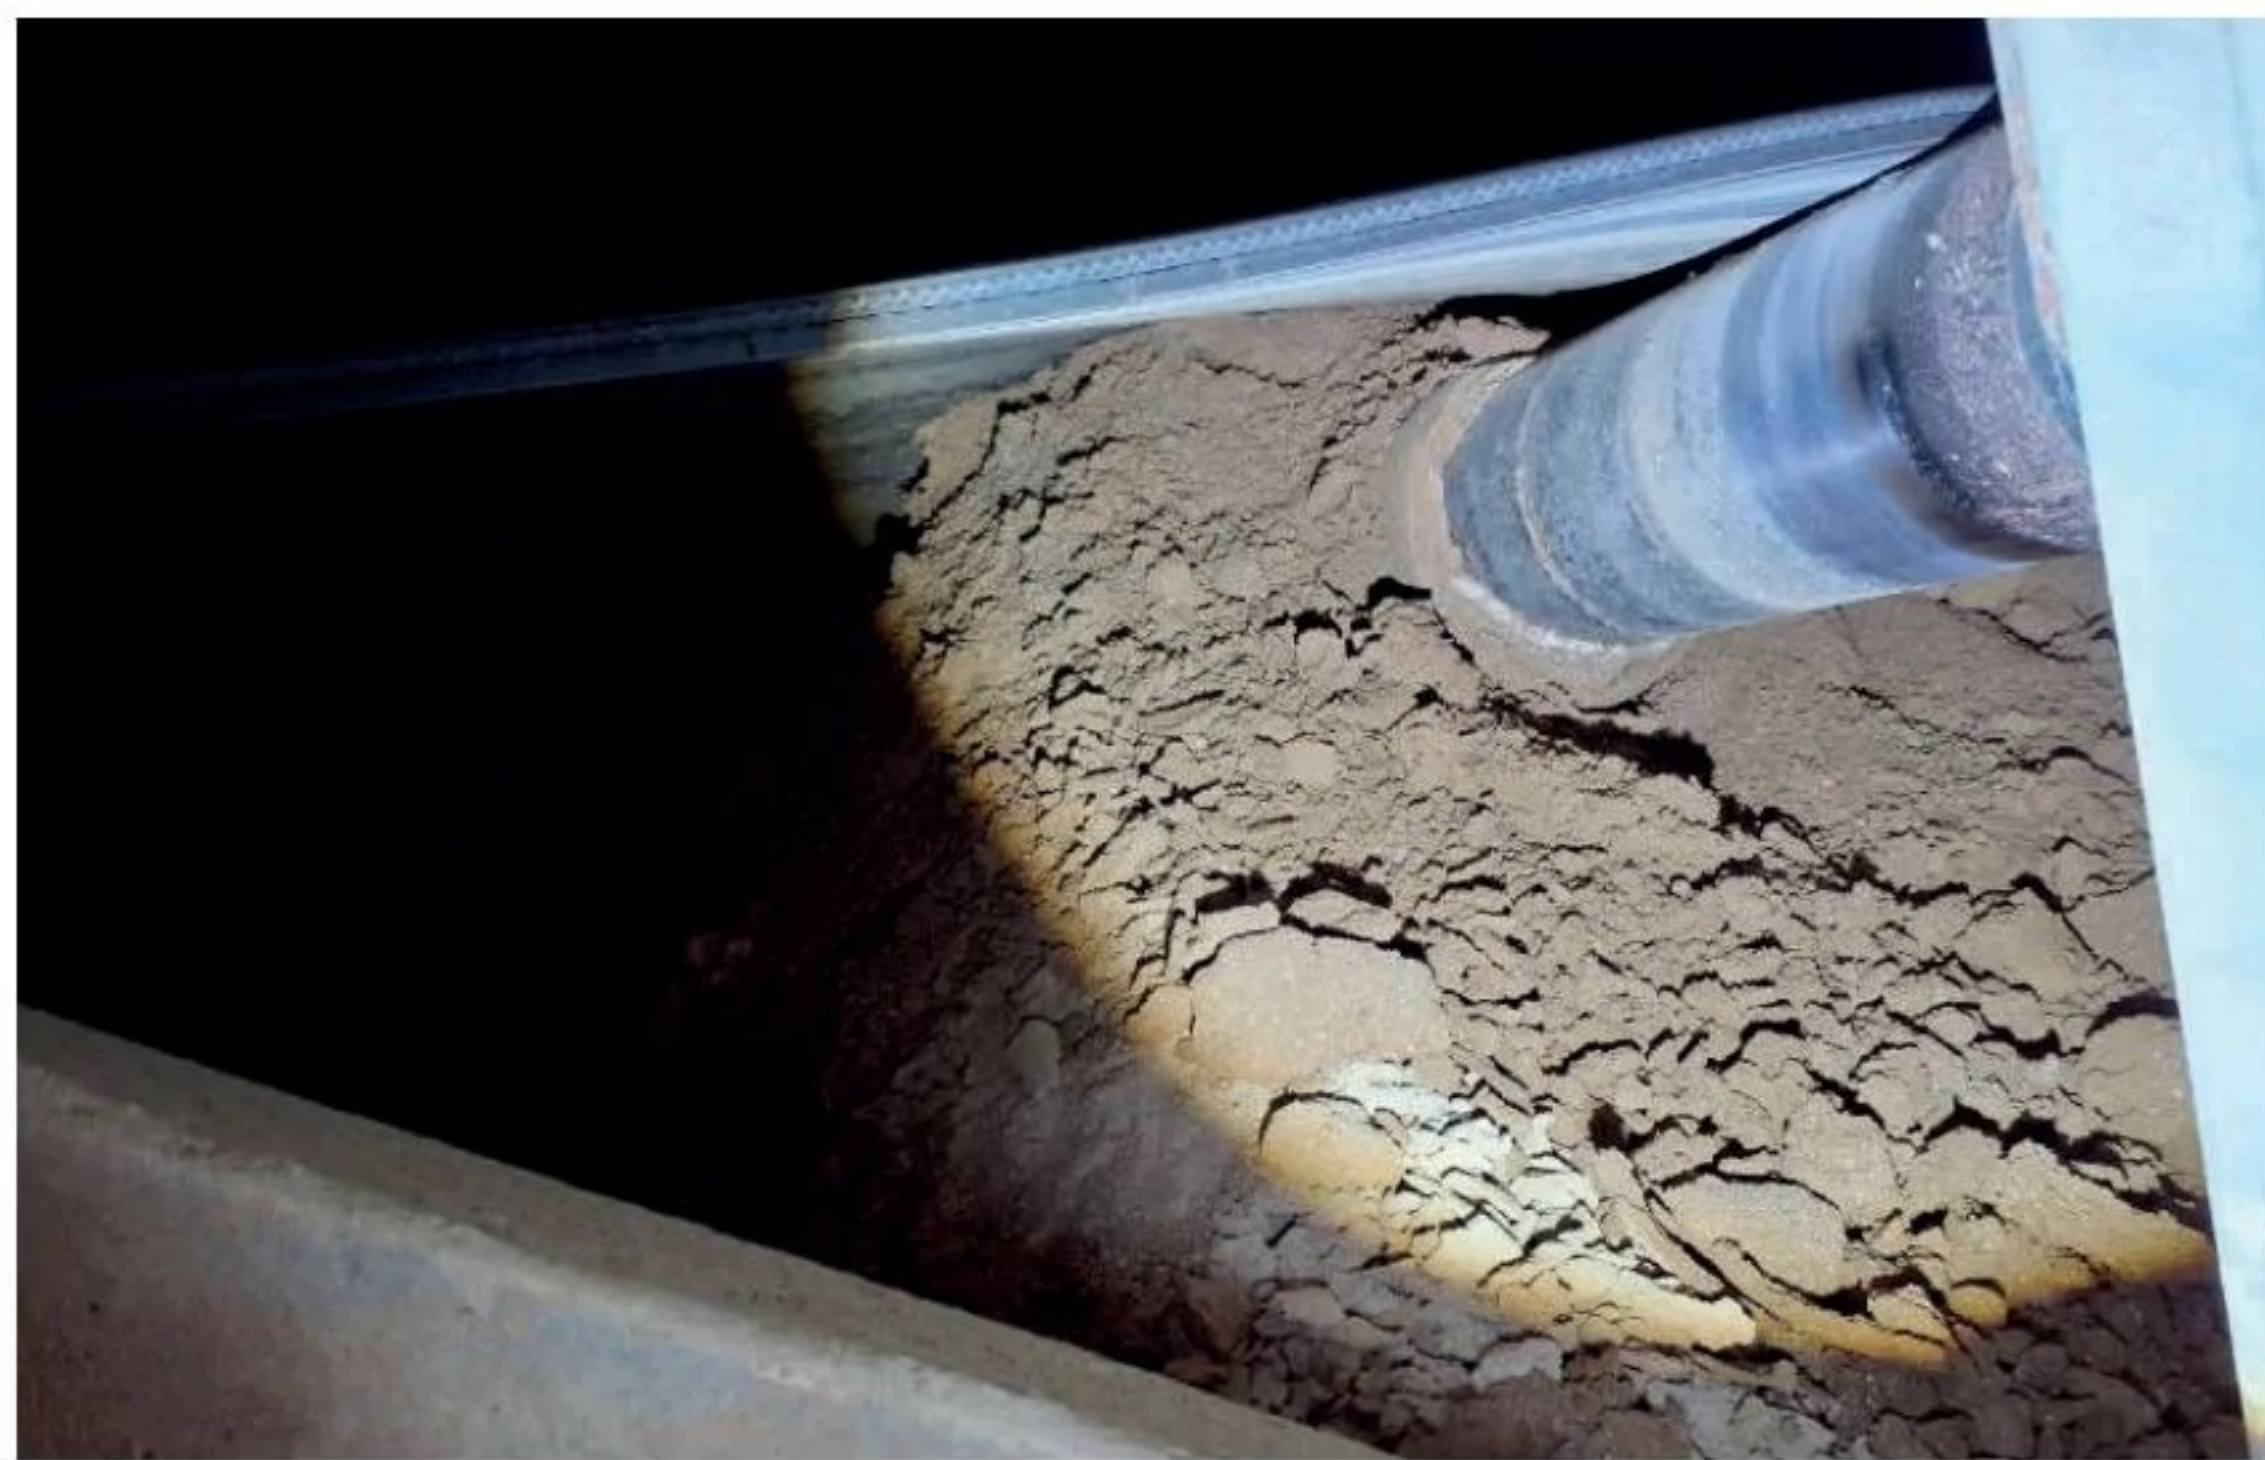
Figure 2. Unclean work environments are the most common cause of accelerated wear and damage.

Waste build up is a very common cause of avoidable wear and damage to conveyor components, so areas where product spillage occurs need to be routinely cleaned.

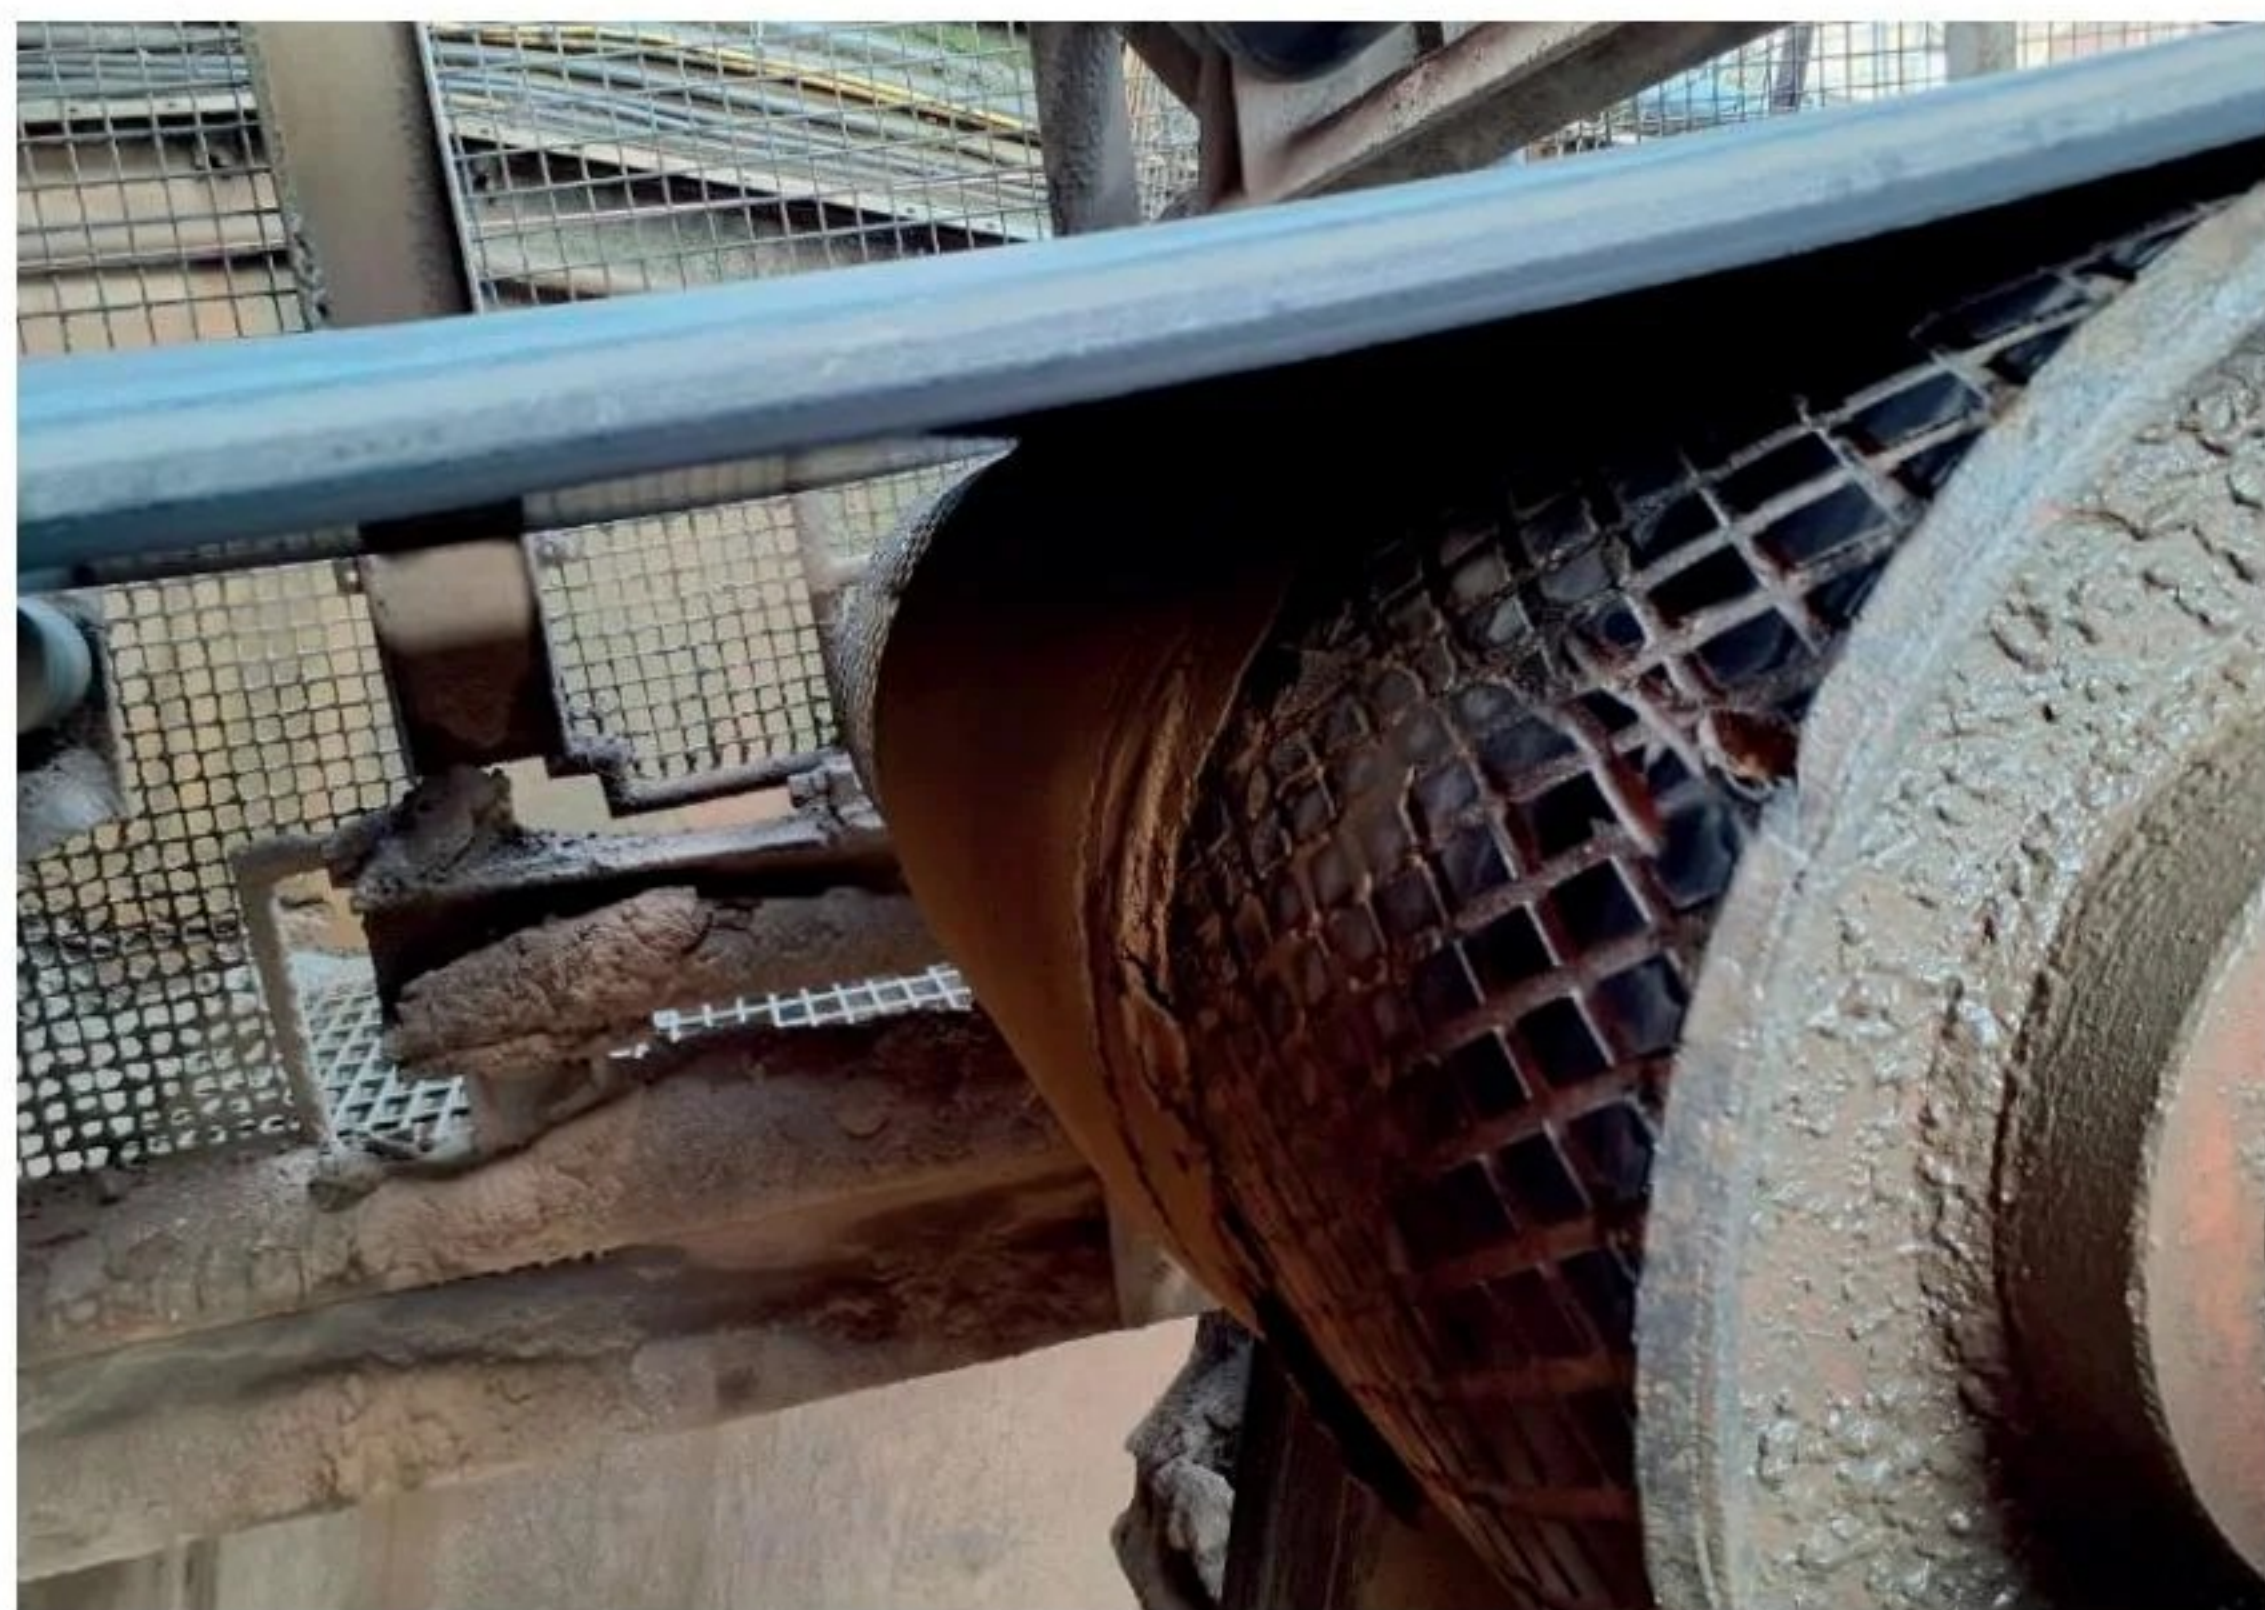
Figure 4. Belt slippage caused by waste matter increases strain on motor.

A sure sign of an overloaded belt is a high-pitched screeching sound as it loses traction on the pulley and starts to slip. This creates extreme friction that heats up the pulley and strains the motor as it tries to move the load. Other common causes are inadequate belt tension, worn drum linings, waste matter between belt (unclean environment), and belt surfaces where the rubber has aged and become brittle.

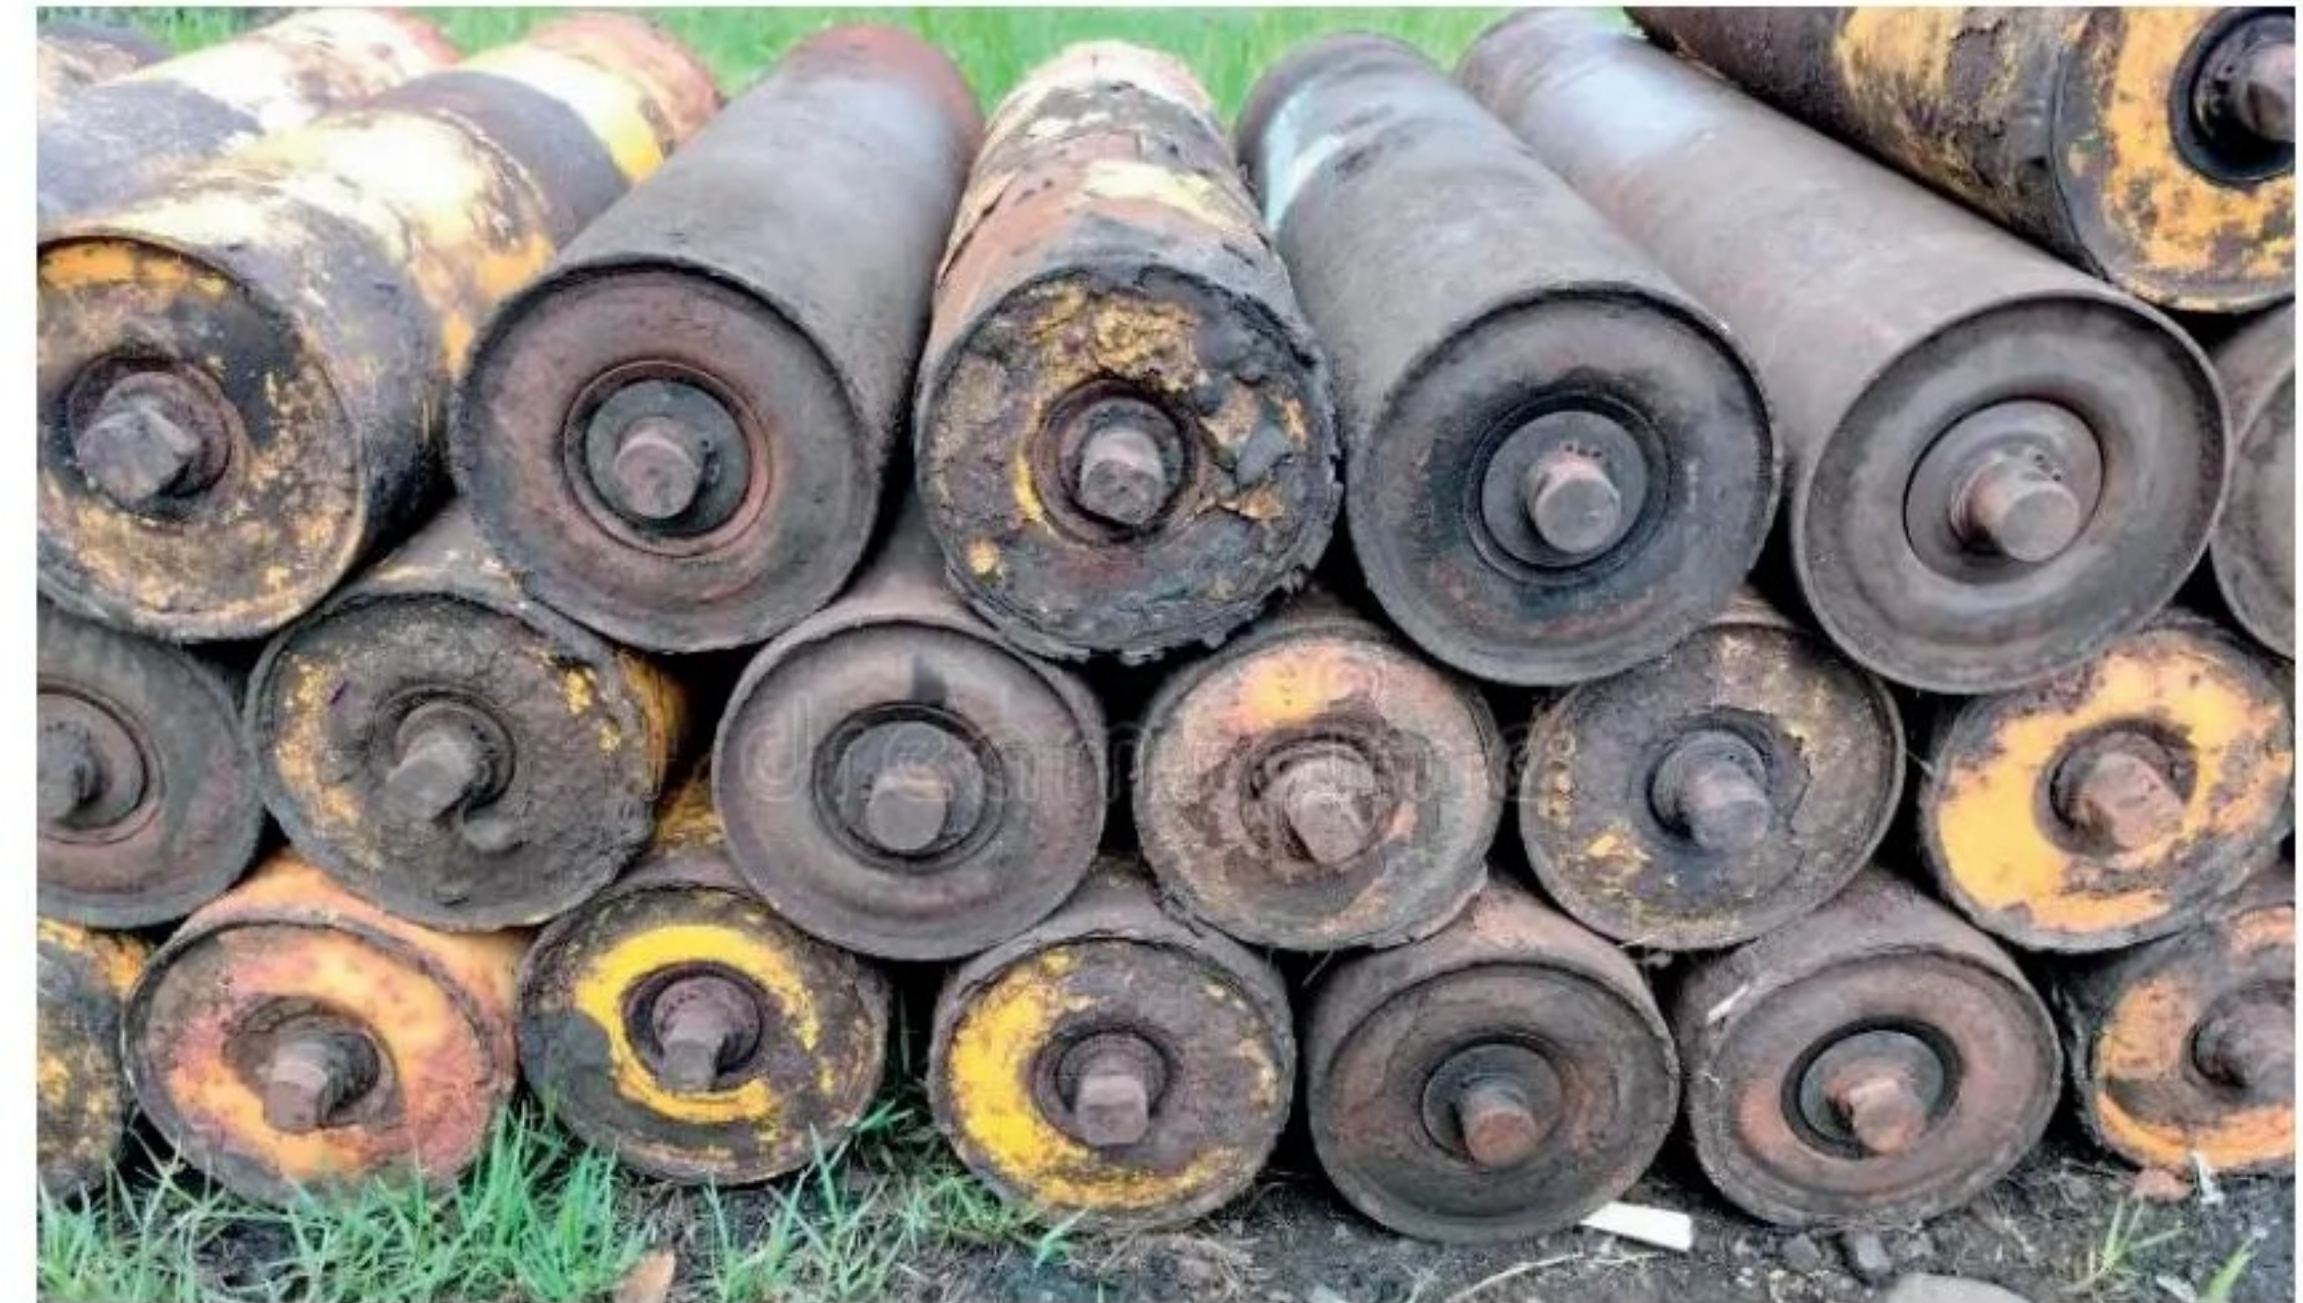
Figure 5. Low-priced components are low priced for a reason – they do not last.

Experience consistently proves that a purchasing policy based on the low buying price of a component rather than its whole life cost is a false economy. Low-grade bearings and rollers are susceptible to premature wear and can seize up or disintegrate very easily, causing significant friction that can lead to motor burnout or extremely expensive belt damage.

priced components are low priced for a reason. Precision-engineered bearings and robust rollers are more expensive to make, but they are specifically engineered for prolonged use and requiring less power to operate. Exactly the same principle applies when buying drive motors and conveyor belts.
