UNPLANNED CONVEYOR STOPPAGES

Steven Kidd, Conveyor Belt Specialist, outlines the causes and effects of unplanned conveyor stoppages, and investigates the extent to which repair costs and loss of productivity can be easily avoided.

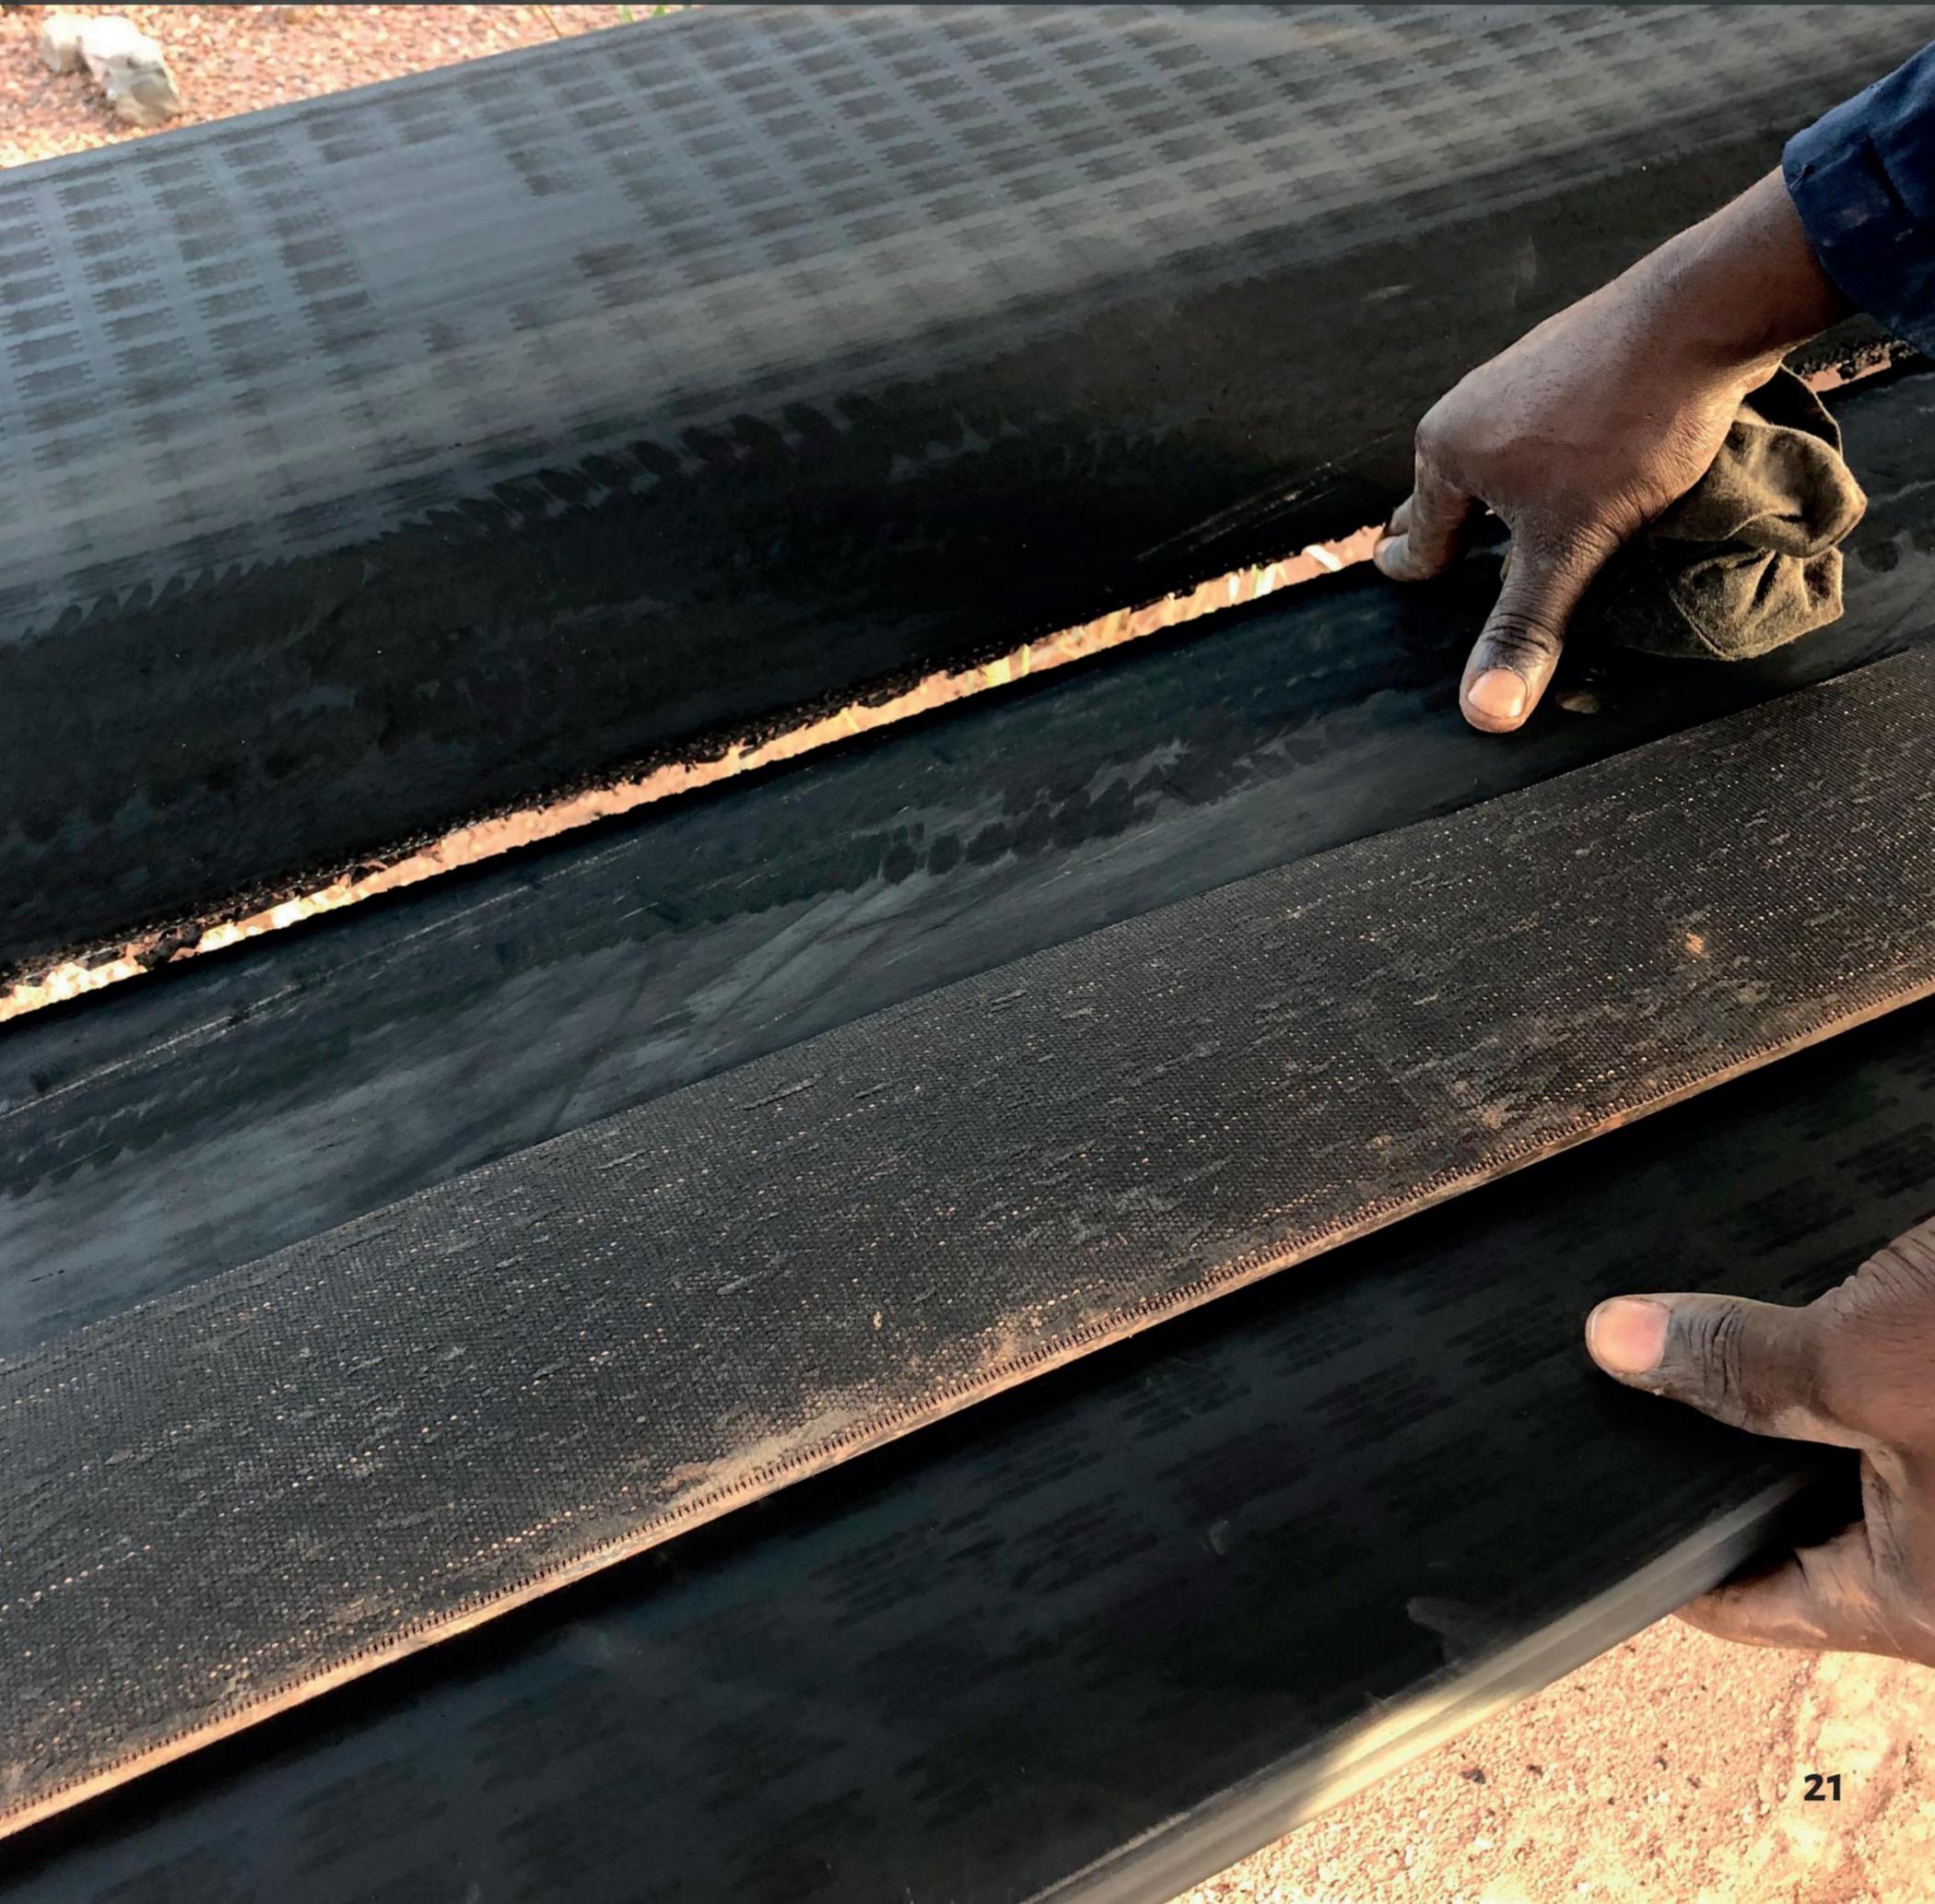
Figure 1. 'Cheap' imported belts are much more prone to ripping.

Despite apparently being the same specification on paper, the strength under load both longitudinally and transversely can be inconsistent. Although the amount of nylon used in the longitudinal strands of the fabric may be sufficient to achieve the required tensile strength, in an effort to reduce cost, the use of the nylon transversal weft material is often kept to a minimum and in many cases, not used at all.

Consequently, rip and tear resistance are reduced, leading to stoppages to carry out patch and clip repairs and, in more serious cases, inserts or whole belt replacement. In addition, low-quality fabric plies with an inconsistent longitudinal and/or transversal spread of tension can cause a conveyor to be stopped to rectify tracking, steering, and handling problems.

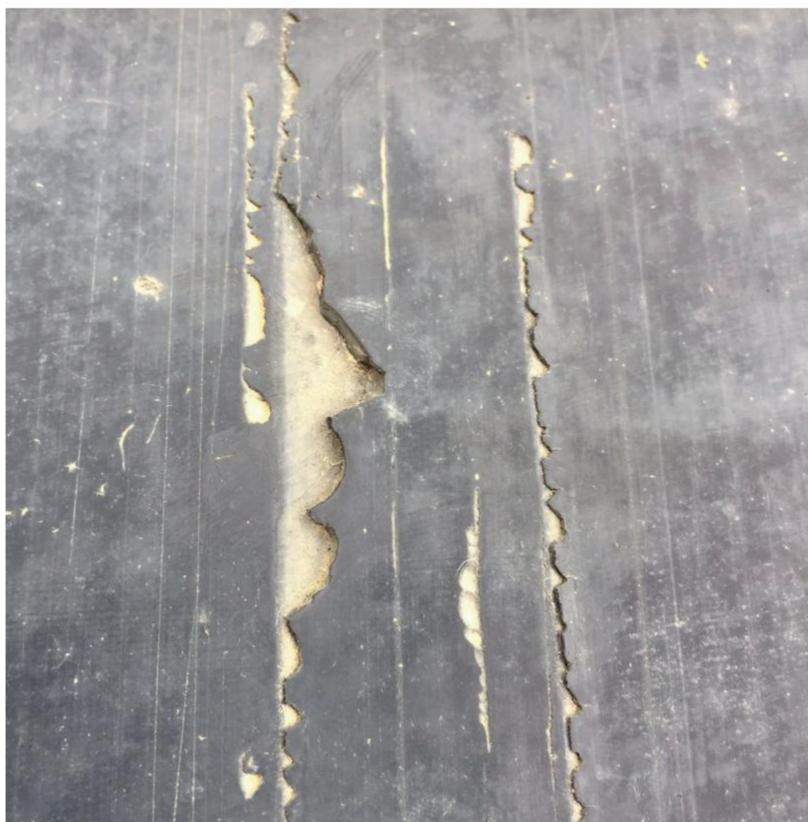
Figure 2. Surface cuts in low grade rubber propagate more quickly and link up with other areas of damage, causing pieces of rubber to detach completely.

Both standards measure abrasion resistance based on the amount of rubber lost during ISO 4649/DIN 53516 testing, but the test cannot measure resistance to cut and tear propagation. If it is insufficient, then a small area of damage can easily increase in size due to the continuous material loading and the flexing around the drums and pulleys, which spreads and links up with another area of damage causing pieces of rubber to be cut out from the surface and become yet another reason to stop and carry out running repairs.

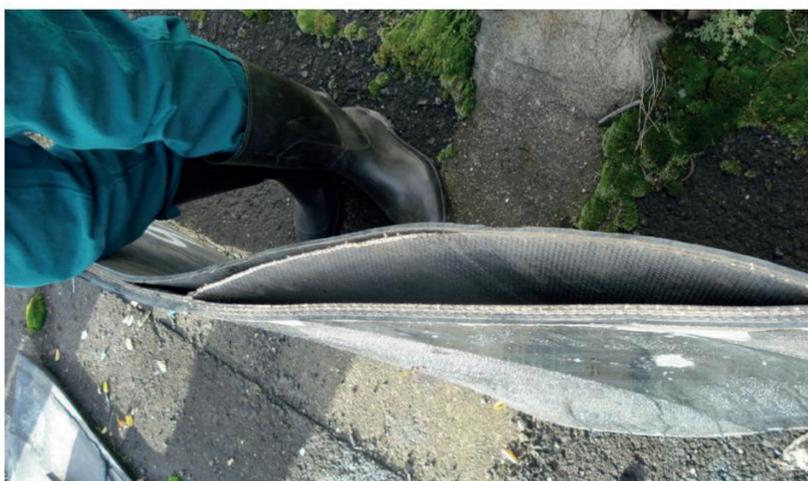
Figure 4. Insufficient elongation is a major cause of delamination.

Low elongation is another symptom of low-price multi-ply belting and is mostly an issue in areas where the belt needs to stretch, such as troughing and bending round pulleys, which can cause localised tension build-up leading to shear stresses that may in turn cause delamination (ply separation) issues.
