HANDLING THE HEAT

Dr Michiel Eijpe, Dunlop Conveyer Belting, provides a guide to heat-resistant conveyor belts.

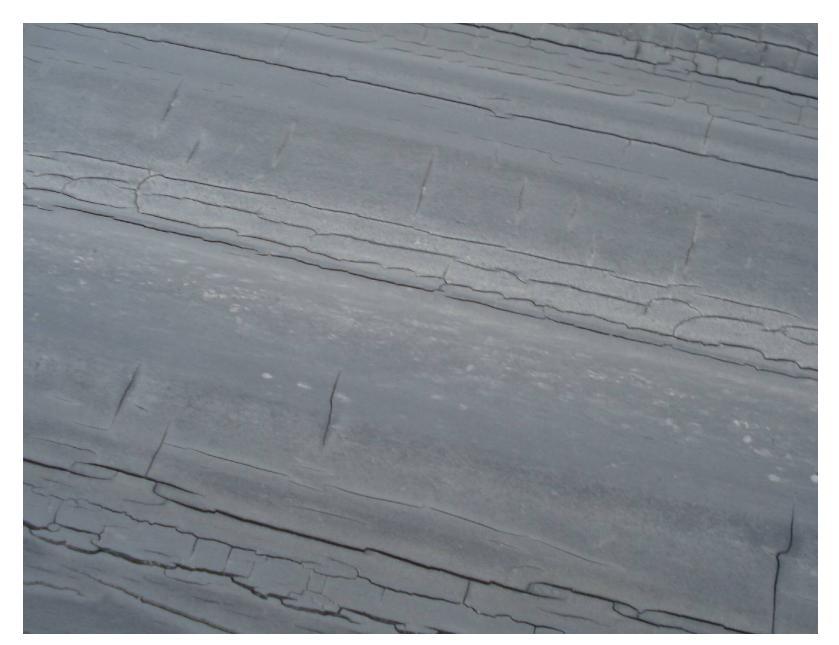
Cooked to perfection.

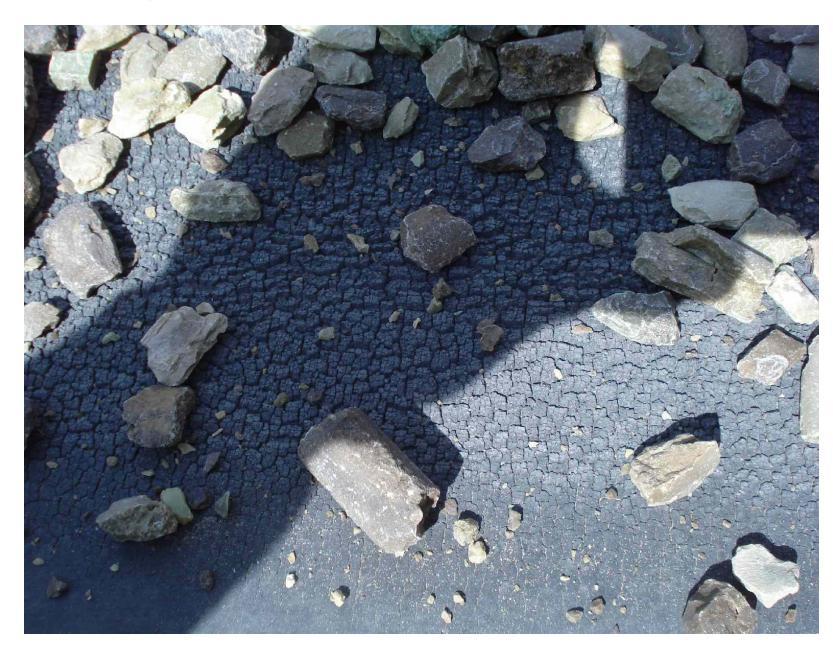
The result of poor heat-resistant rubber

Of all the demands placed on conveyor belts, heat is without question the most unforgiving and damaging. High-temperature materials and working environments cause a rapid acceleration in the ageing process. This results in a hardening and cracking of the rubber covers. High temperatures also have a very destructive effect on the actual carcass of the belt because it damages the adhesion between the covers on the top and bottom

of the carcass, as well as between the inner plies contained within the carcass. The layers of the belt literally detach themselves. This is known as delamination.

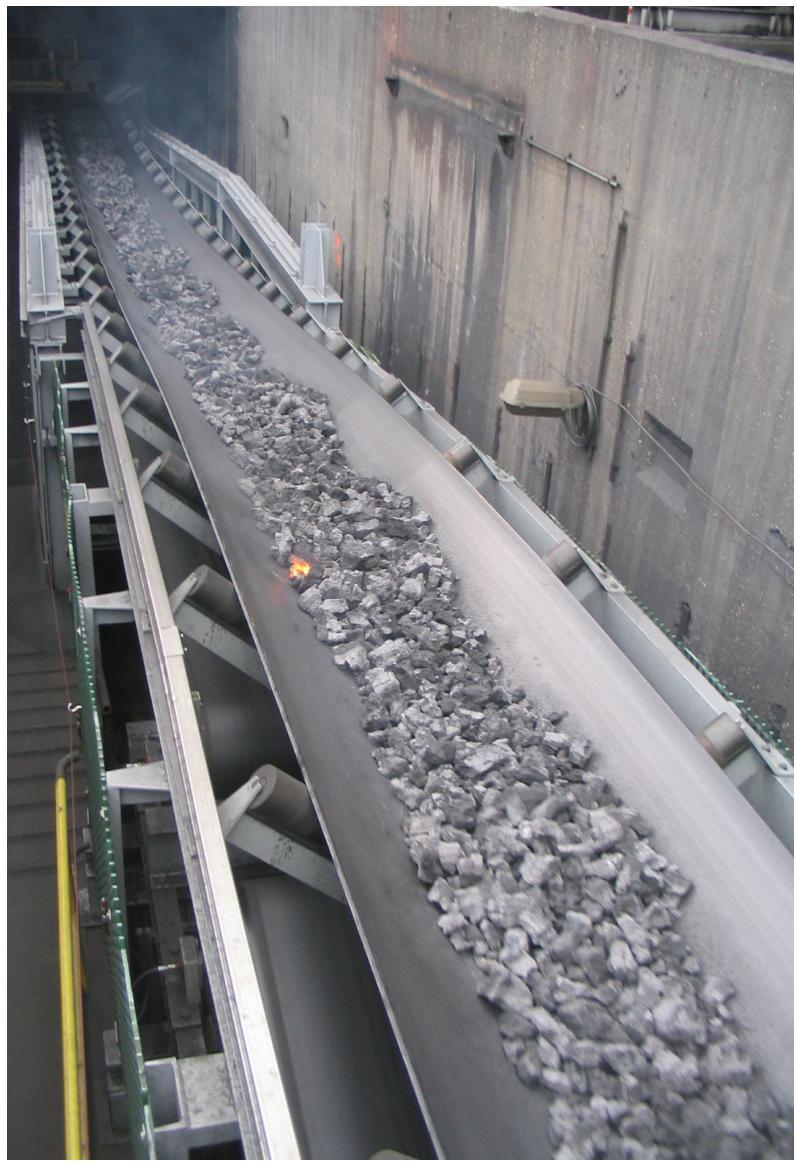
Heat-resistant belts usually have less resistance to abrasion.

The biggest downside to heat-resistant rubber is that the treatments used to create the heat resistance can also have a very negative effect on the rubber's ability to resist abrasion. As the covers protecting the carcass become thinner, the level of heat protection is gradually reduced. This invariably results in belts having to be replaced at much more frequent intervals than necessary.

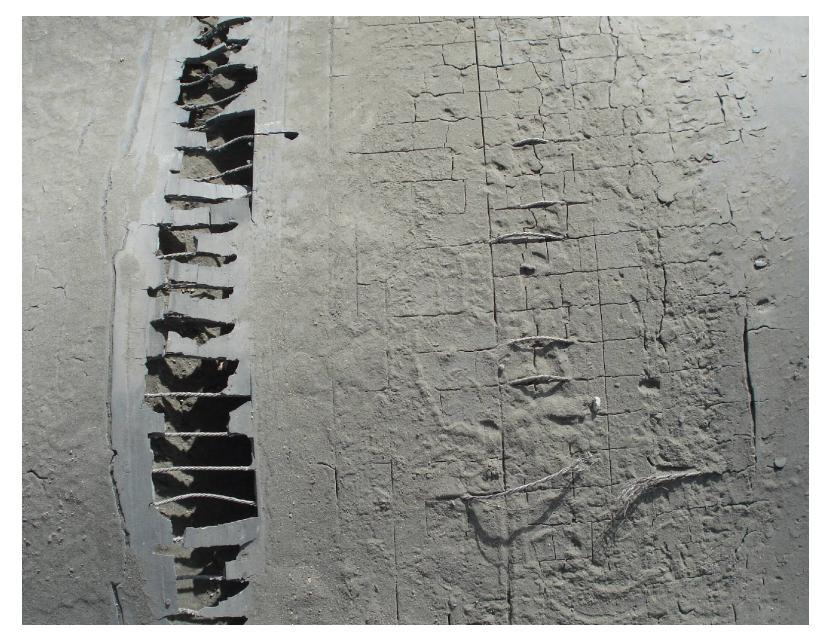
The heat build-up in enclosed environments is far higher than conventional conveyors.

The ultimate test of heat-resistant belting is usually bucket elevator systems because the heat build up in enclosed environments is far higher than conventional conveyor systems. Bucket elevator belts need to operate under high tensile loads and be able to withstand material temperatures as high as 130°C. Conventional textile-reinforced belts cannot withstand this kind of treatment and will stretch permanently. Ideally, bucket elevator belts should be steel reinforced.

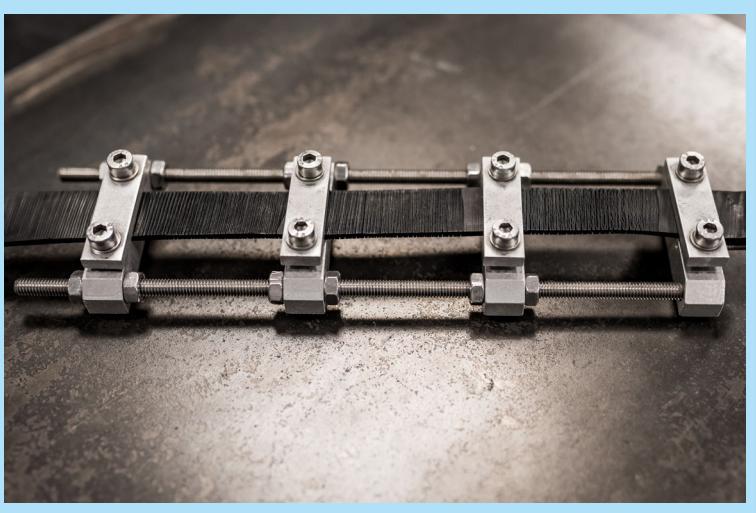
Ozone test sample.

Exposure to ozone increases the acidity of carbon black surfaces and causes reactions to take place within the molecular structure of the rubber. This can have several consequences, such as a surface cracking, a marked decrease in the tensile strength of the rubber and consequently a much shorter belt life. The same applies to exposure to UV light (including fluorescent light) and is referred to as UV degradation.

Apart from the damage caused in their own right, the cracking of the rubber covers by ozone and UV exposure also plays a major role in magnifying other causes of damage. The cracks allow heat to penetrate the carcass more easily. At the same time, as the rubber becomes more brittle and loses strength, it also loses the ability to resist wear.
