# THE HEATTER OF THE MATTER

Leslie David, Conveyor Belt Specialist, highlights how deficiencies in the carcass of a conveyor belt significantly reduce both performance and longevity.

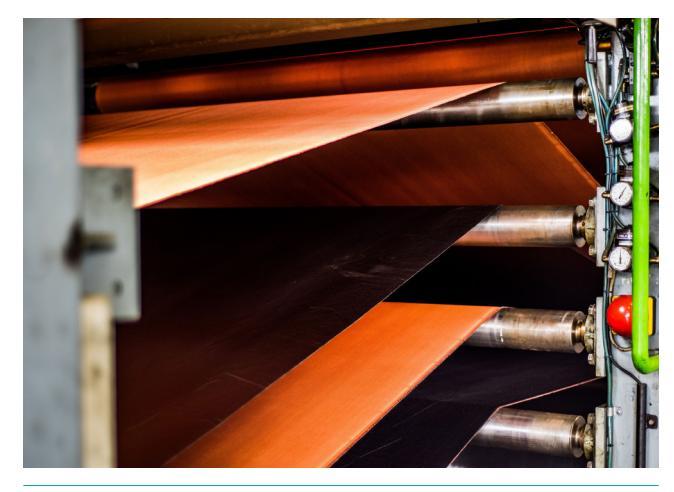
Figure 2. Not what they seem – some belts are supplied totally EE fabric plies in a carcass declared as being an EP carcass.

Unfortunately, due to price competition, it is becoming increasingly common for some manufacturers, traders, and importers to supply belts that have totally polyester (EE) fabric plies in a carcass that is declared to be a polyester/nylon mix (EP) construction. The reason for this deception is that EE fabric costs some 30% less than EP fabric. This is significant because, after rubber, the fabric is the highest cost component, so using cheaper polyester fabric is a big help towards achieving the perception of a lower 'like for like' price.

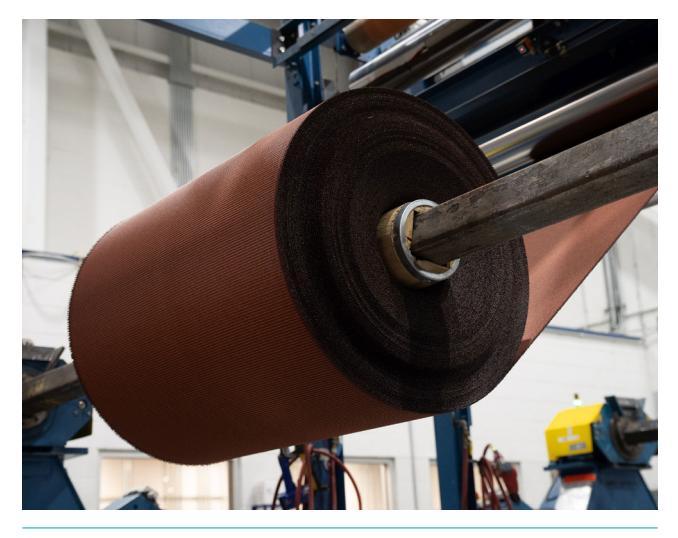
Figure 3. There can be enormous differences in the strength and quality of the fabric, and a corresponding difference in their cost.

There can be enormous differences in the strength and quality of the actual fabric, and a corresponding difference in their cost. Yet again, this is almost entirely influenced by whether the belt manufacturer is at the 'quality end' of the market or the 'cut-throat' end. Although they may be the same specification on paper, the strength under load, both longitudinally and transversely, can be inconsistent and prone to steering and handling problems.

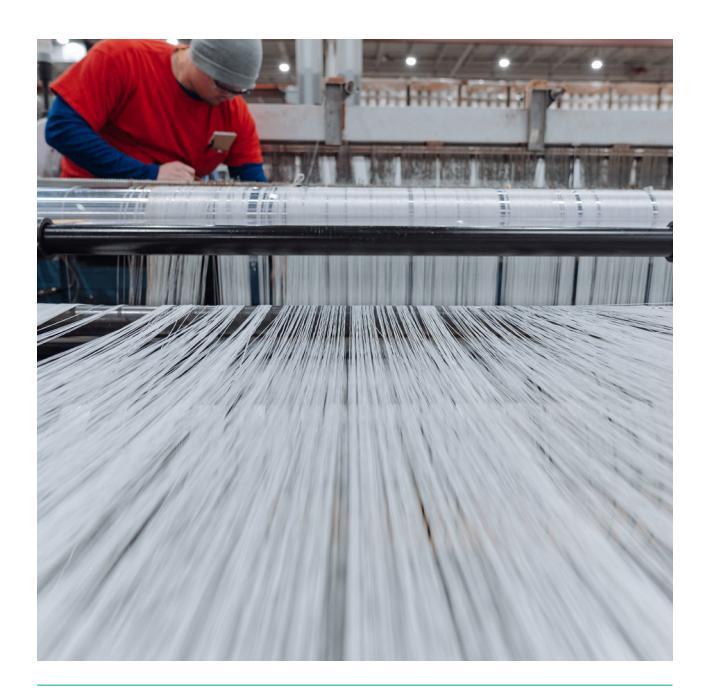
Figure 4. Fenner Dunlop engineer and manufacture their own 'special task' fabrics.

The unique range of special fabrics developed and manufactured by Fenner Dunlop provide an example of 'specific task engineering'. What they all have in common is weave patterns that consist of longitudinal strands lengthwise, and heavy strands running crosswise, held in position by a strong yarn. In Fenner Dunlop's UsFlex fabrics, the strands are completely straight in both directions and not interlocked as in conventional fabric. This allows the weft to float free from the warp, creating a shock absorber effect by dissipating impact energy over a larger area, allowing the belt to withstand the kind of punishment that would destroy a normal multi-ply belt. Arguably even more important is the ability to resist rip and tear damage. When penetrated, and being pulled through a trapped object such as a large, sharp rock, the unique weave design allows the strands to gather in a bundle that can eventually become strong enough to stop the belt or even expel the object causing the damage. Strange as it may seem, synthetic plies are usually more effective than steel when it comes to minimising the length of a rip.

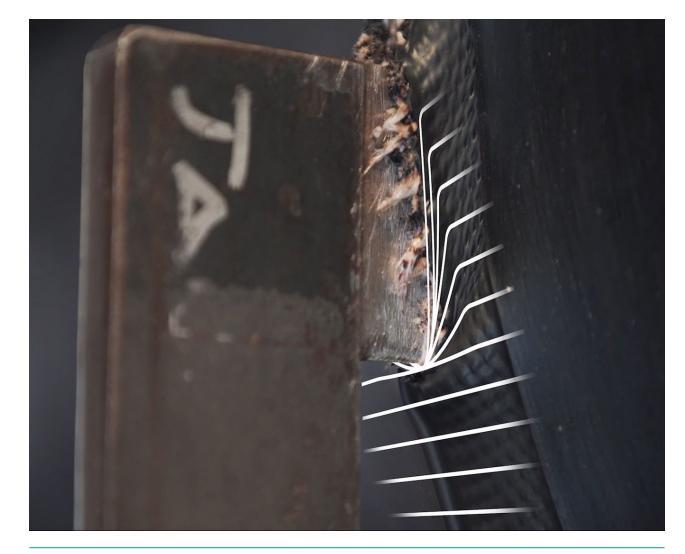
Figure 5. Weft strands bundle together to stop the belt or expel the penetrating object (Source: Fenner Dunlop).

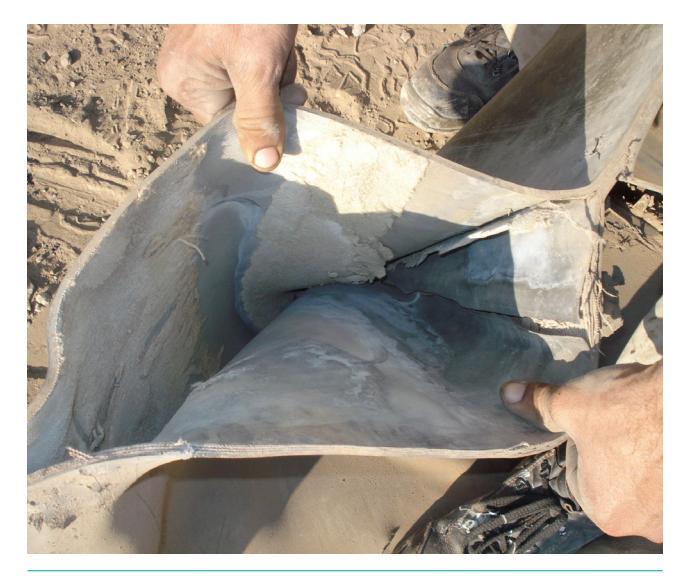
Figure 6. Delamination – layers separate and the belt falls apart.

The term 'adhesion' relates to the adhesive bond between the inner ply layers to adjoining layers, and between the surfaces of the outer plies and the rubber covers. It is defined as the force required to separate adjoining plies and/or between the plies and the outer covers. The adhesion properties of a belt are fundamental to its durability, functionality, and structural integrity, and determine a belt's ability to trough and carry heavy loads without the risk of ply separation. Conveyor belts continually flex over pulleys and drums, which creates stress. It is therefore essential that the belt has adequate ply adhesion to withstand this stress without delaminating (where the various layers separate, and the belt literally falls apart).

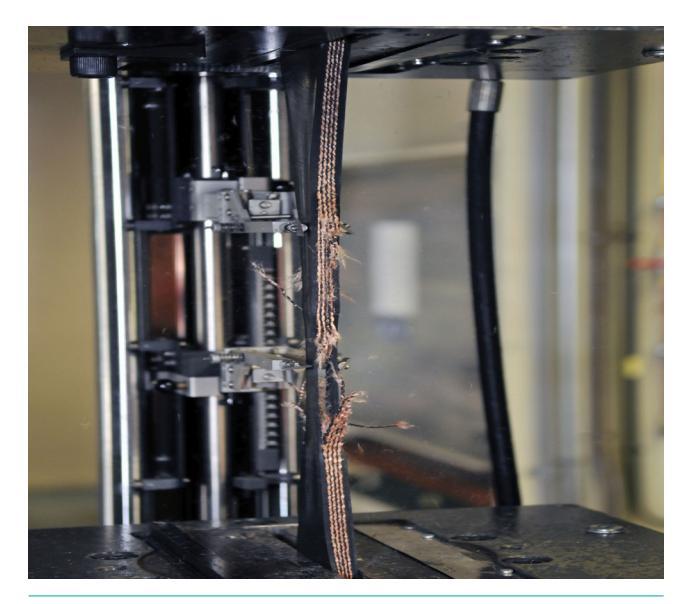
Figure 7. Elongation at break is the amount of elongation at the moment the belt breaks.

Elongation is an often-misunderstood technical term applied to rubber conveyor belts. It is best defined as the change in length (stretch) of a belt when subjected to tensile stress of which there are three forms - elastic elongation, permanent elongation, and elongation at break. With each tensile stress below break load, the belt is subject to an elongation which, when the stress is relieved, partly recovers (elastic elongation) and partly remains (permanent elongation). The elongation at break is the amount of elongation at the moment the belt breaks. All three forms are effectively determined by the properties engineered into the belt during its manufacture. The primary influence on those properties is the quality, type, and weave design of the fabric plies, and secondary are the elongation characteristics of the rubber covers.
