Thanks to advances in rubber technology, the wear life of today's industrial conveyor belts should be at least two or times longer than it was as recently as a decade ago. Here, conveyor specialist Bob Nelson explains the causes and effects of conveyor belt wear and tear and the reasons why there are such huge differences in operational lifetime and durability between one manufacturer and another.

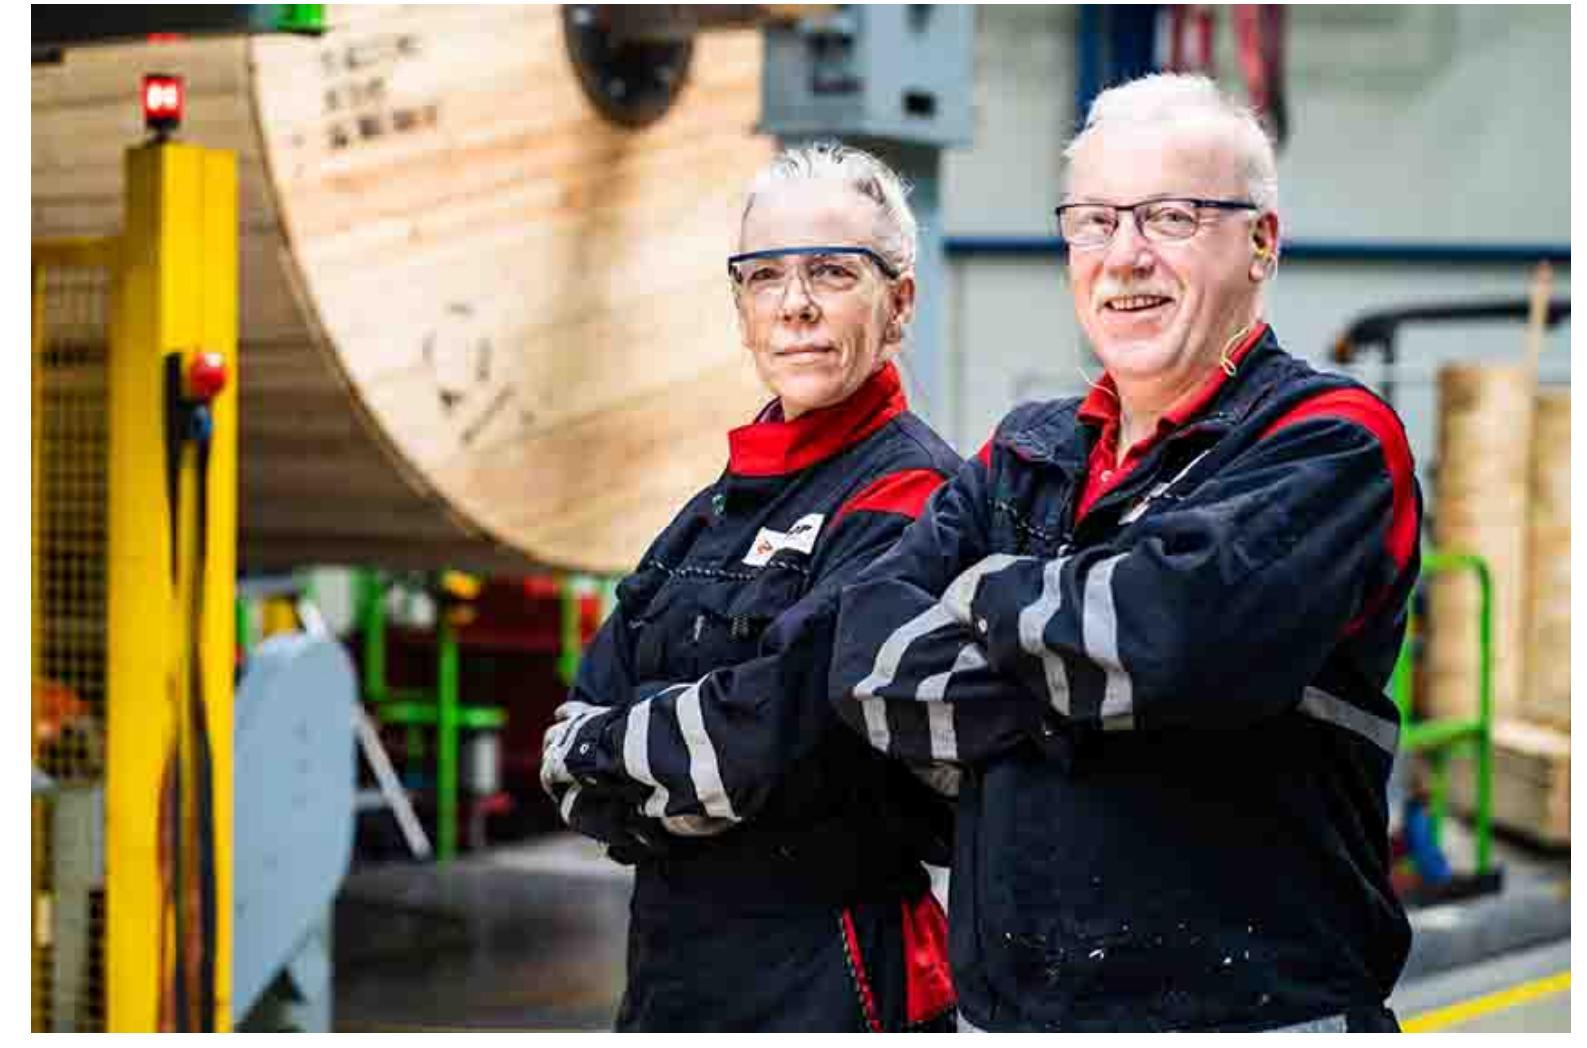
Always check the origin of manufacture

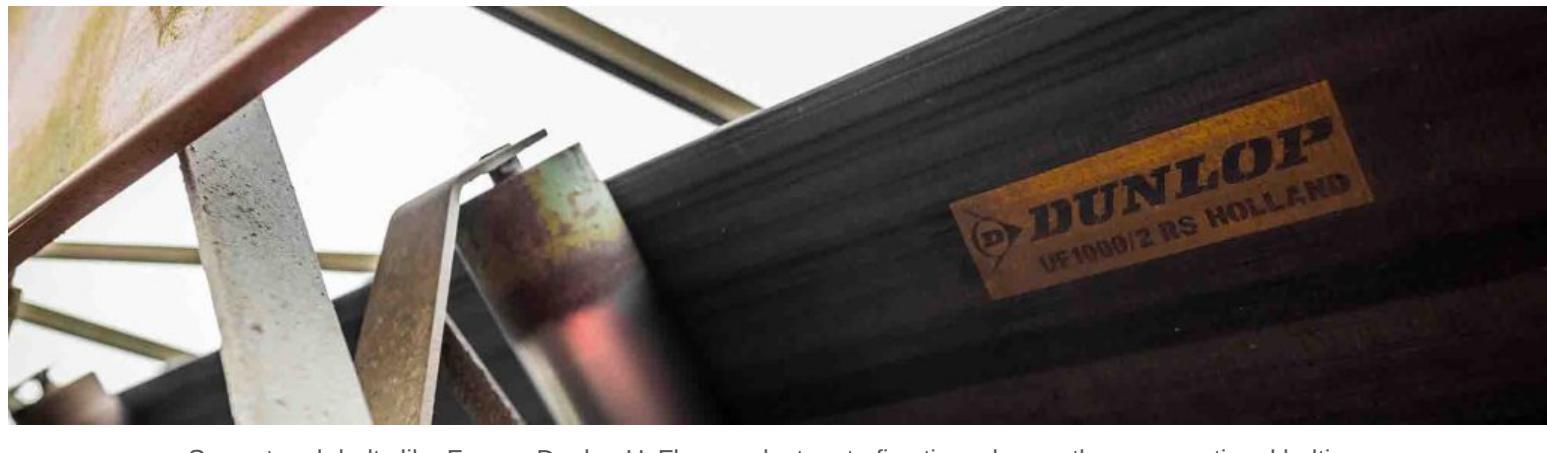
Super-tough belts like Fenner Dunlop UsFlex can last up to five times longer than conventional belting.

The most practical and economical solution is to fit a conveyor belt that has been specifically engineered for the purpose, such as Fenner Dunlop UsFlex or Ultra X, which are proven to last up to four or five times longer than conventional multi-ply conveyor belts. True, the initial buying price will be much higher but over the lifetime of the belt, the cost will be substantially less, as well as significantly less output disruption caused by unplanned stoppages to carry out repairs. As they say, price is what you pay but cost is what you actually spend.

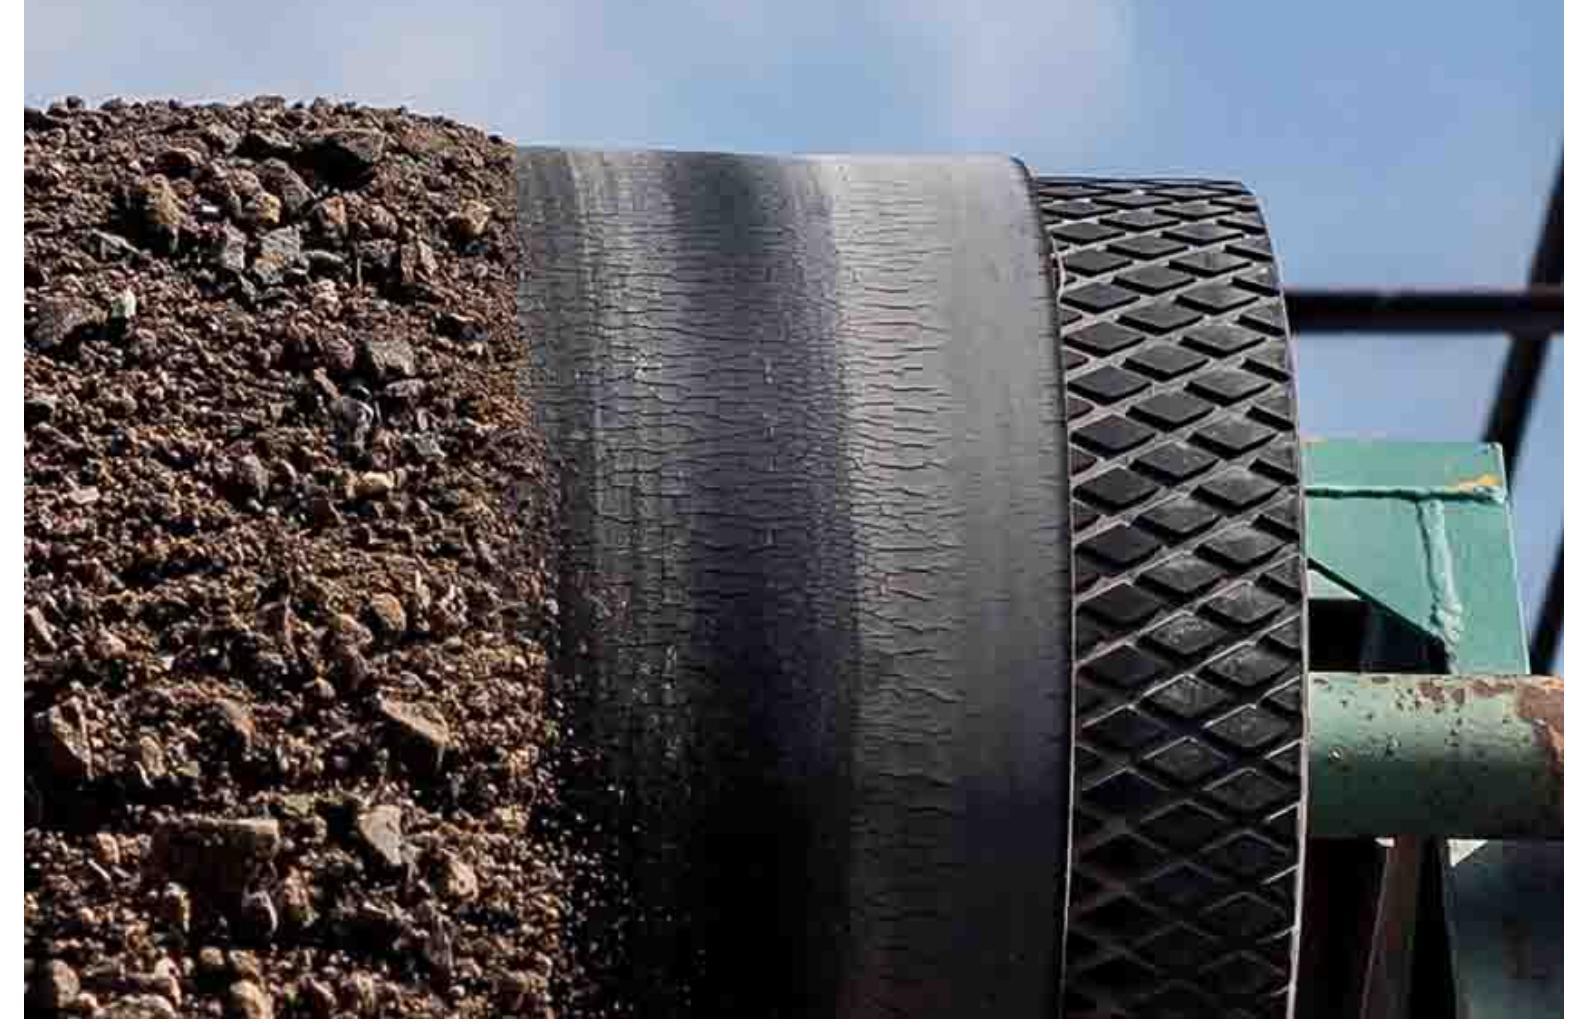
Cracking up - ozone and ultraviolet light accelerate wear and tear.

Although protection against ozone and ultraviolet damage is easy to achieve by using antioxidants within the rubber compound, laboratory testing reveals that some 90% of belts sold in Europe, Asia and Africa have virtually no protection. The reason is that antioxidants are regarded as an 'avoidable cost' by manufacturers wishing to be 'competitively' priced. The solution, therefore, is to always insist on the provision of certification confirming that the belt you are buying has successfully passed the EN ISO 1431/1 procedure B static ozone resistance test (@20% elongation; 50 p.p.h.m. ozonised air and 40°C).

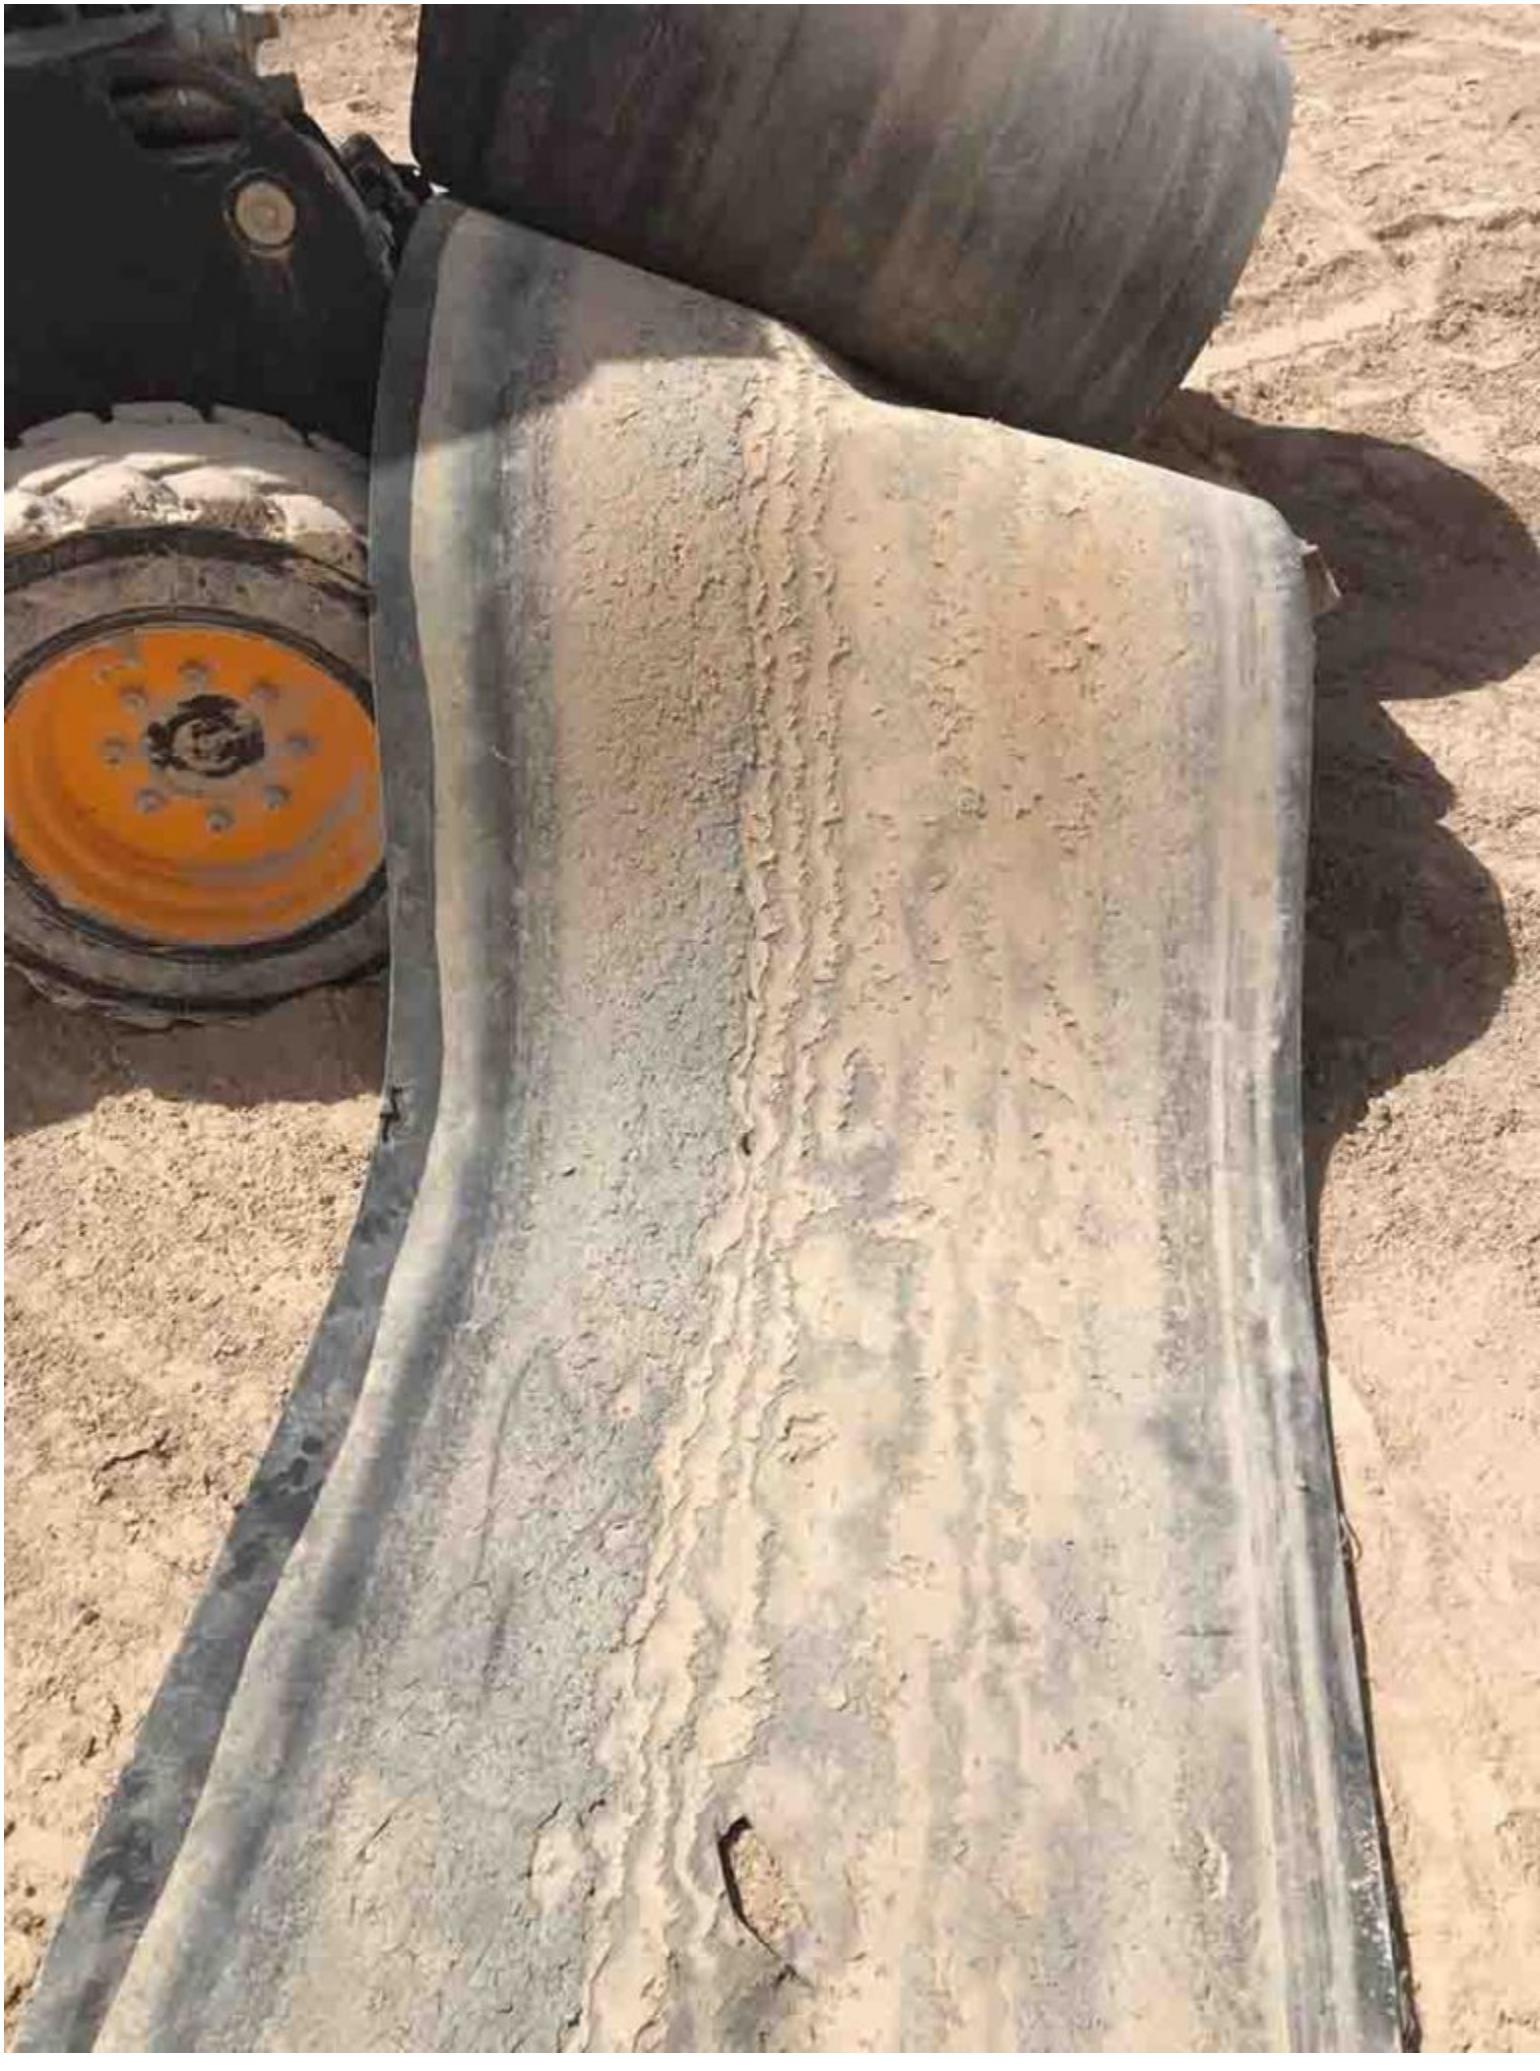
The biggest single cause of rapid cover wear is poor quality rubber

Rubber forms some 50% of the cost of a conveyor belt so it is consequently the biggest opportunity for manufacturers to cut costs in order to achieve greater price competitiveness. In such a cut-throat market, it is therefore no surprise that the primary reason why belts lack durability, is that they have been made using low grade 'economy' raw materials.
