TECHNICAL INFORMATION BULLETIN

THE EFFECTS OF OZONE ON RUBBER CONVEYOR BELTS

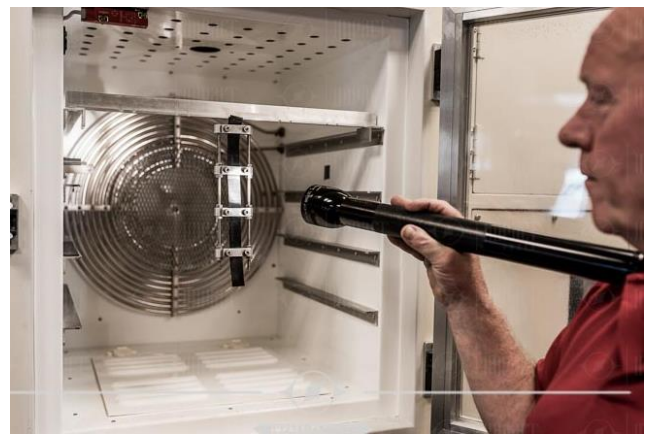
Testing at Dunlop lab

To scientifically measure resistance to ozone, samples are placed under tension (20% elongation) inside the ozone testing cabinet and exposed to highly concentrated levels of ozone for a period up to 96 hours. At Dunlop the pass criteria is that the rubber sample does not show any signs of cracking after 96 hours (@ 20°C, 50 ppm and 20% strain) inside the ozone cabinet. Every sample is closely examined for evidence of cracking at two-hourly intervals and the results carefully measured and recorded. As a general rule, based on experience, failure to exceed more than 8 hours under test without surface cracking will most certainly mean that the belt will start to deteriorate in less than 2 years. In many cases, particularly in coastal locations, deterioration will begin within a matter of months.

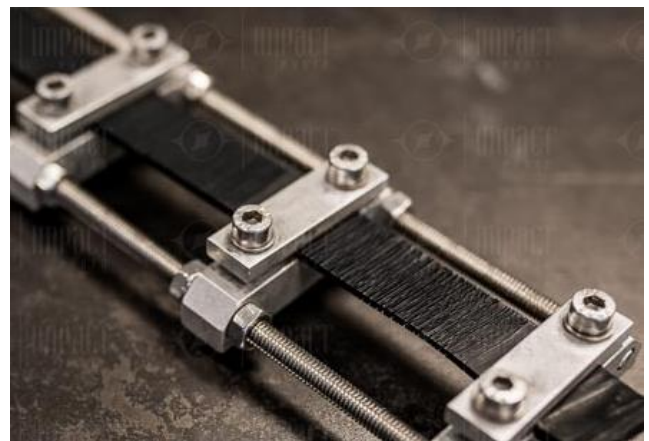
The effect of the exposure to ozone

At first glance, fine cracks in the surface rubber may not seem to be a major problem but over a period the rubber becomes increasingly brittle. Transversal cracks deepen under the repeated stress of passing over the pulleys and drums and, if the conveyor has a relatively short transition distance, longitudinal cracks can also begin to appear.

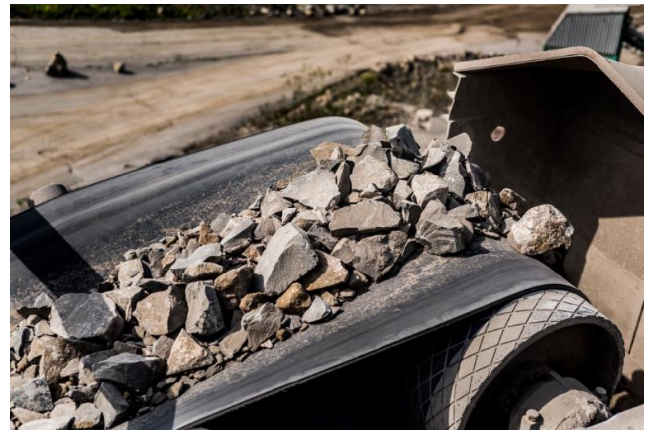
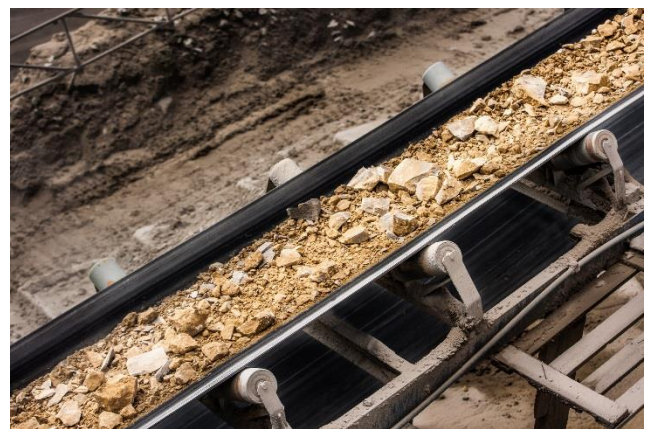
Exposure to ozone may decrease the tensile strength of the rubber, which is crucial some industries.
