# Ozone and UV Damage to Rubber Conveyor Belts

## The effects of exposure to ozone

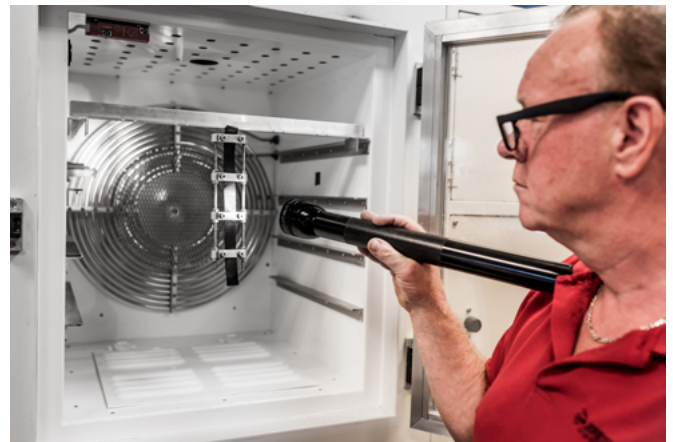
*Testing at Fenner Dunlop lab.*

To scientifically measure resistance to ozone, samples are placed under tension at 20% elongation inside an ozone testing cabinet and exposed to highly concentrated ozone levels for up to 96 hours.

At Fenner Dunlop, the pass criterion is that the rubber sample must show no signs of cracking after 96 hours at 20°C, 50 pphm and 20% strain. Each sample is closely examined for evidence of cracking at two-hour intervals, and the results are carefully measured and recorded.

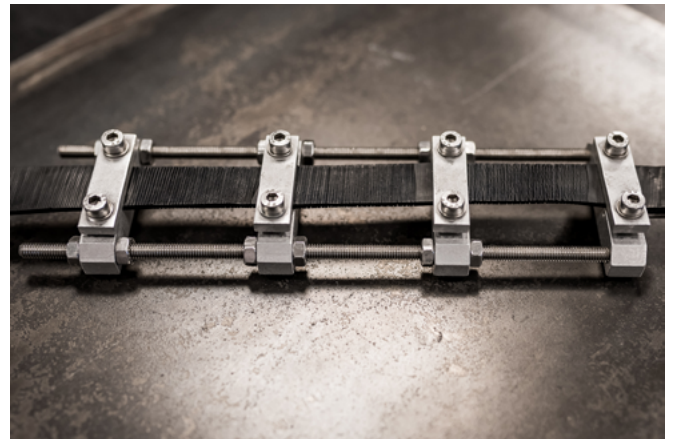
*The effect of the exposure to ozone.*

Exposure to ozone increases the acidity of carbon black surfaces and causes reactions within the molecular structure of the rubber. This can result in surface cracking and a reduction in the tensile strength of the rubber.

Transverse cracks deepen under the repeated stress of passing over pulleys and drums. If the conveyor has a relatively short transition distance, longitudinal cracks may also begin to appear.

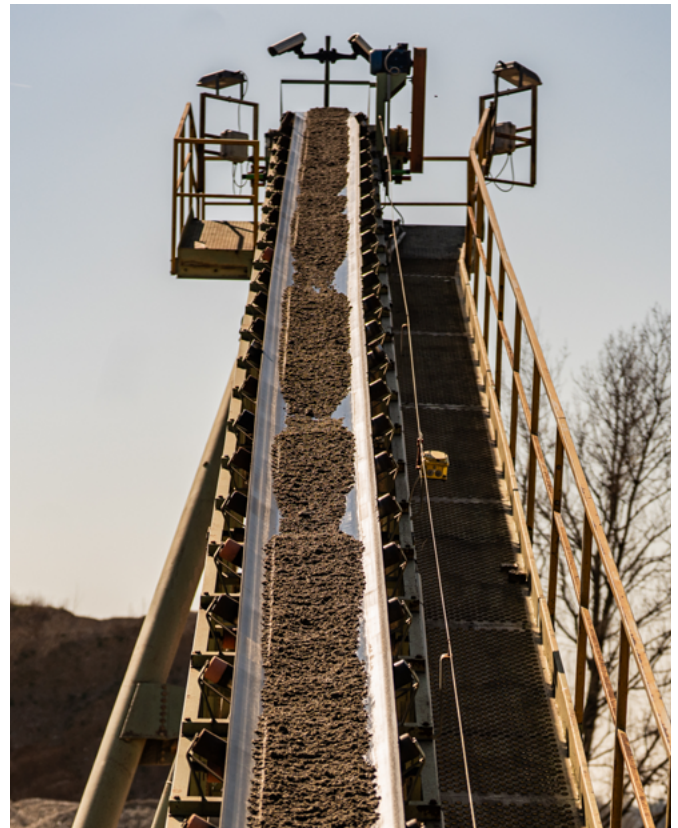
*Exposure to ozone may decrease the tensile strength of the rubber, which is crucial some industries.*
